20720 Goshen Road
November 12, 2006

Dispatch 1953
06-0100855

This document contains analysis from the Incident Commander as well as the input from company officers operating on the fireground. A PIA is required by FRC Policy 20-02. A firefighter was hospitalized from this incident prompting a formal review by policy.

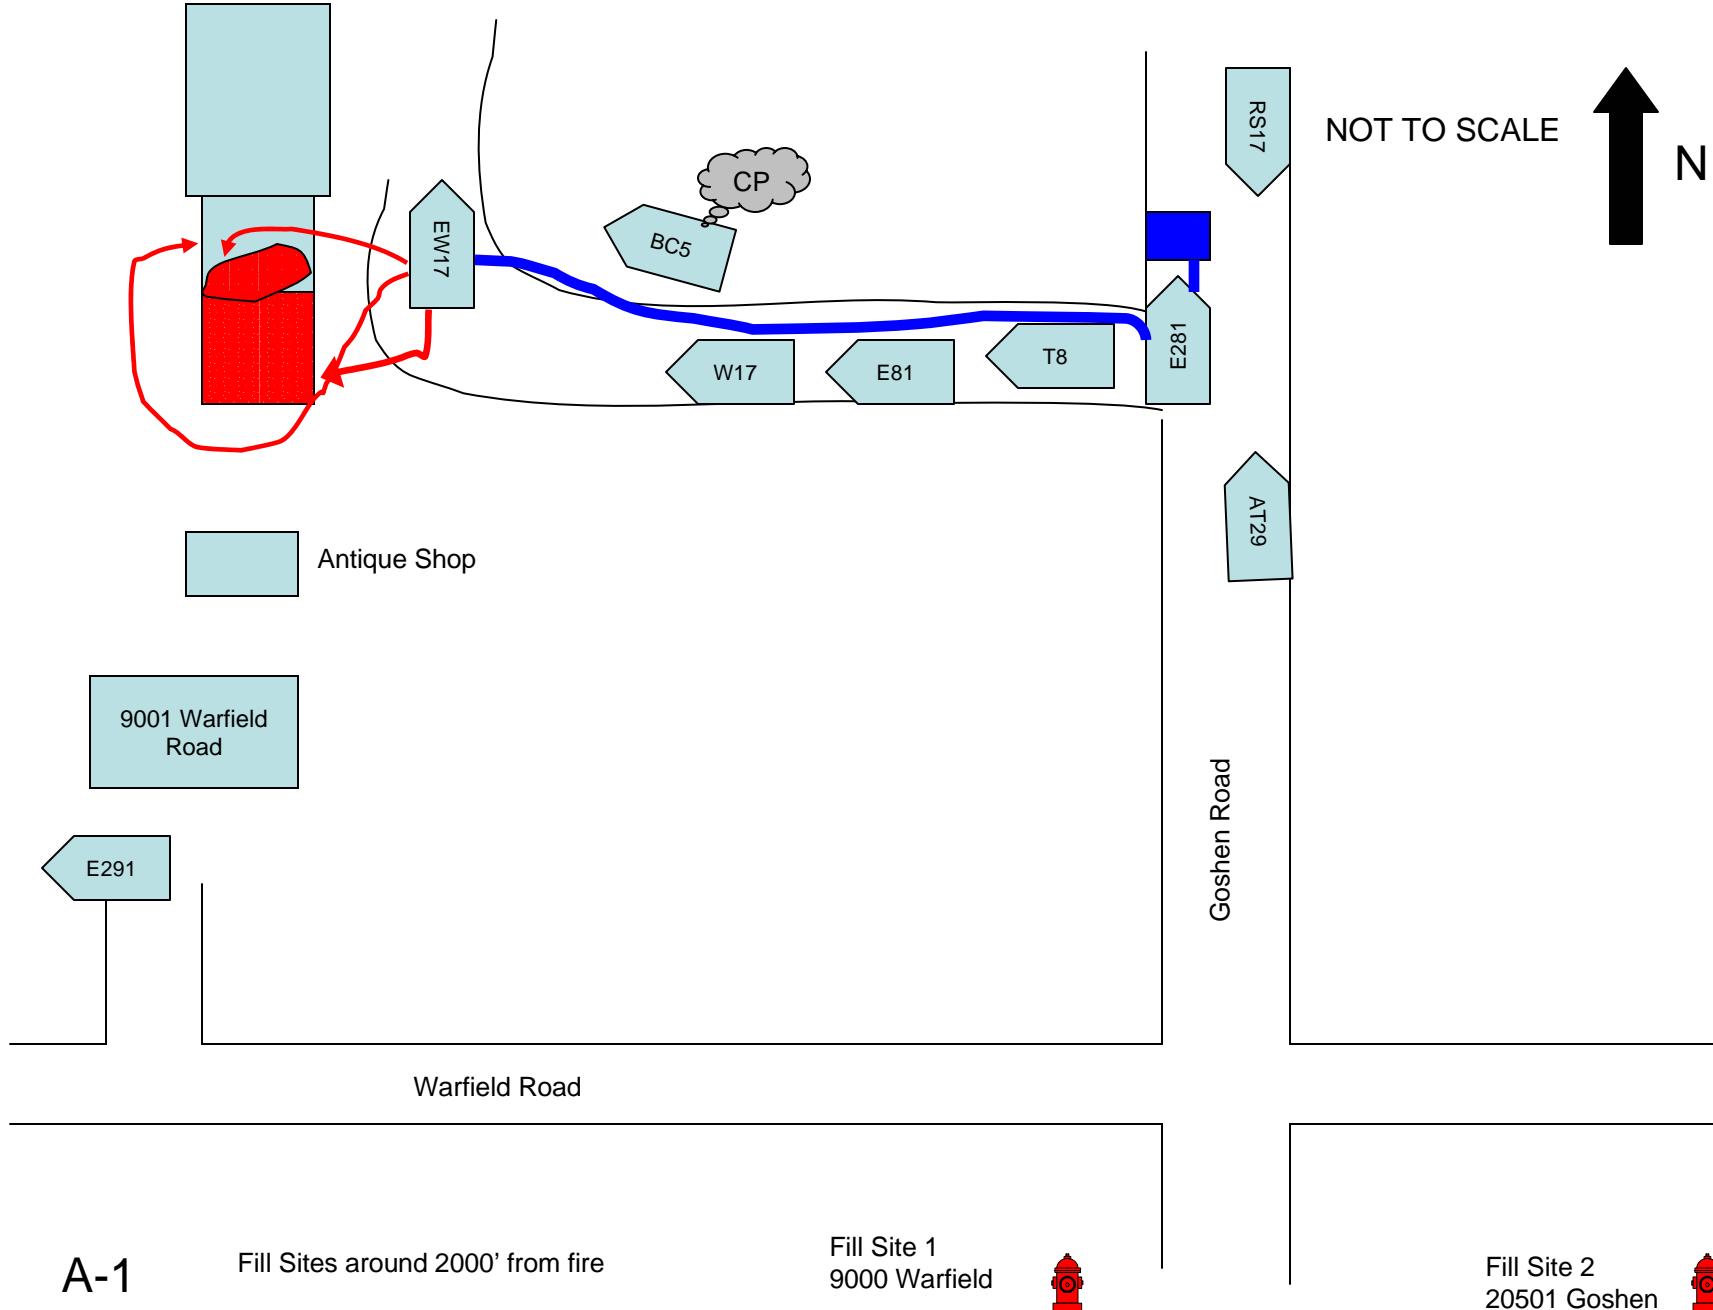
NOT TO SCALE

20720 Goshen Road

11/12/06

Position of Units at time of PAS Activation
MAYDAY 20:16
