## **Piney Branch Special Protection Area**

### **4.3.1 Description of the Piney Branch SPA Watershed**

### **4.3.2 Status of Development in Piney Branch SPA as of June 2003**

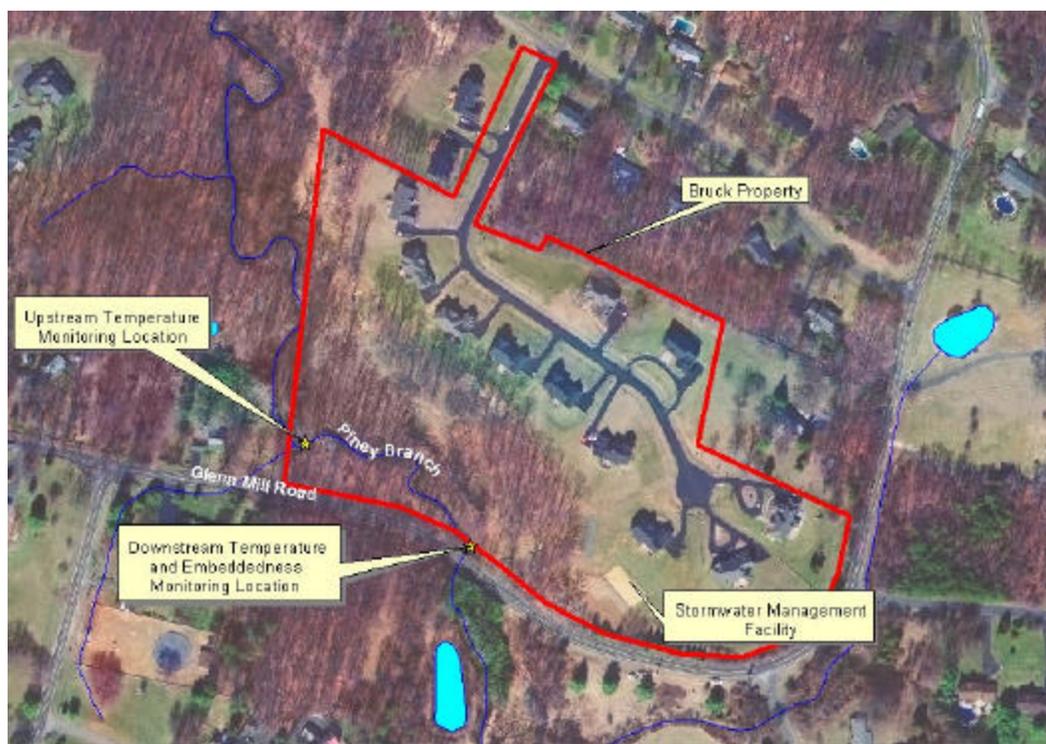
**Figure 50 Aerial Photo of Bruck Property**

photo taken 12/02

BMP monitoring includes two continuous water temperature loggers and one stream habitat / embeddedness monitoring station. One temperature logger is placed near the western property line, the other at the southern property line where the stream exits the property. Habitat and embeddedness monitoring is done near the point that Piney Branch exits the property (Figure 50).

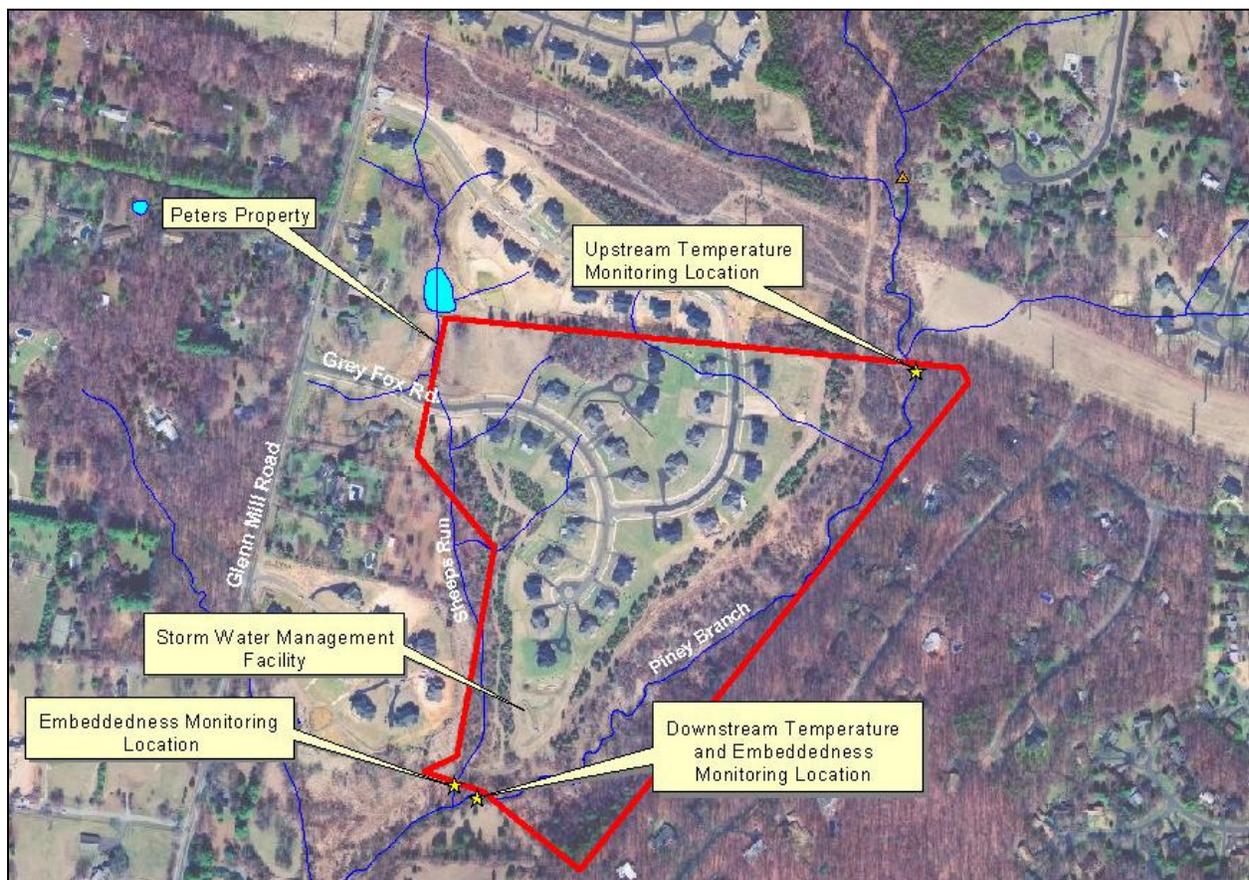
**Figure 55 Aerial Photo of Peters Property - Construction Completed in Dec. 2001** Photo taken 12/02

BMP monitoring includes the following (see Figure 55 for monitoring locations):

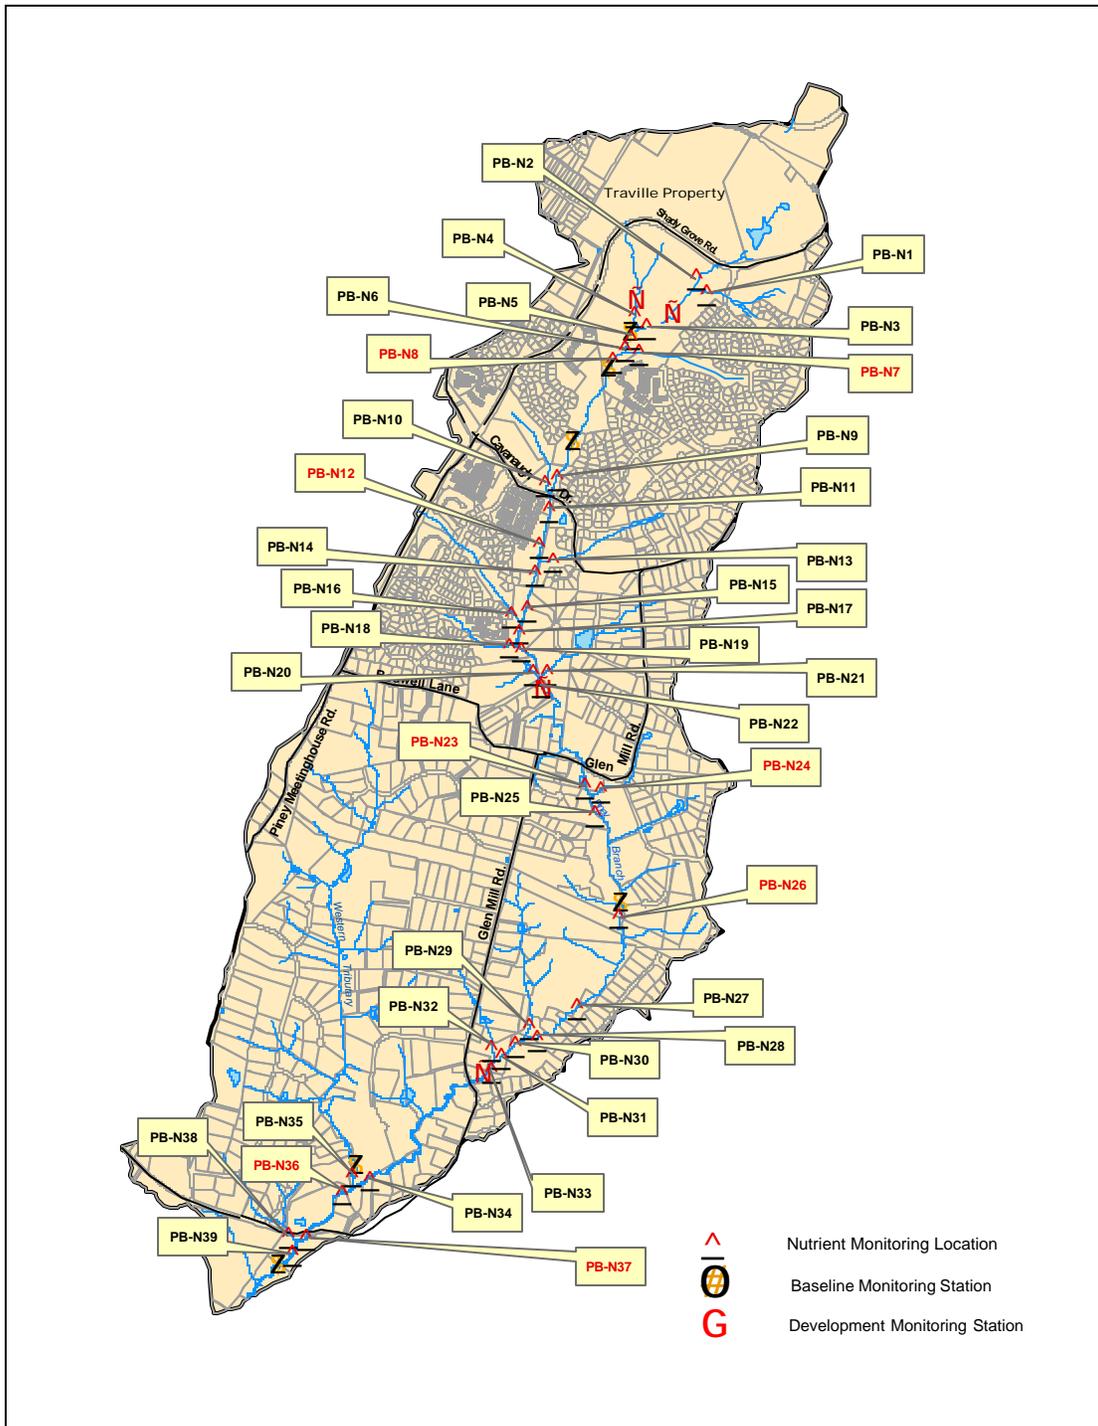
Figure 68 Nutrient Monitoring Sites - Samples Labeled in Red Were Analyzed by WSSC Lab

The study was designed to get a 'snapshot' of nutrient concentrations from throughout Piney Branch during baseflow condition when stream flow originates mainly from groundwater input. Nutrient parameters analyzed were nitrate and ortho-phosphate. CHEMetrics field test kits were used for sample analysis. Detection limits on the field test kits were 0.1 ppm for nitrate and 0.05 ppm for ortho-phosphate. Eight (8) samples were sent to the WSSC lab for comparison with and validation of field test kits. Thirty nine (39) locations throughout Piney Branch were selected to isolate most tributaries ( Figure 68). Two rounds of sampling were completed, one on 3/7/02 the other on 8/15/02.
