SWM #67
 8' WIDE SWALE WITH 56 UNIT RAINSTORE
 (MODIFIED DETAIL SW-301 W/O PARKING)
 DEPTH OF FACILITY = 4.0'

Redesign of SWM#53
 Reason for Design Change:
 Property Owner Request
 Date: 12/13/13
 Scale: 1" = 20'

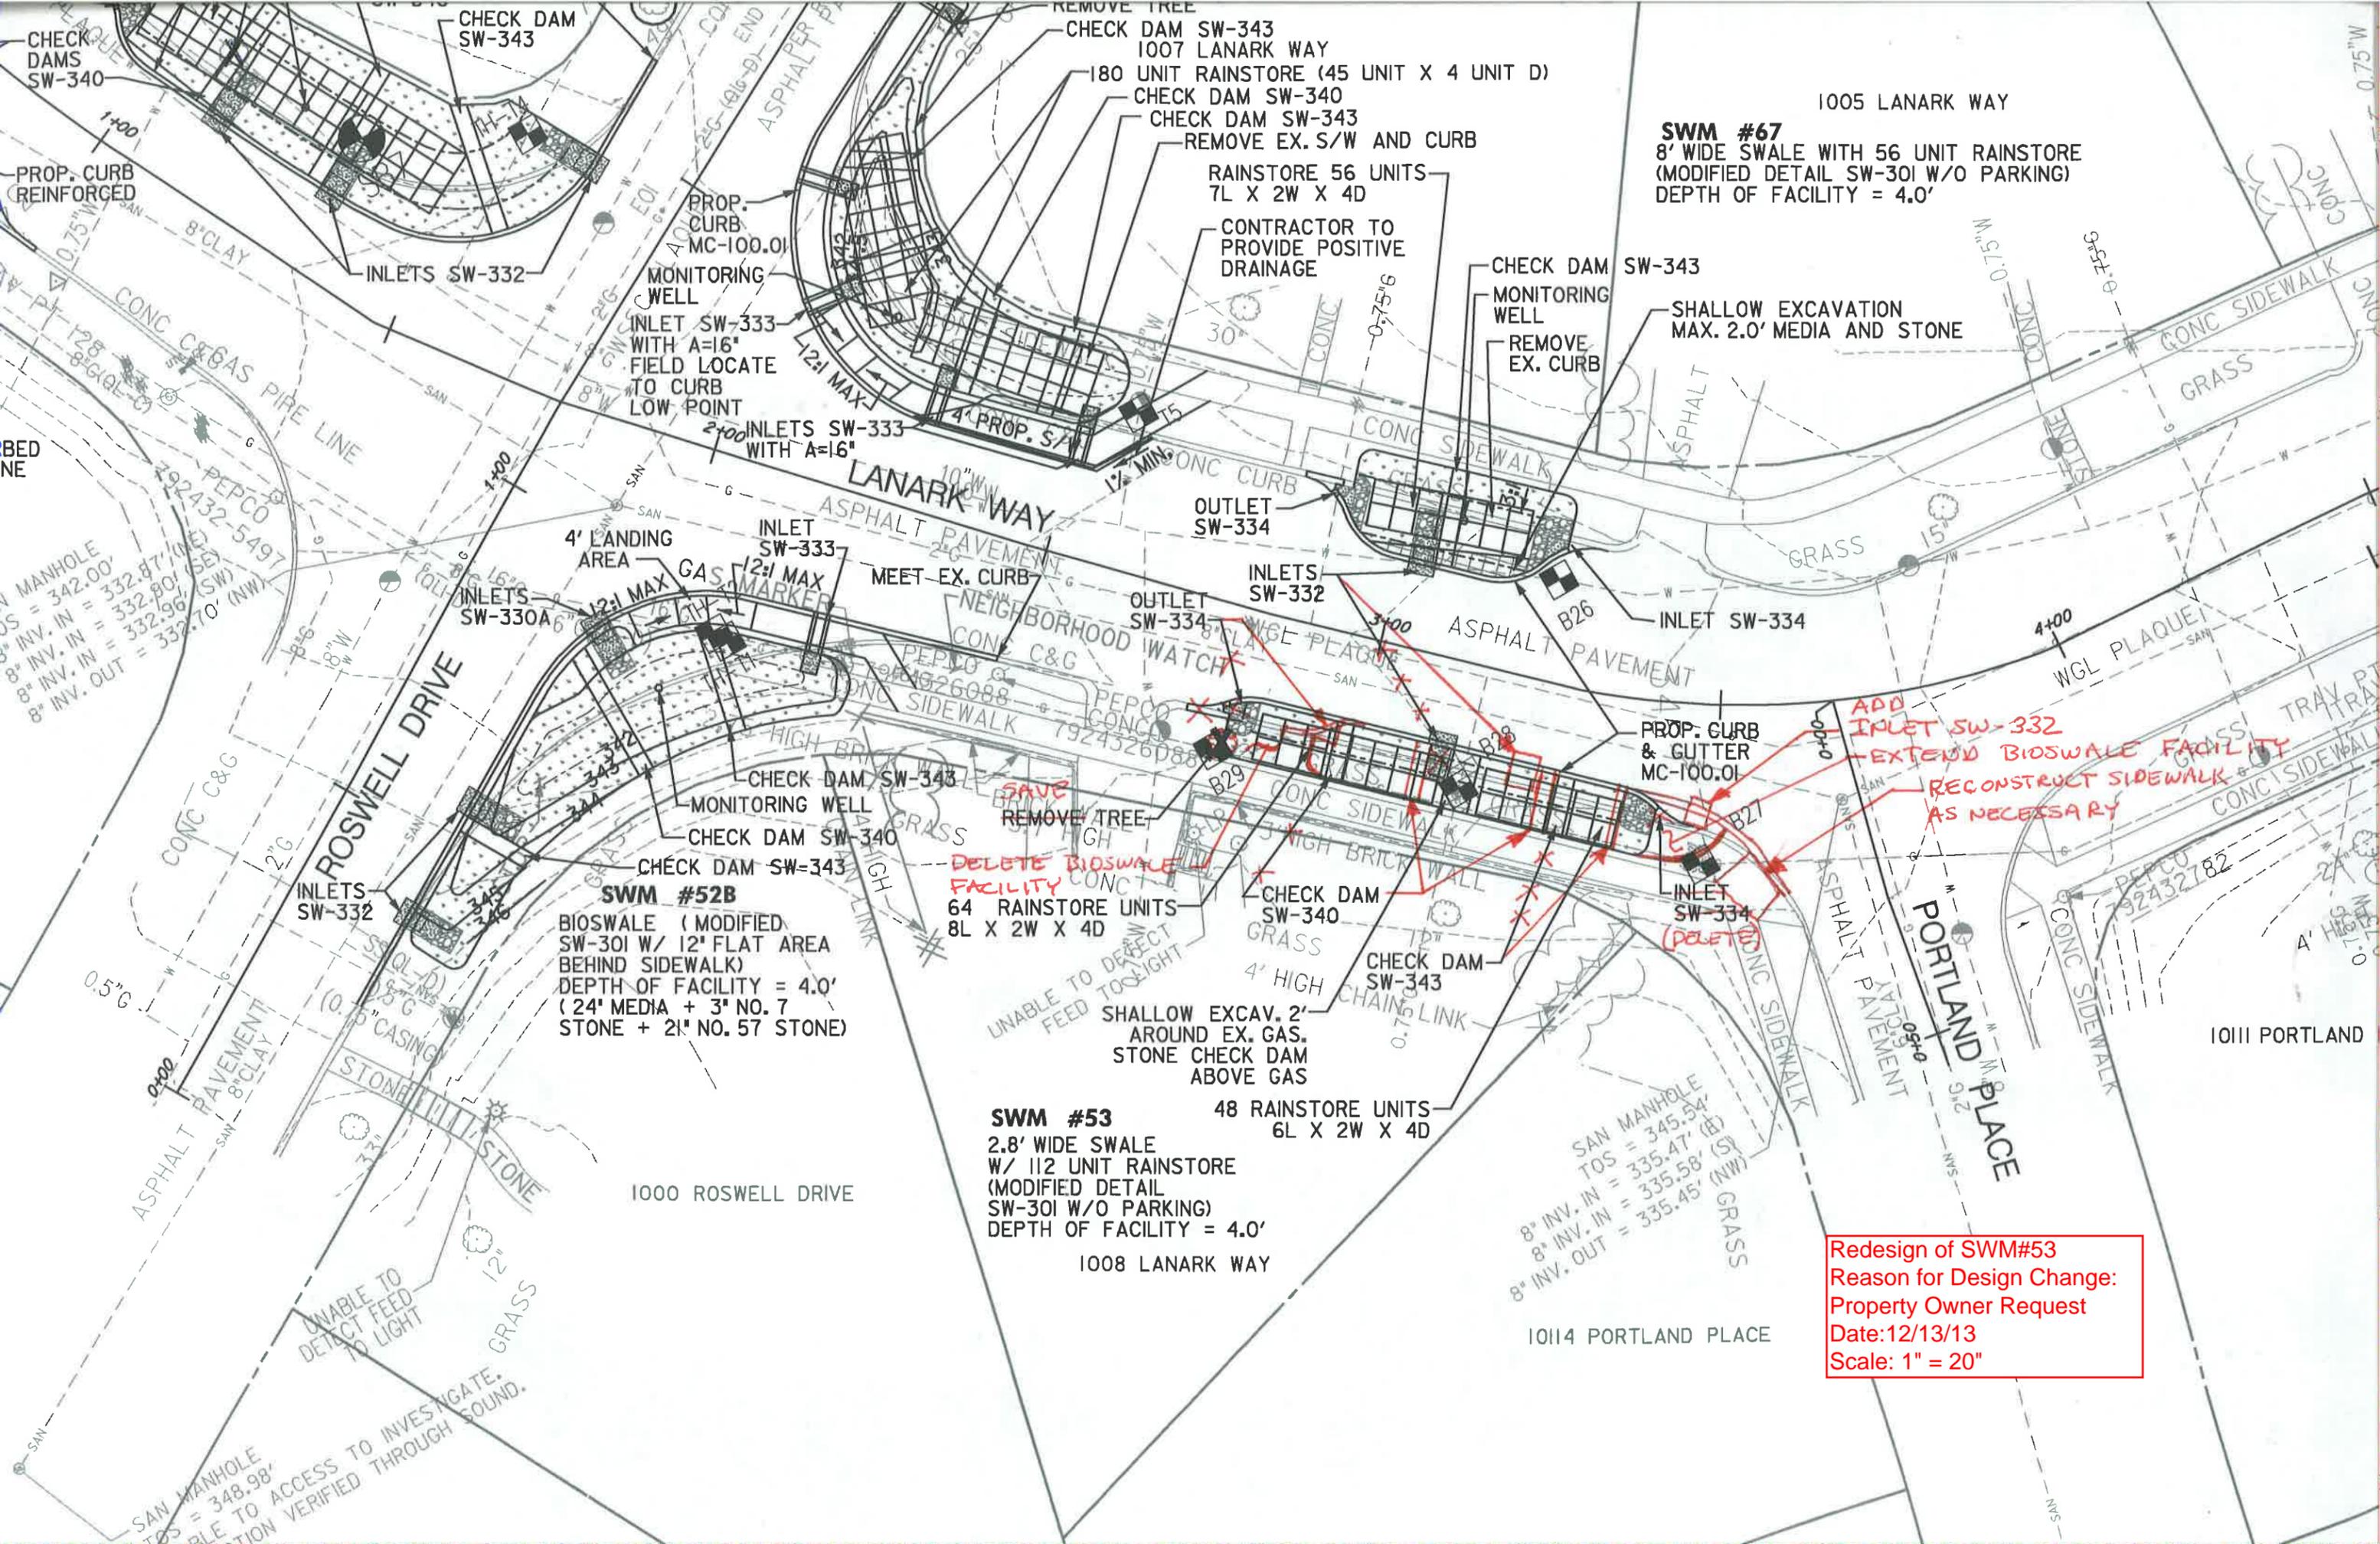
SWM #52B
 BIOSWALE (MODIFIED SW-301 W/ 12' FLAT AREA BEHIND SIDEWALK)
 DEPTH OF FACILITY = 4.0'
 (24' MEDIA + 3' NO. 7 STONE + 21' NO. 57 STONE)

SWM #53
 2.8' WIDE SWALE W/ 112 UNIT RAINSTORE (MODIFIED DETAIL SW-301 W/O PARKING)
 DEPTH OF FACILITY = 4.0'

CHECK DAM SW-343
 1007 LANARK WAY
 180 UNIT RAINSTORE (45 UNIT X 4 UNIT D)
 CHECK DAM SW-340
 CHECK DAM SW-343
 REMOVE EX. S/W AND CURB
 RAINSTORE 56 UNITS
 7L X 2W X 4D

ADD INLET SW-332
 EXTEND BIOSWALE FACILITY
 RECONSTRUCT SIDEWALK AS NECESSARY

DELETE BIOSWALE FACILITY
 REMOVE TREE
 SAVE

48 RAINSTORE UNITS
 6L X 2W X 4D
