Gridley Ln at Grandin Rd Intersection  
 - High visibility crosswalks and ADA ramps  
 - Curb extension

Grandin Rd at Florin St Intersection  
 - High visibility crosswalks and ADA ramps  
 - Reduced curb radius

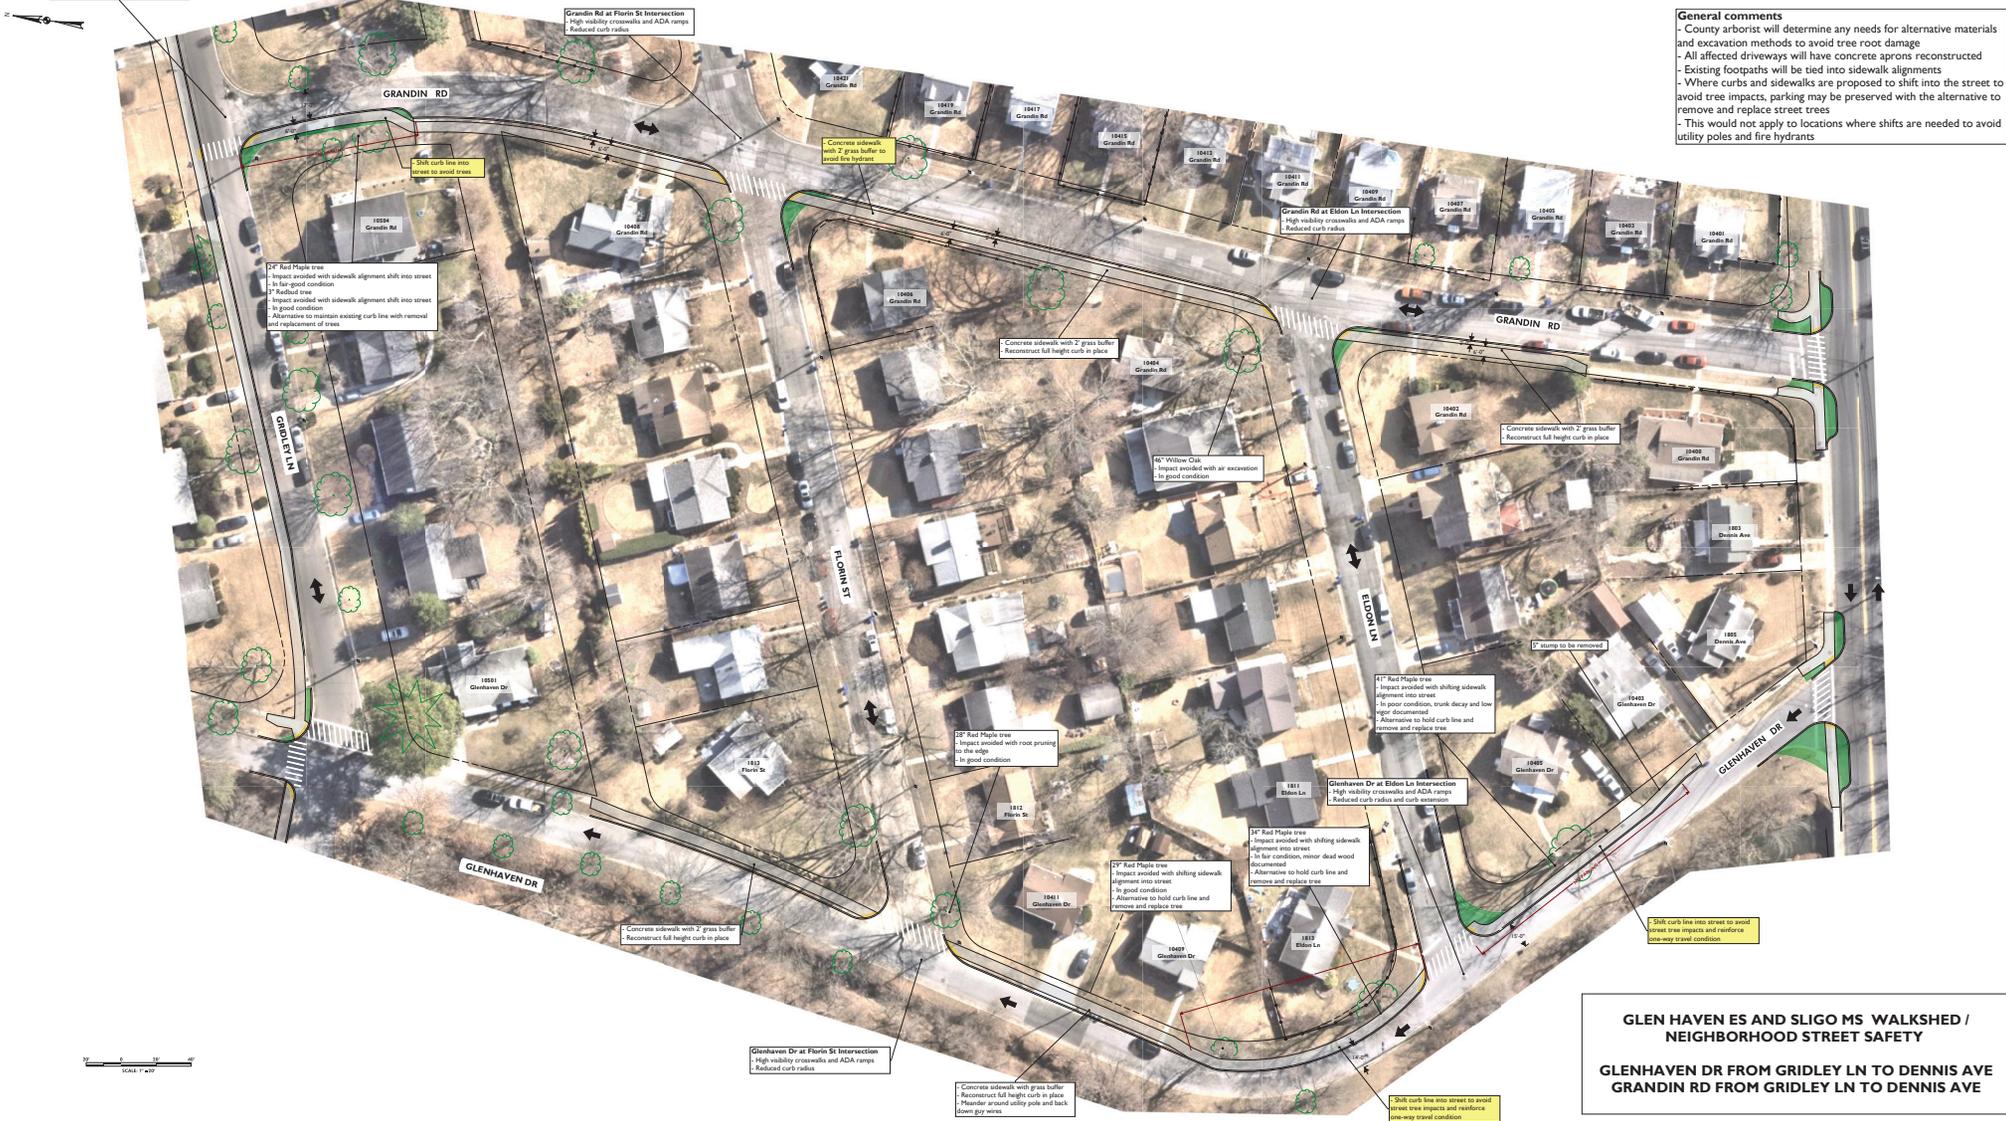
24" Red Maple tree  
 - Impact avoided with sidewalk alignment shift into street  
 - In fair-good condition  
 - 2" Red Maple tree  
 - Impact avoided with sidewalk alignment shift into street  
 - In good condition  
 - Alternative to maintain existing curb line with removal and replacement of trees

Concrete sidewalk with 2' grass buffer  
 - Reconstruct full height curb in place

Grandin Rd at Eldon Ln Intersection  
 - High visibility crosswalks and ADA ramps  
 - Reduced curb radius

46" Willow Oak  
 - Impact avoided with air excavation to good condition

24" Red Maple tree  
 - Impact avoided with root pruning to the edge  
 - In good condition

41" Red Maple tree  
 - Impact avoided with shifting sidewalk alignment into street  
 - In poor condition, trunk decay and low vigor documented  
 - Alternative to hold curb line and remove and replace tree

5" stump to be removed

Glenhaven Dr at Eldon Ln Intersection  
 - High visibility crosswalks and ADA ramps  
 - Reduced curb radius and curb extension

24" Red Maple tree  
 - Impact avoided with shifting sidewalk alignment into street  
 - In good condition  
 - Alternative to hold curb line and remove and replace tree

24" Red Maple tree  
 - Impact avoided with shifting sidewalk alignment into street  
 - In fair condition, minor dead wood documented  
 - Alternative to hold curb line and remove and replace tree

Shift curb line into street to avoid street tree impacts and reinforce one-way travel conditions

**General comments**  
 - County arborist will determine any needs for alternative materials and excavation methods to avoid tree root damage  
 - All affected driveways will have concrete aprons reconstructed  
 - Existing footpaths will be tied into sidewalk alignments  
 - Where curbs and sidewalks are proposed to shift into the street to avoid tree impacts, parking will be preserved with the alternative to remove and replace street trees  
 - This would not apply to locations where shifts are needed to avoid utility poles and fire hydrants
