## Grosvenor - Timberlawn Stream Restoration Project

### Stream Restoration Techniques

June 2021

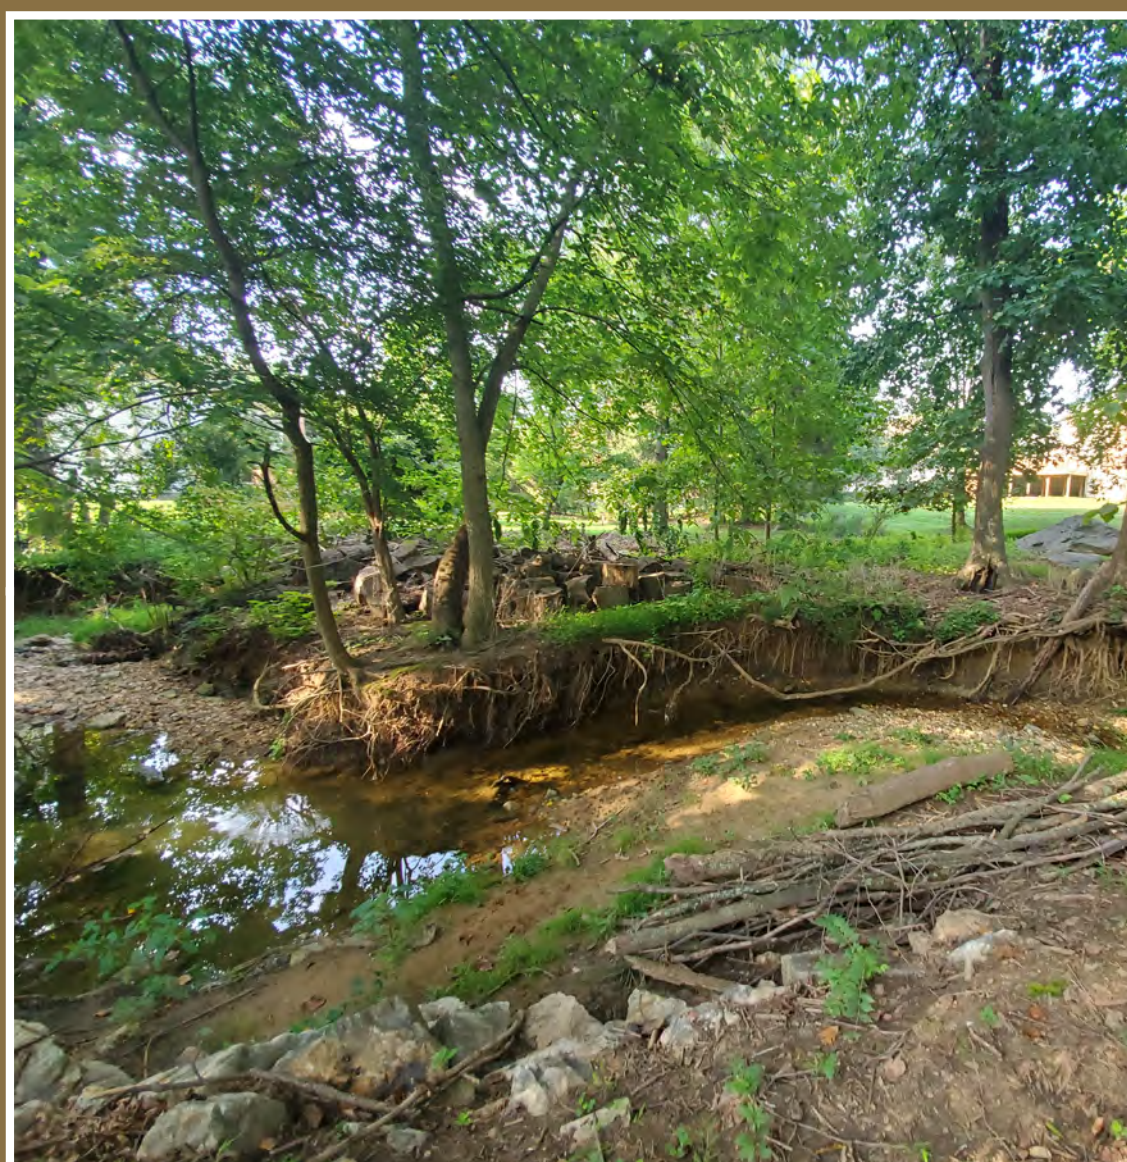
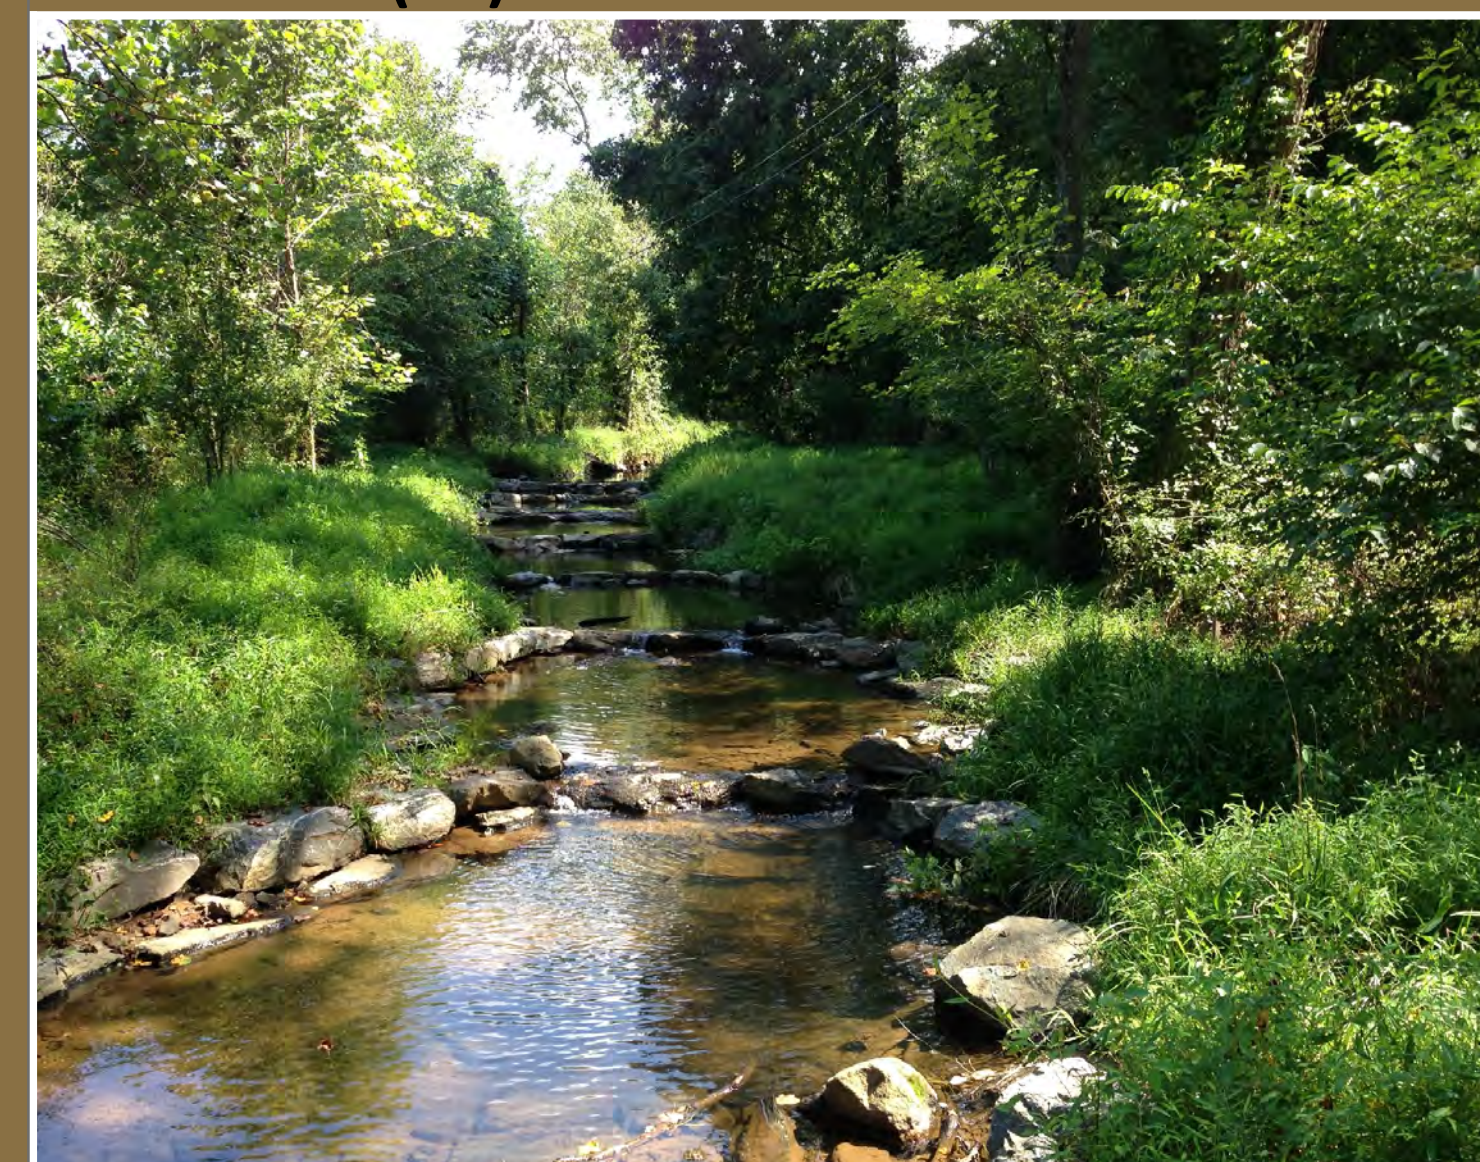
### STEP POOL (SP)

Before

After

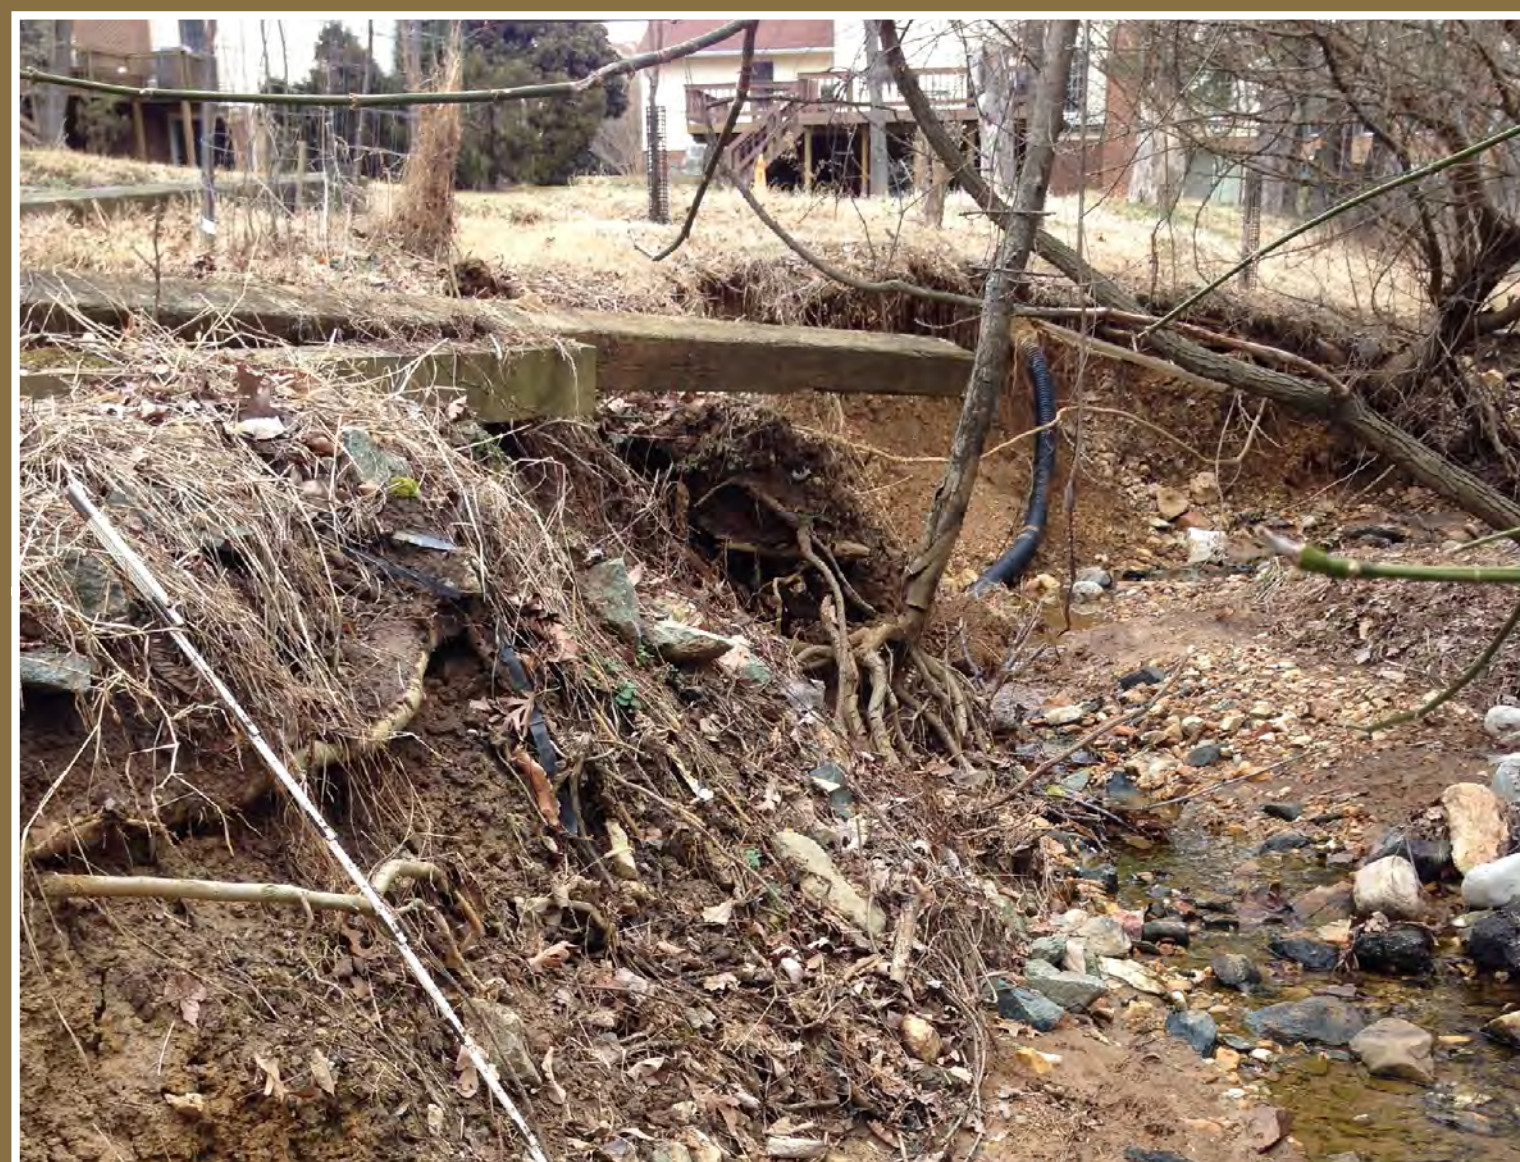
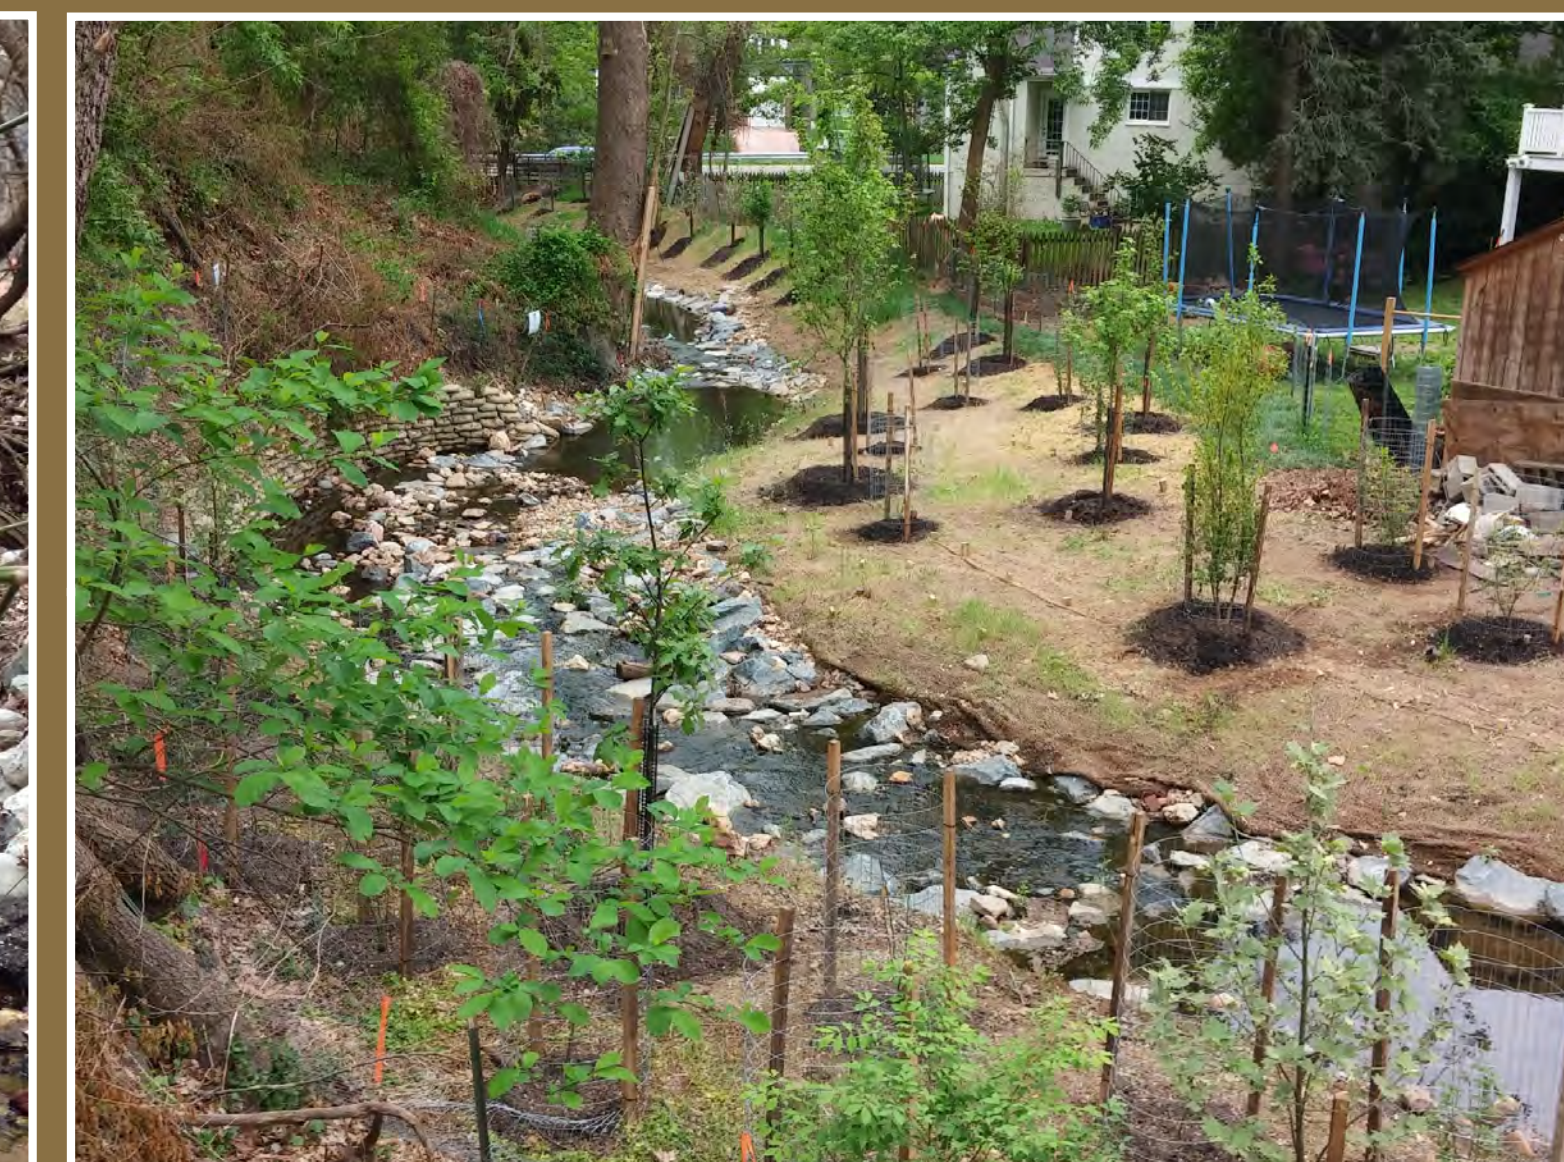
### VEGETATIVE PLANTING

Before

After

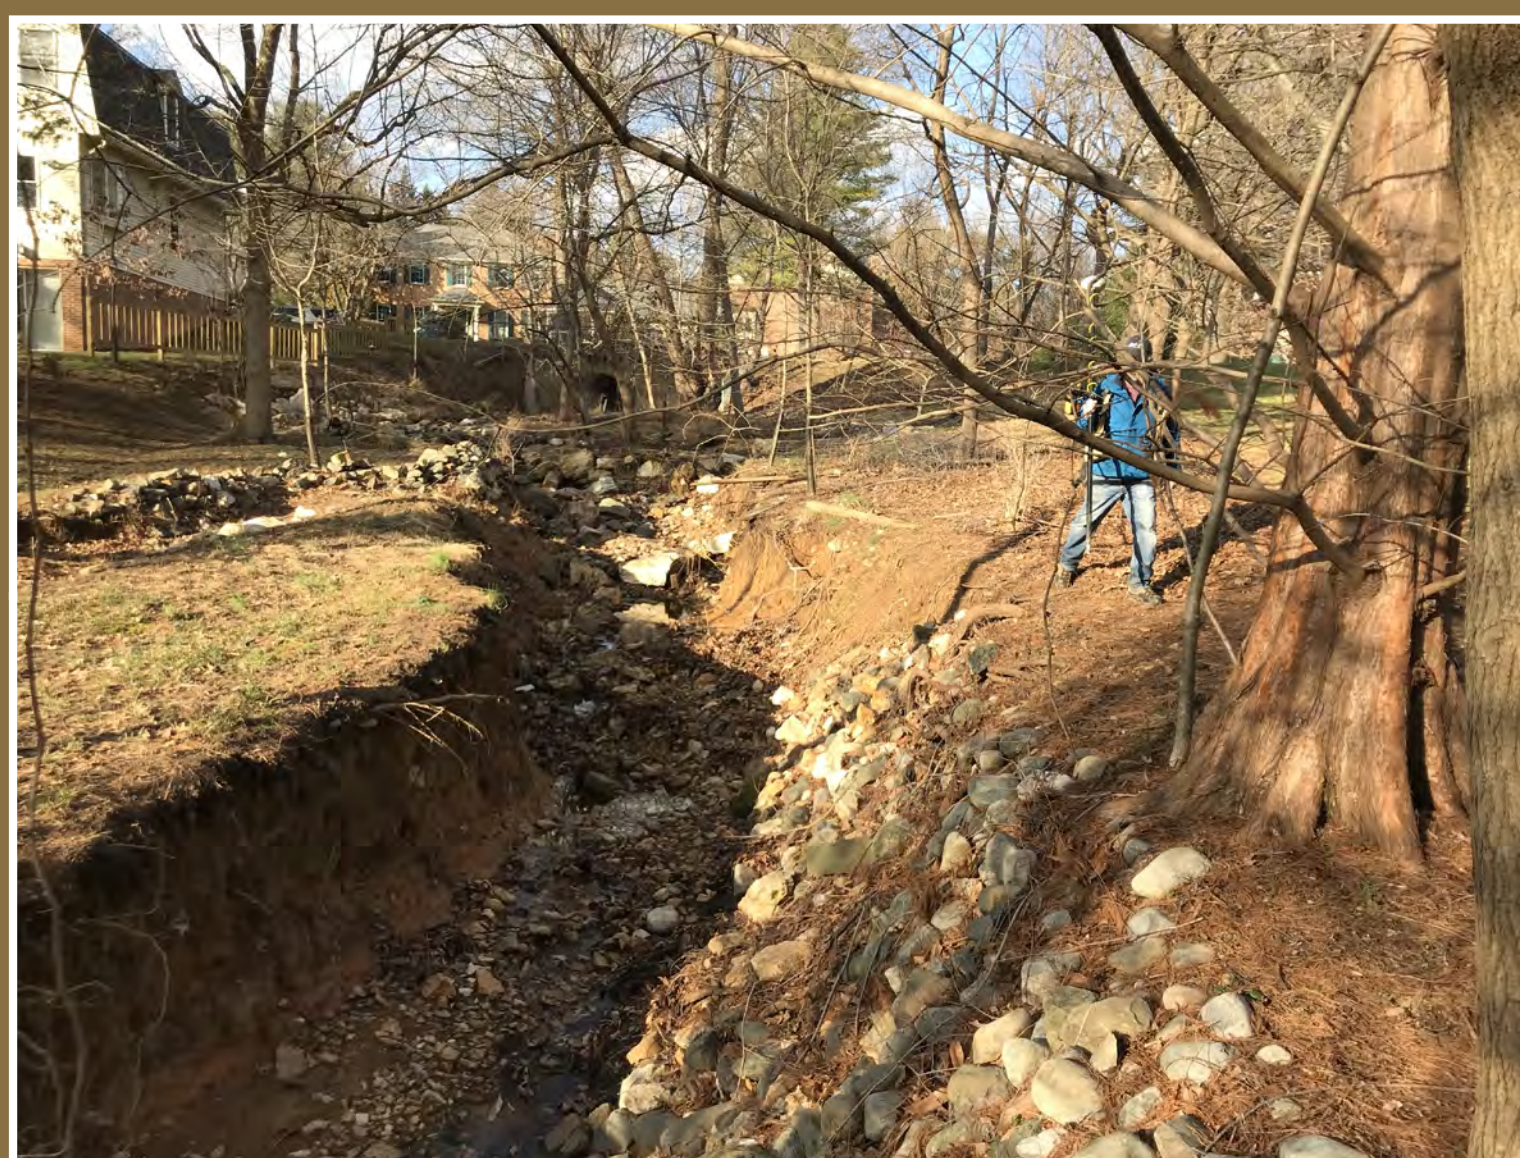
### CROSS-VANE (CV)

Before

After
