# POST INCIDENT ANALYSIS

## STRUCTURE FIRE

17121 Queen Victoria Court  
Gaithersburg, MD. 20877

November 6, 2007  
Incident #07-0110860

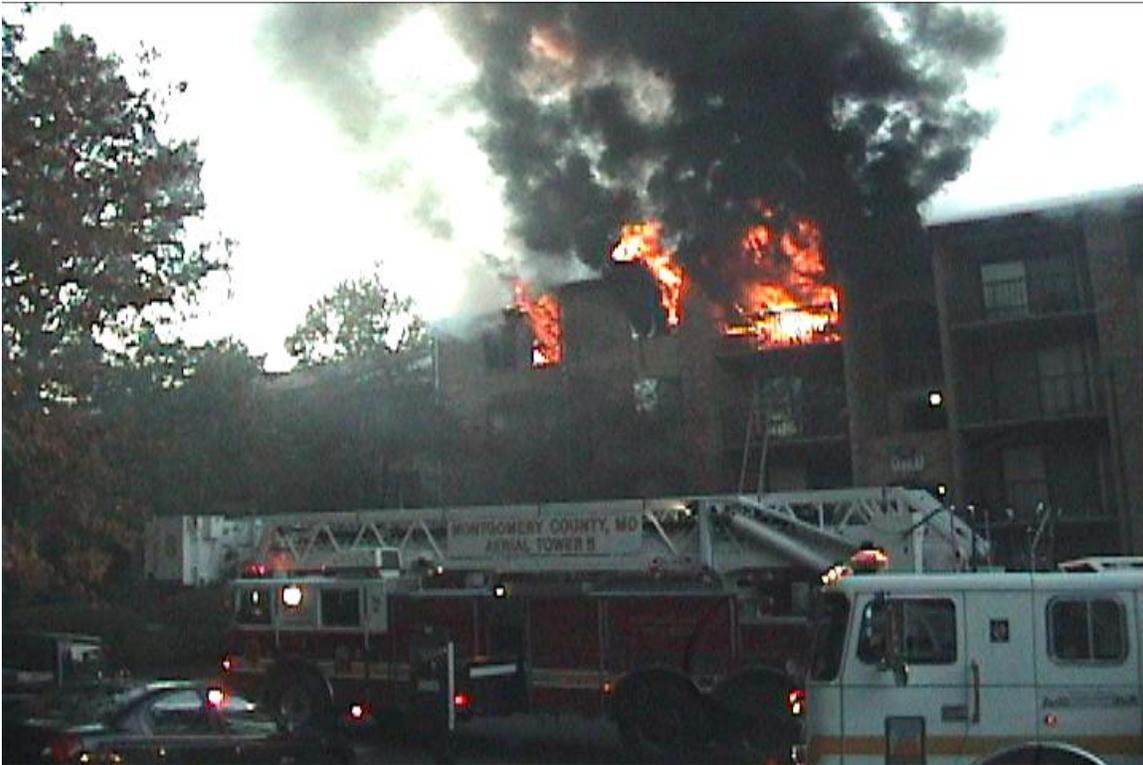
The fire began in a carpet shampoo machine in the rear bedroom of a top floor garden apartment. The resident attempted to fight the fire herself so the 911 call was delayed. Upon fire department arrival, fire was showing from the single window of the rear bedroom. Residents were evacuating the building. The officer on E708 initially went with a leader line but, seeing a standpipe riser, changed his mind. The standpipe system failed forcing the engine crew to return to the leader line. During this delay the truck company ventilated the apartment which drew the fire into the rest of the apartment. The fire was eventually controlled with moderate extension into the attic above the involved apartment. Other units in the building were damaged by smoke and water. The fire displaced the residents of 16 apartments.
