Cabin John - Normandy Falls Stormwater Retrofit

Montgomery County Department of Environmental Protection

Cabin Branch, a tributary to Seneca Creek in the Potomac River Watershed

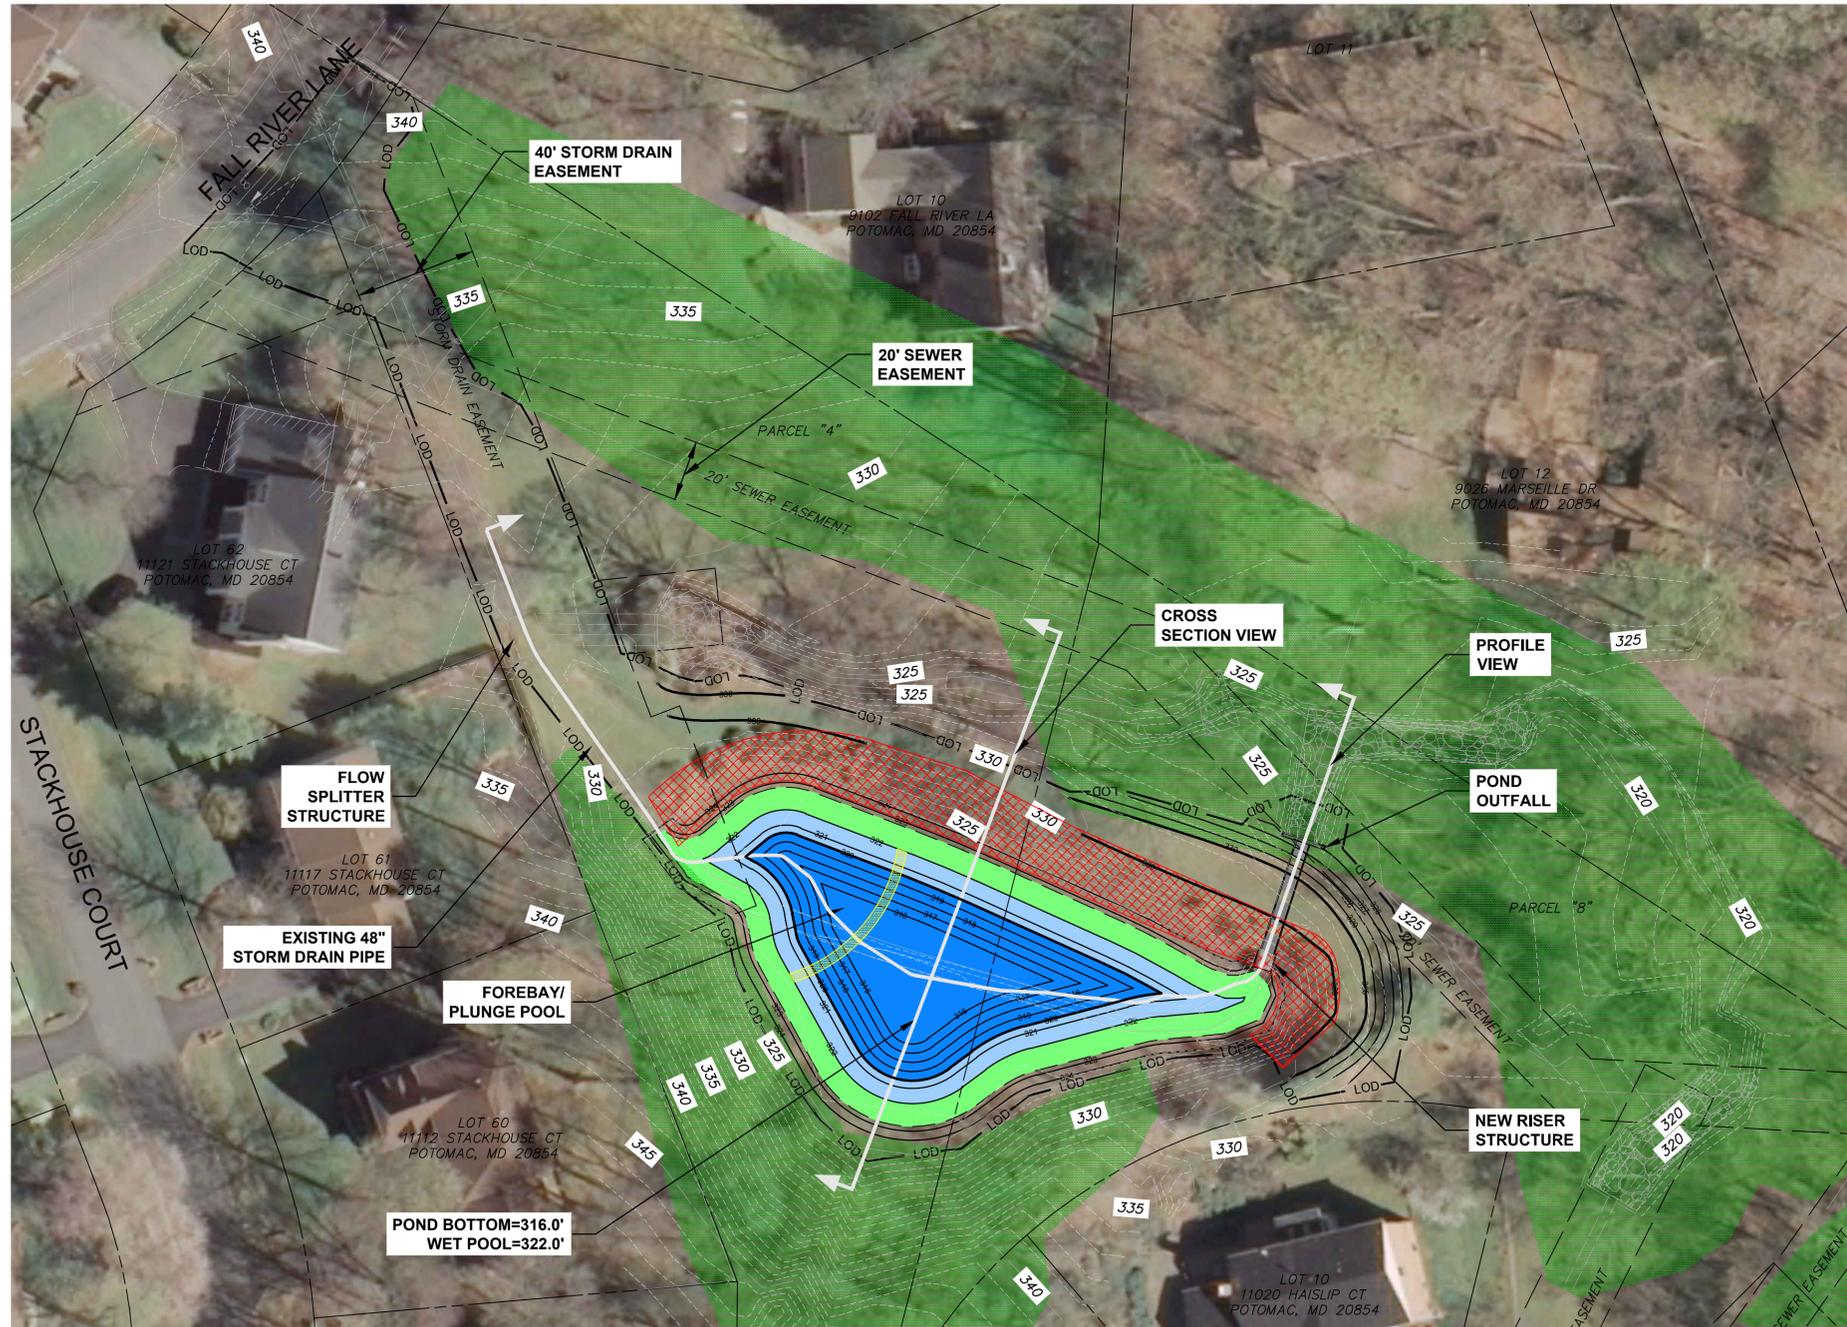
CLAY LINER
	FORESTED AREA
	UP TO 6 FT DEPTH
	AQUATIC BENCH (0"-18")
	GABION
	SAFETY BENCH

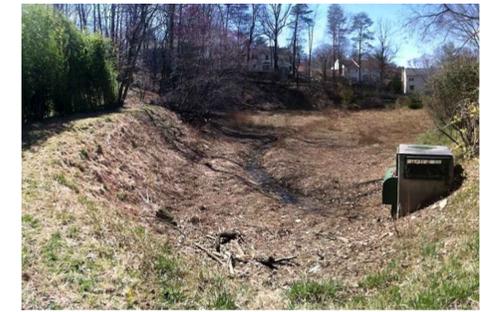
POND LOOKING WEST

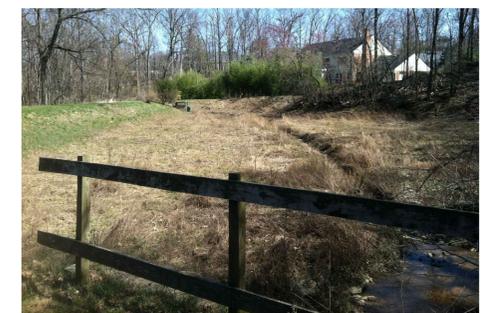
POND LOOKING EAST

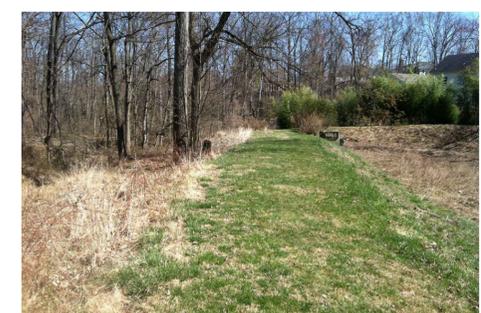
EMBANKMENT LOOKING EAST

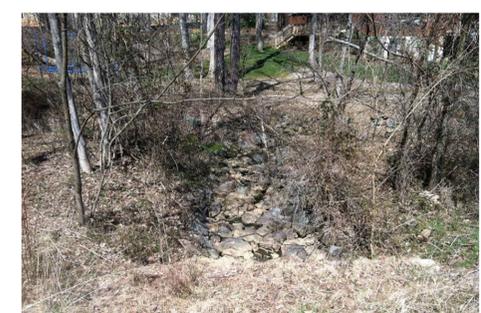
POND OUTFALL

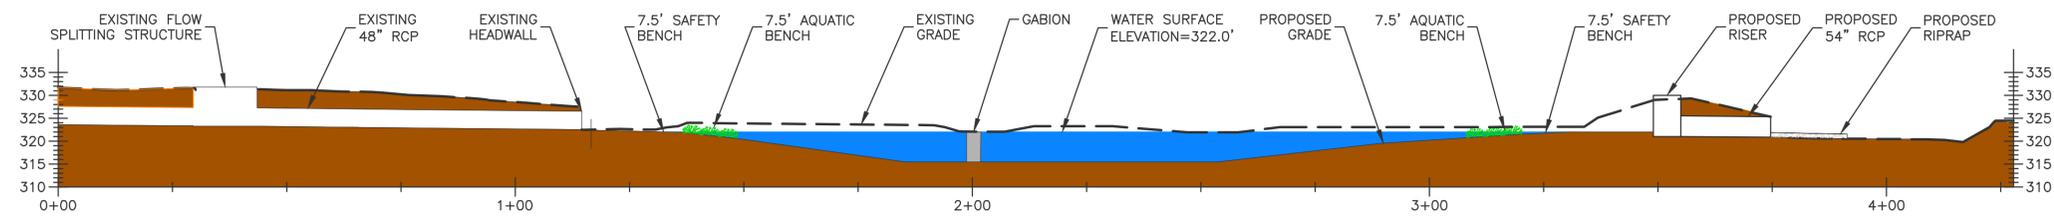
PROFILE VIEW

PERMANENT POOL ELEVATION (322.0')
-

POOL (3-6 FOOT DEPTH)
-

SHALLOW WATER ZONE (0-18" DEPTH)
-

EXISTING GROUND SURFACE
-

PROPOSED GROUND SURFACE
