Stormwater Management Facility Repair and Retrofit FACT SHEET:

Chadswood Regional Stormwater Management Pond

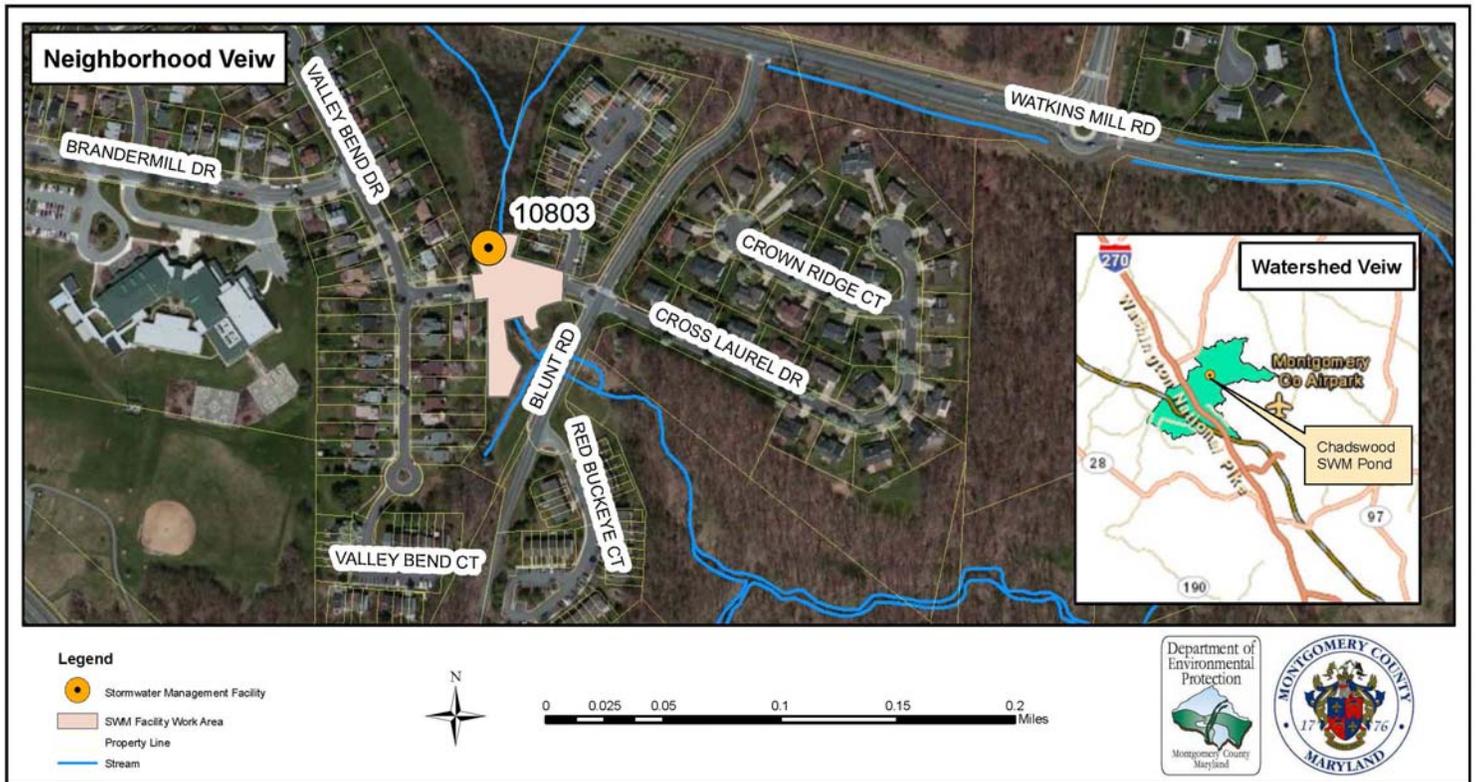
During a routine inspection of the Chadswood Storm Water Management Facility, Montgomery County Department of Environmental Protection (MCDEP) observed several problems. Among the issues observed were: multiple slope failures and sink holes on the upstream side of the dam which expose a spillway pipes, steep slopes on upstream embankment,

and a partially blocked low flow pipe.

- Replace the outlet works of the facility
- Properly re-build the dam embankment
- Repair slope failure and re-grade upstream embankment to be flatter
- Rebuild storm drains and other utilities currently located inside the embankment
- Remove accumulated sediment from bottom of pond

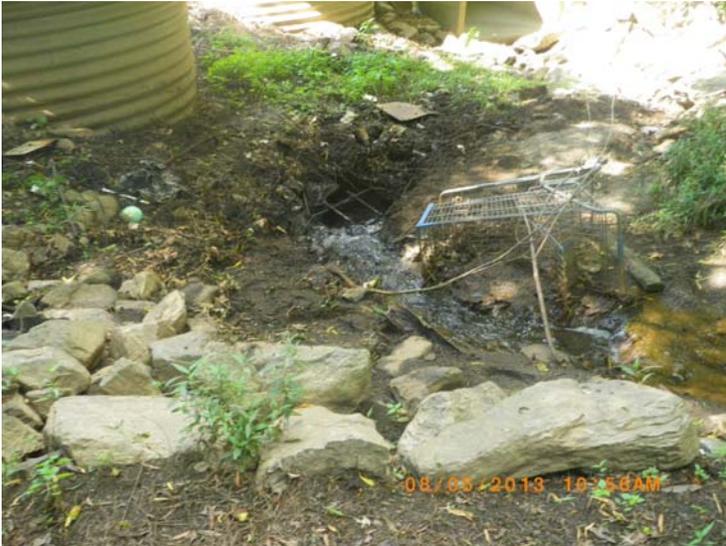
ABOVE: Sediment and debris will be removed from the bottom of the pond and rock installed to control the velocity of the stream

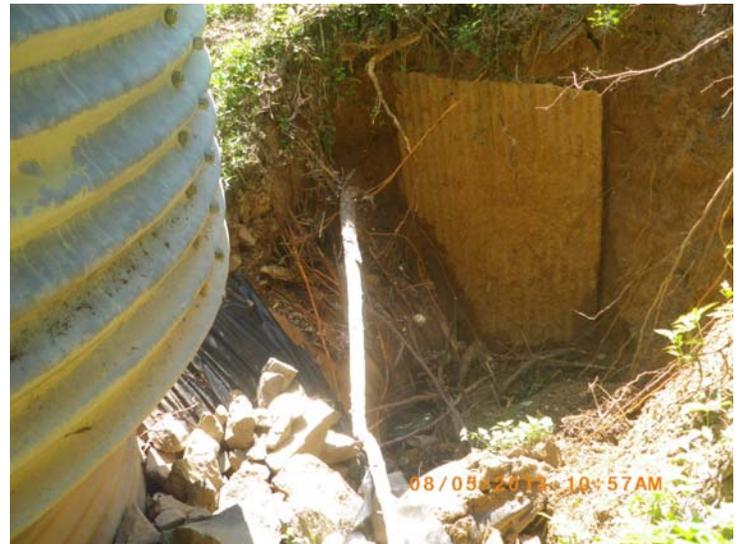
ABOVE: Slope failure on the steep upstream embankment, exposing the stormwater conveyance pipe. Structures will be replaced and slope re-graded.

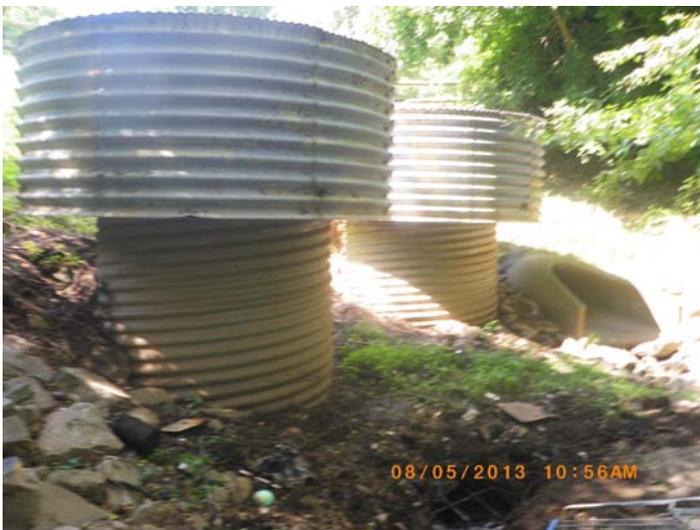
BELOW: Outlet works will be replaced with concrete outlet works which have a longer service life than their metal counterparts seen here.
