# SCHOOL-RELATED CRASH-INFRASTRUCTURE REVIEW

**Location:** Public House Road between Ebenezer Chapel Drive and Martz Street

**Crash Date:** November 8, 2024

**Local Case No.:** 240053629

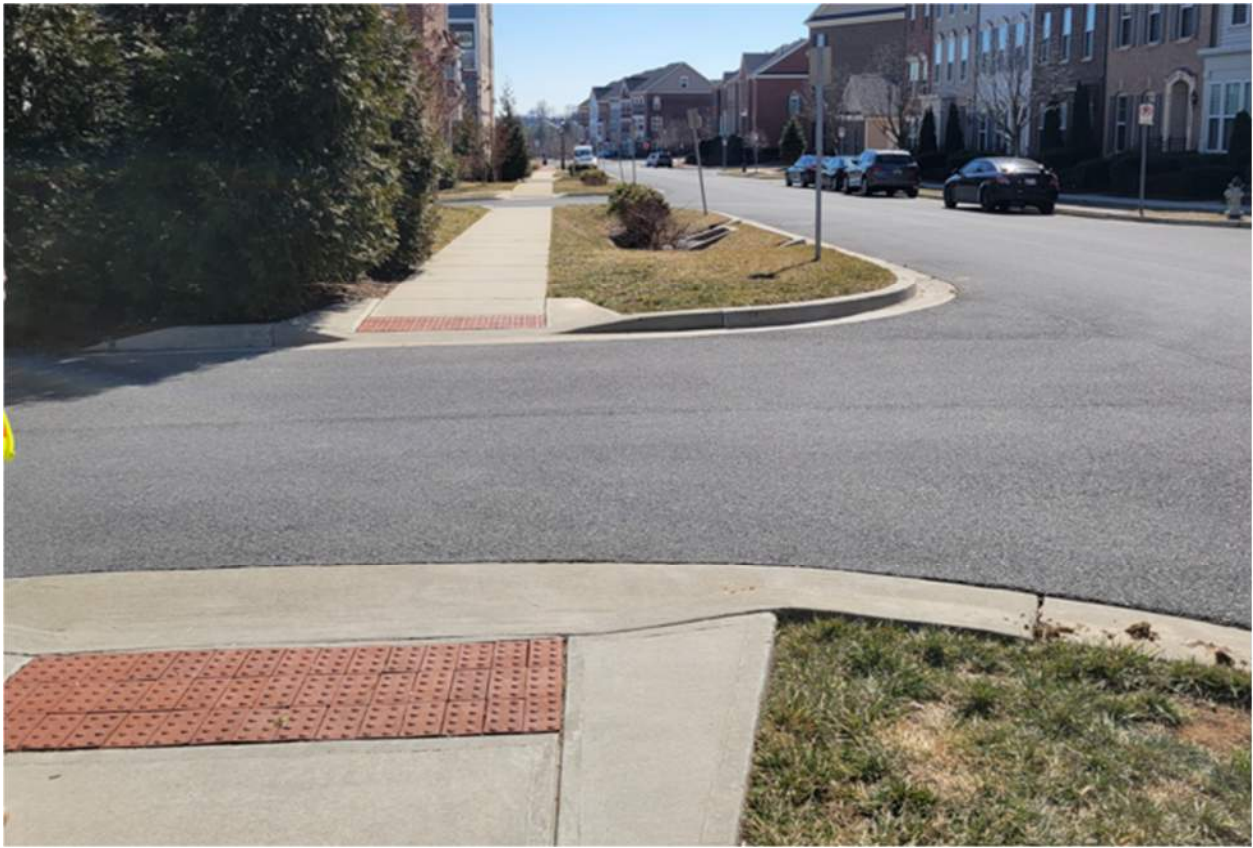
Field observations were performed on Monday, March 3, 2025, at approximately 11 AM. Weather conditions were clear, and the roadway surface was dry. Pedestrian and vehicular activity was low during the observation period. There is limited sight distance due to adjacent foliage in the southbound direction looking to the right and left. Vehicles are parked along Public House Road on both sides of the street despite the “No Parking” signs. Two mailboxes are located on the south leg, across the street from the unnamed driveway. At the southbound approach, the stop line is faded and there is no existing stop sign.

**Photo 1. Taken from northwest corner looking eastbound along Public House Road at the north leg crossing. Approximate crash location.**

1. Refresh stop line at the southbound approach of the driveway.
2. Install a stop sign at the southbound approach of the driveway adjacent to the stop line.
3. Recommend trimming existing foliage to improve sight distance.

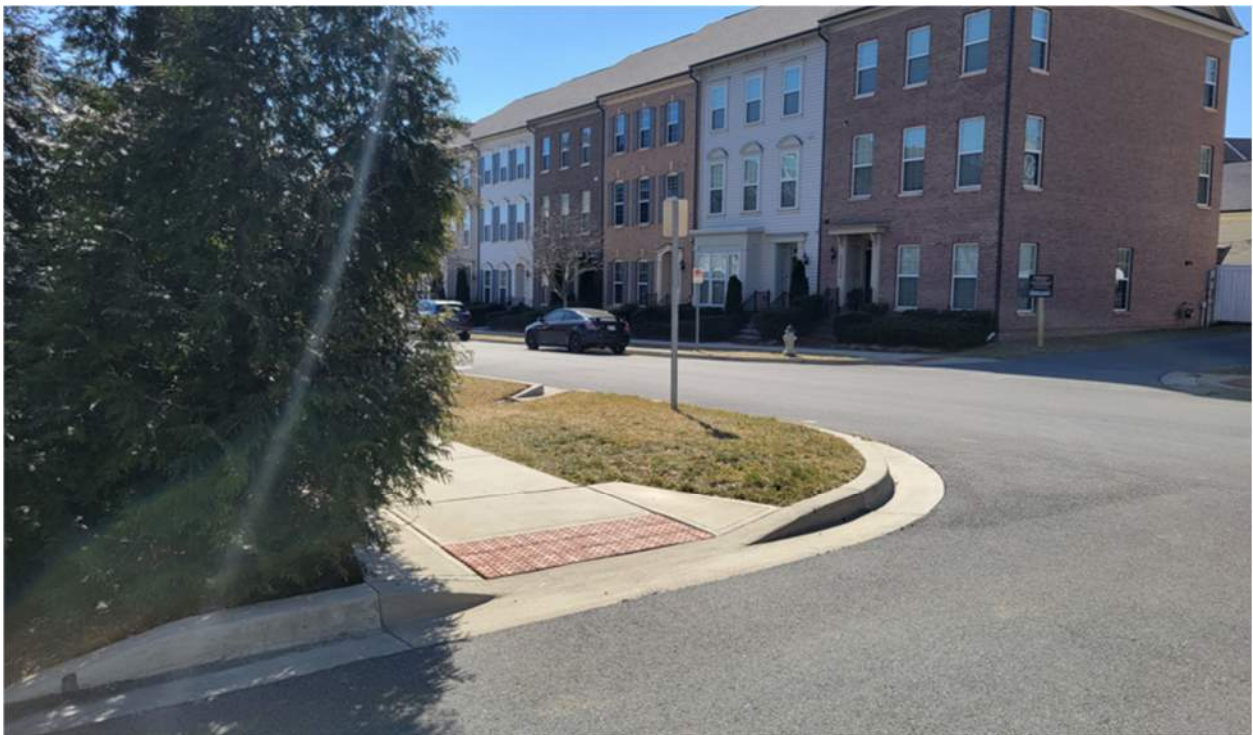
**Photo 2. Taken from the southbound approach looking eastbound along Public House Road.**

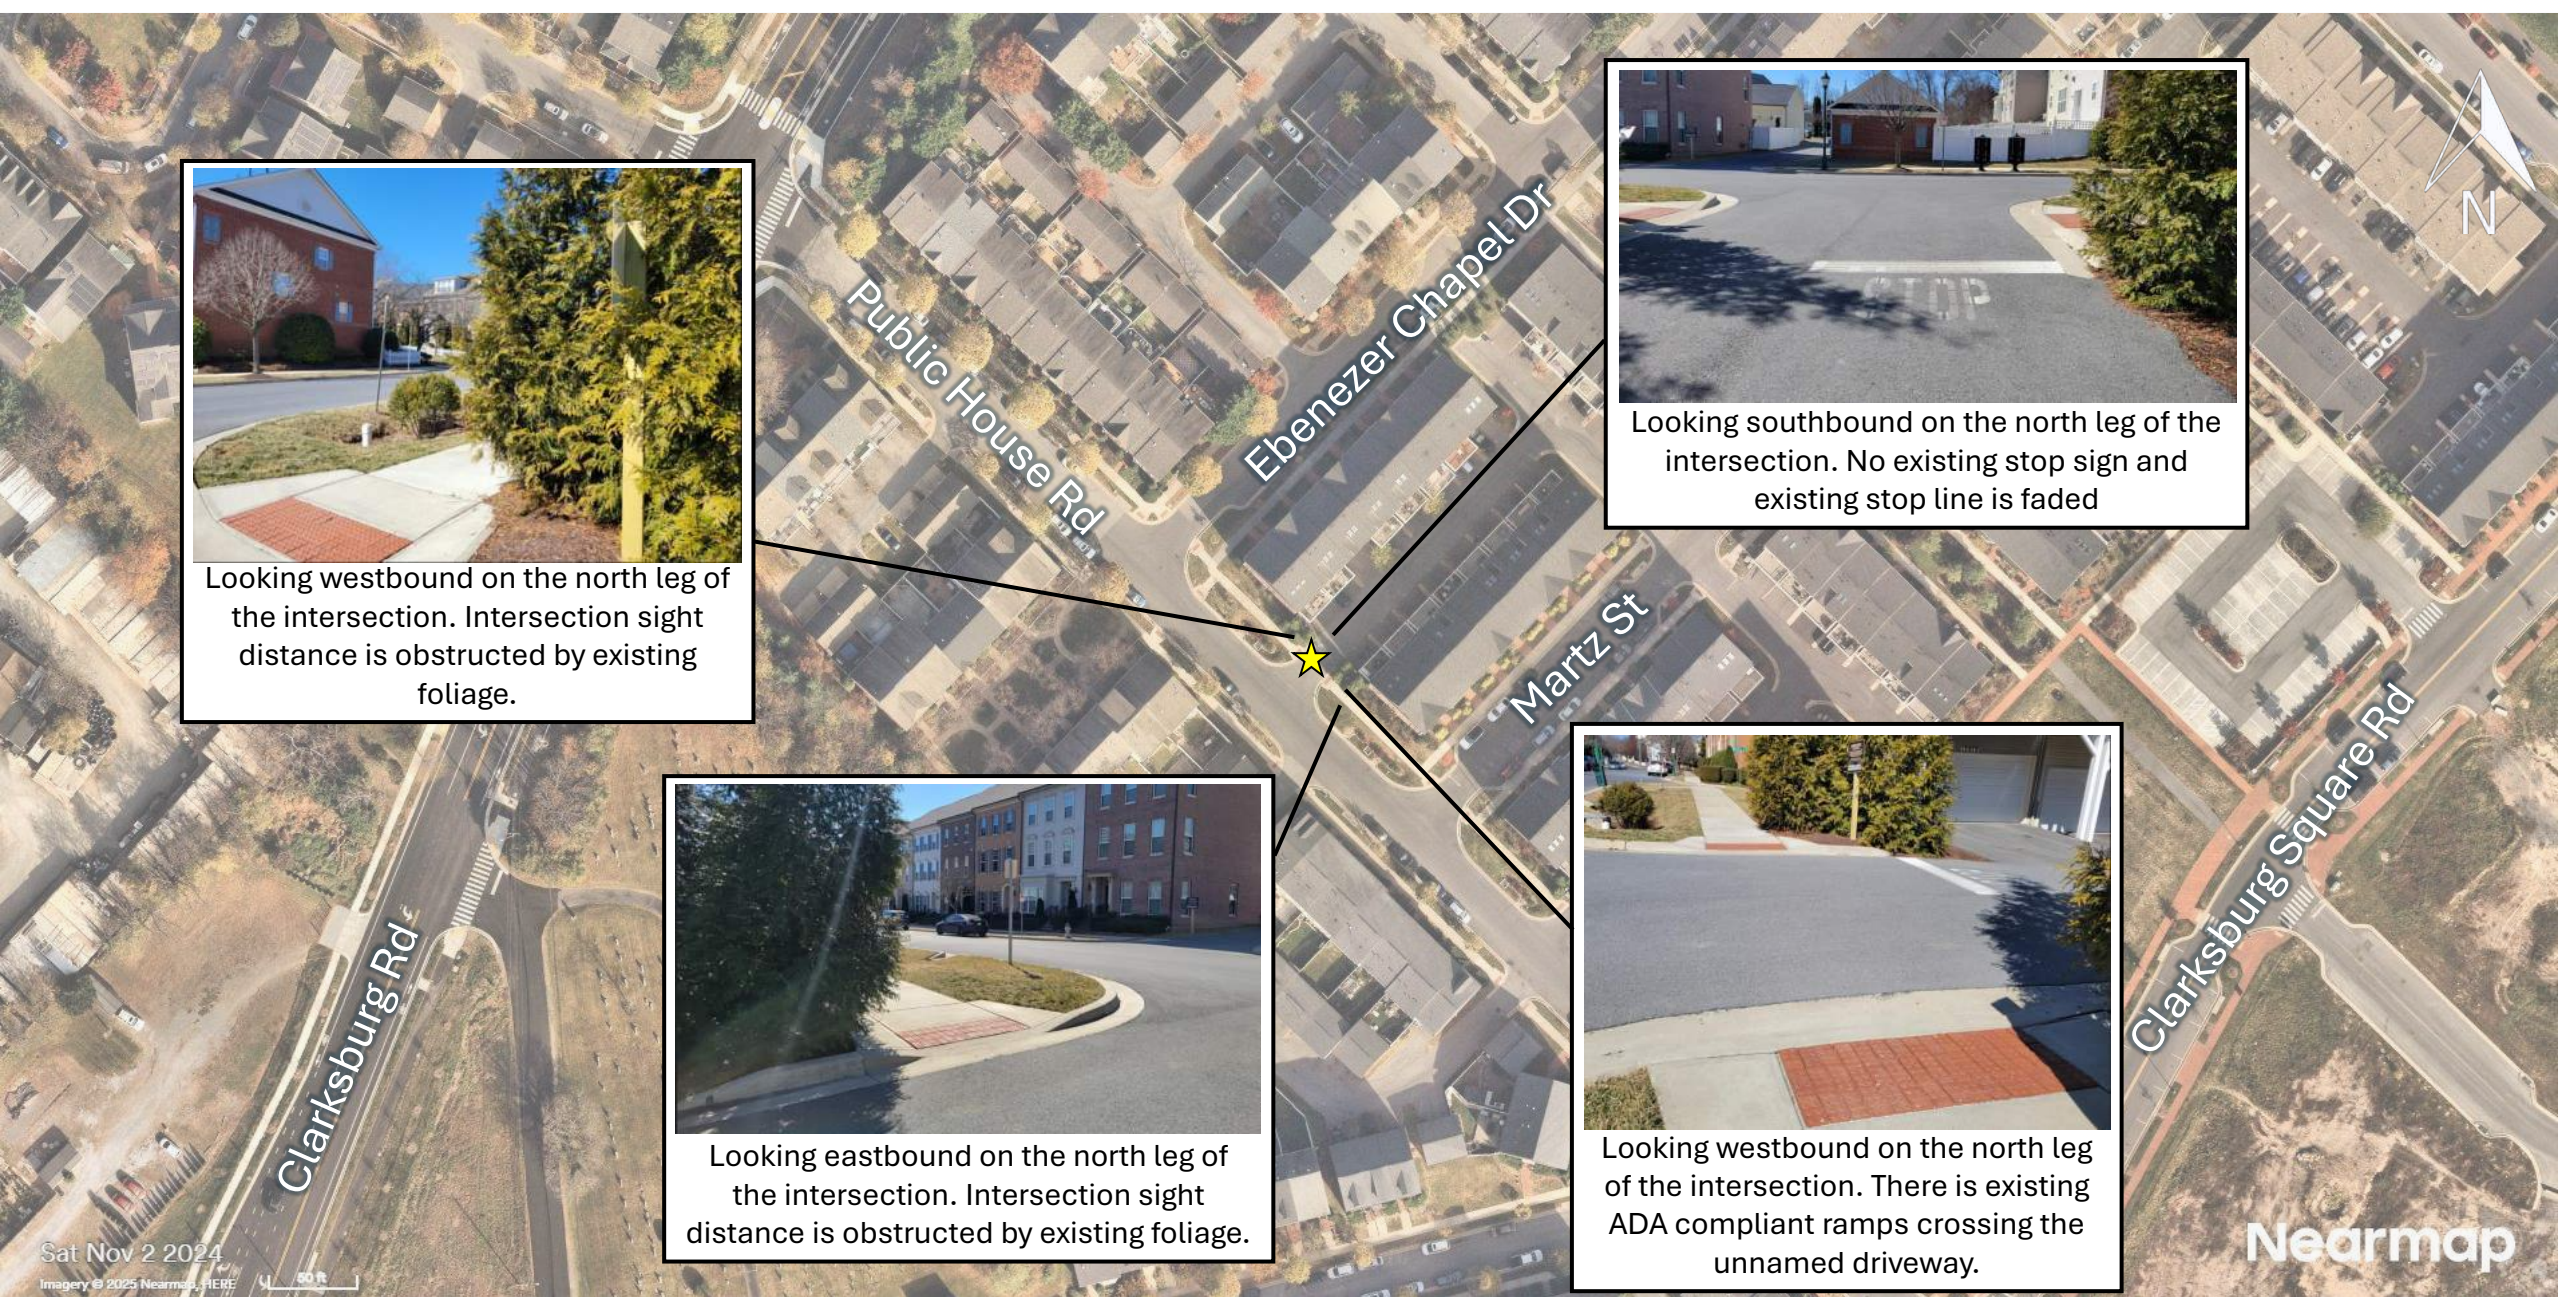
Figure 1 – Public House Rd between Ebenezer Chapel Dr and Martz Street Observations

Public House Road is approximately 25 feet wide and is oriented in the east-west direction. Public House Road spans a distance less than a quarter mile long, beginning at Clarksburg Road to the west and ending at Clarksburg Square Road to the east. At the crash location, Public House Road has buffered sidewalks in the eastbound and westbound directions. There is no shoulder in either direction. Street parking is not permitted along Public House Road on the north leg of the street in the westbound direction. In the eastbound direction, on the south leg, street parking is permitted in certain designated spots.

The intersection of Public House Road at the unnamed driveway between Ebenezer Chapel Drive and Martz Street is an unsignalized, three-legged intersection, with the unnamed driveway extending northerly from Public House Road. The unnamed driveway is an alleyway providing access to residential homes to the north of Public House Road.

Pedestrian facilities are ADA compliant along the north leg of the intersection, with sidewalk ramps and Detectable Warning Surface (DWS). There are no marked crosswalks at the intersection.

The Public House Road corridor was evaluated to identify potential infrastructure, maintenance activities, and road user behaviors that contribute to increased safety risk at and in the vicinity of the school-related crash location. The Public House Road corridor was reviewed between Clarksburg Road to the west and ending at Clarksburg Square Road to the east. Please refer to **Figure 1** for additional information.

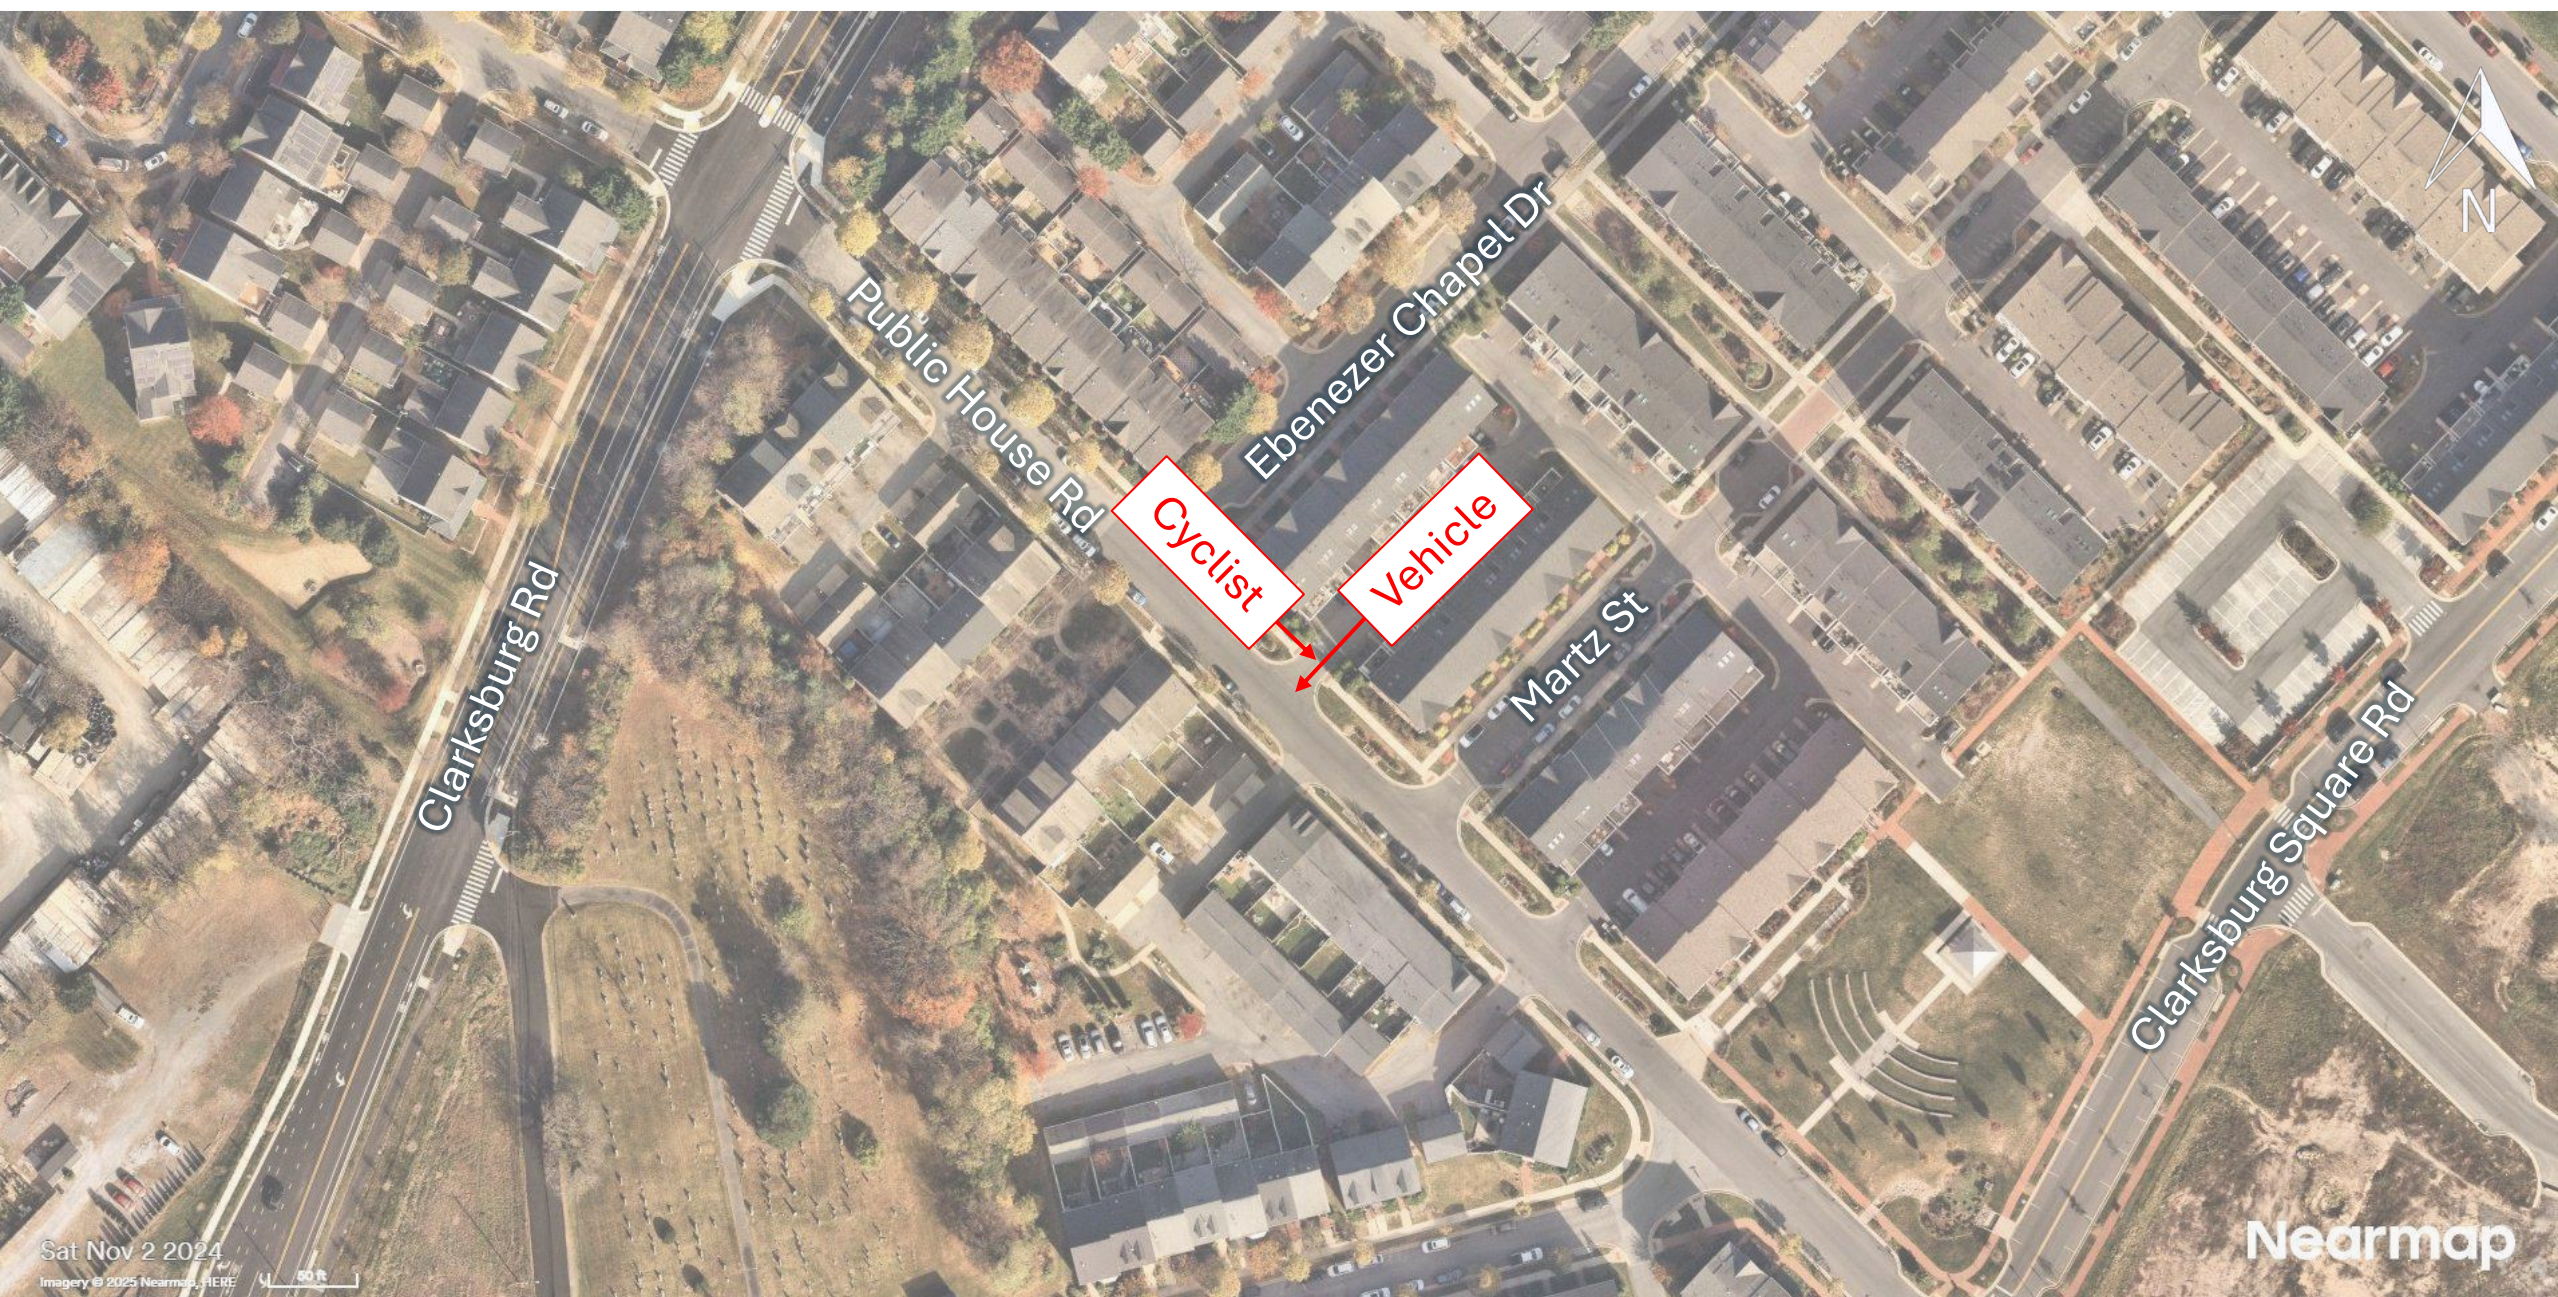
Figure 2 – Crash Diagram

On Friday, November 8, 2024, at approximately 9:01 AM, a motorist was traveling southbound from an unnamed driveway between Ebenezer Chapel Drive and Martz Street. A cyclist was traveling eastbound along Public House Road on the sidewalk crossing the street and struck the side of the motorist's vehicle. The report assigns fault to the 9-year-old cyclist, although the report indicates the motorist was slowing or stopping, meaning they did not stop at the marked stop line in advance of the crossing. The crash report indicated there were no apparent injuries. Daytime weather conditions were clear, and the roadway surface was dry.

**Figure 2** illustrates the crash location and direction of pedestrian and vehicle travel.

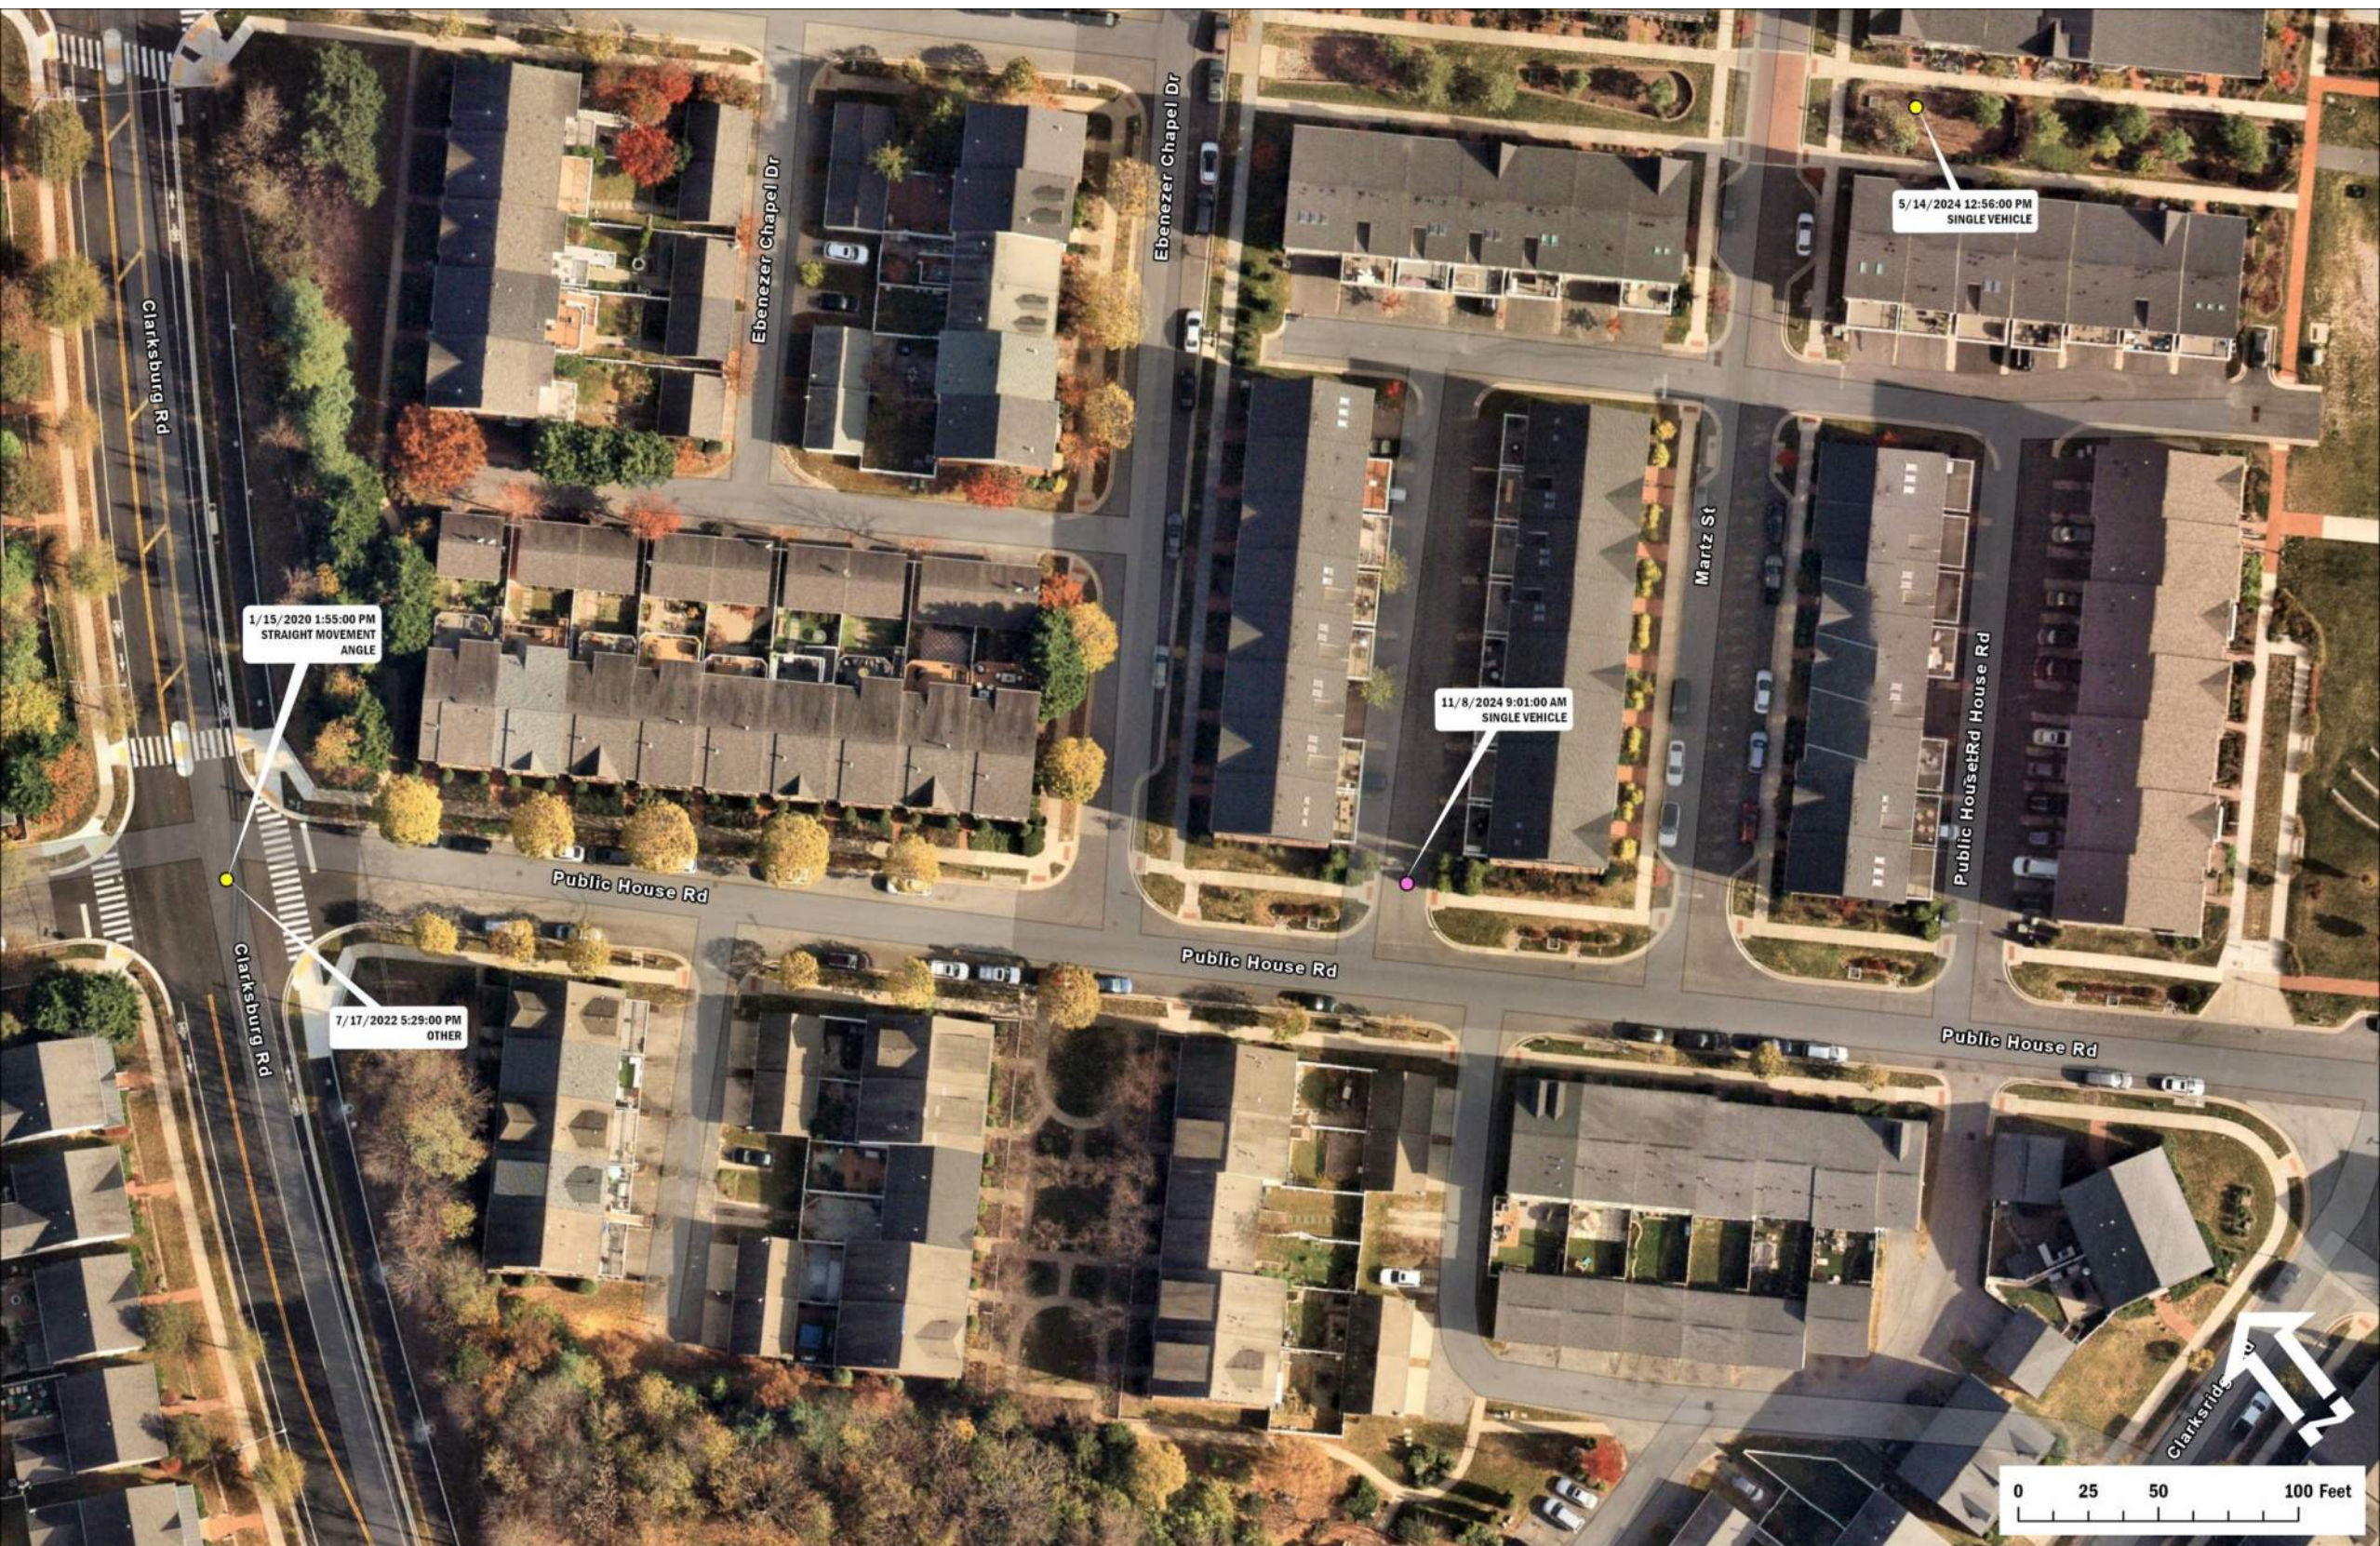
Figure 3 – Crash History (2020-2024)

Crash data obtained from dataMontgomery indicates that four (4) incidents occurred within the vicinity of the crash site between January 2020 and December 2024. Of these four (4) incidents, only one (1) occurred at or near the intersection of Public House Road at the unnamed driveway between Ebenezer Chapel Drive and Martz Street, the subject crash incident. These four (4) crashes included one (1) injury crash and three (3) property damage crashes, and the crash type consisted of one (1) angle collision, two (2) single vehicle collisions, and one (1) classified as “other”. There was one (1) pedestrian-related crash. All of the incidents occurred during daylight and dry pavement conditions.

All incidents are illustrated on Figure 3.
