Draft Final

Engineering Evaluation / Cost Analysis

Control of Exposure to Near-Surface Waste at Ball Field Landfill

Forest Glen Annex

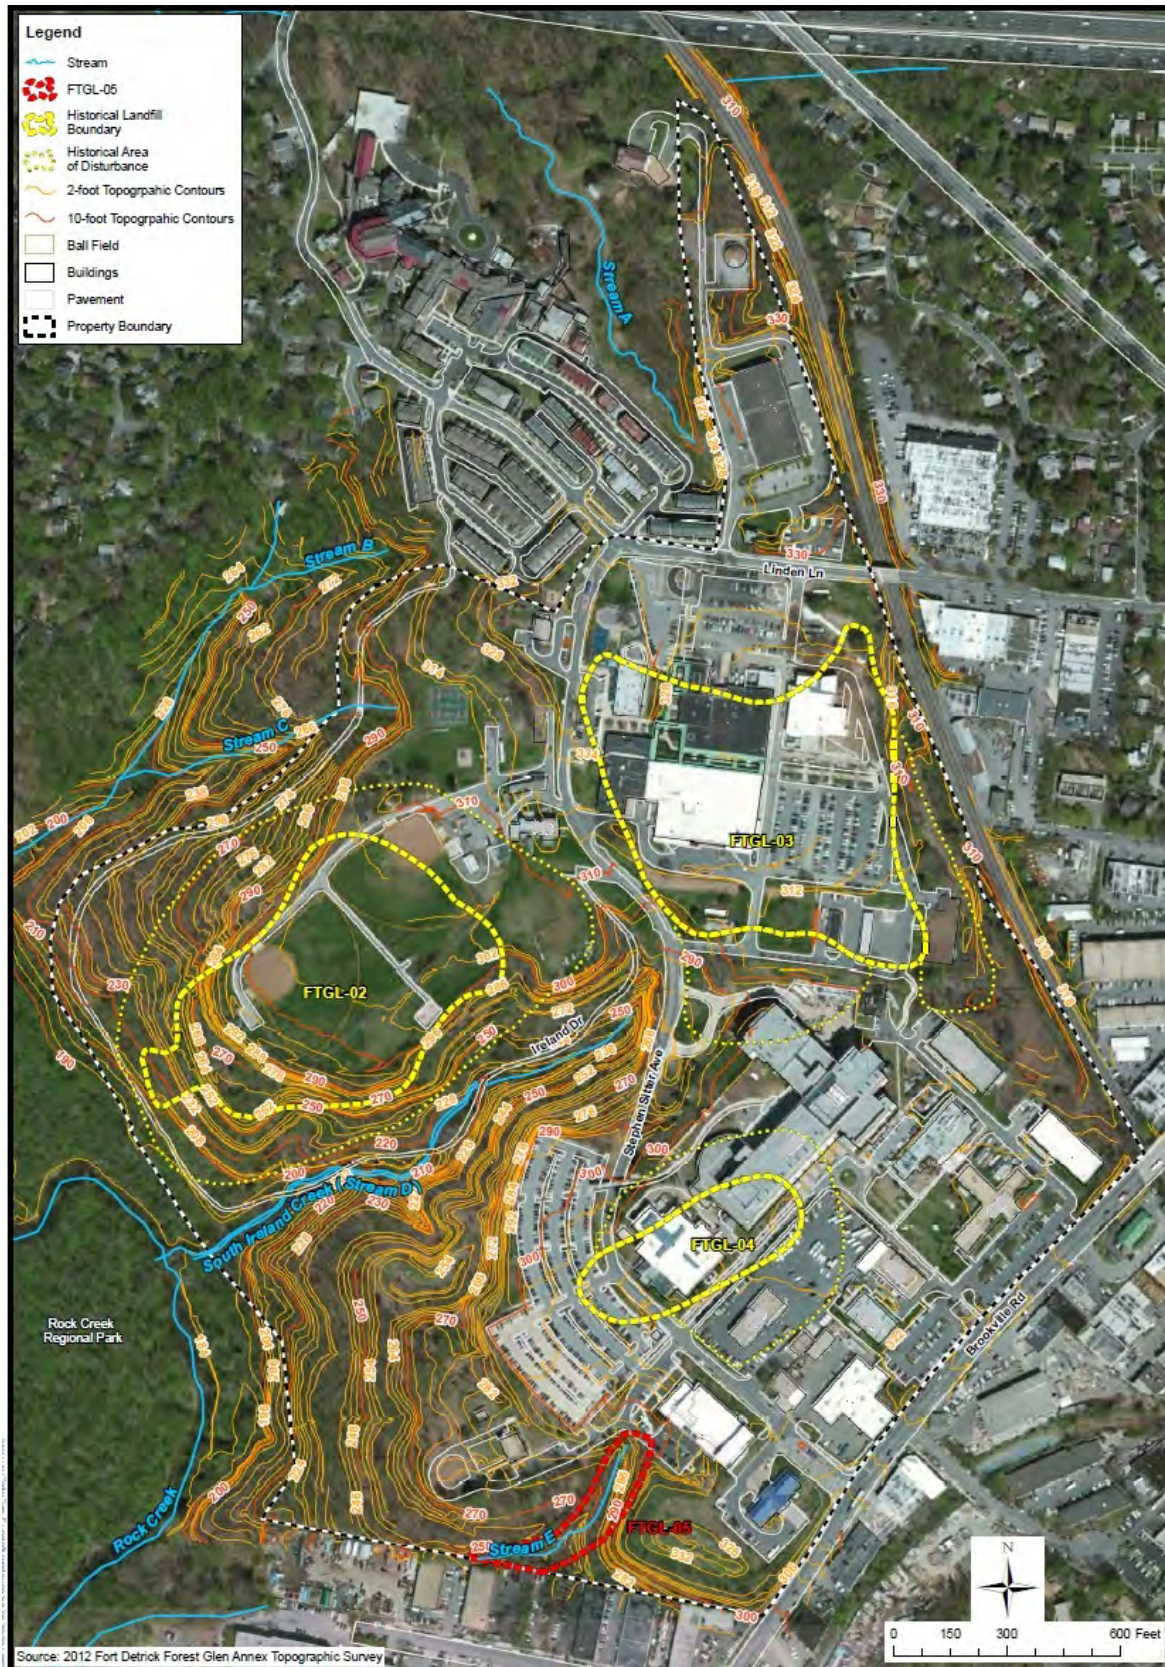
Figure 2-2: Topographic map of FGA, showing terrain around site FTGL-02 on the west side of FGA.

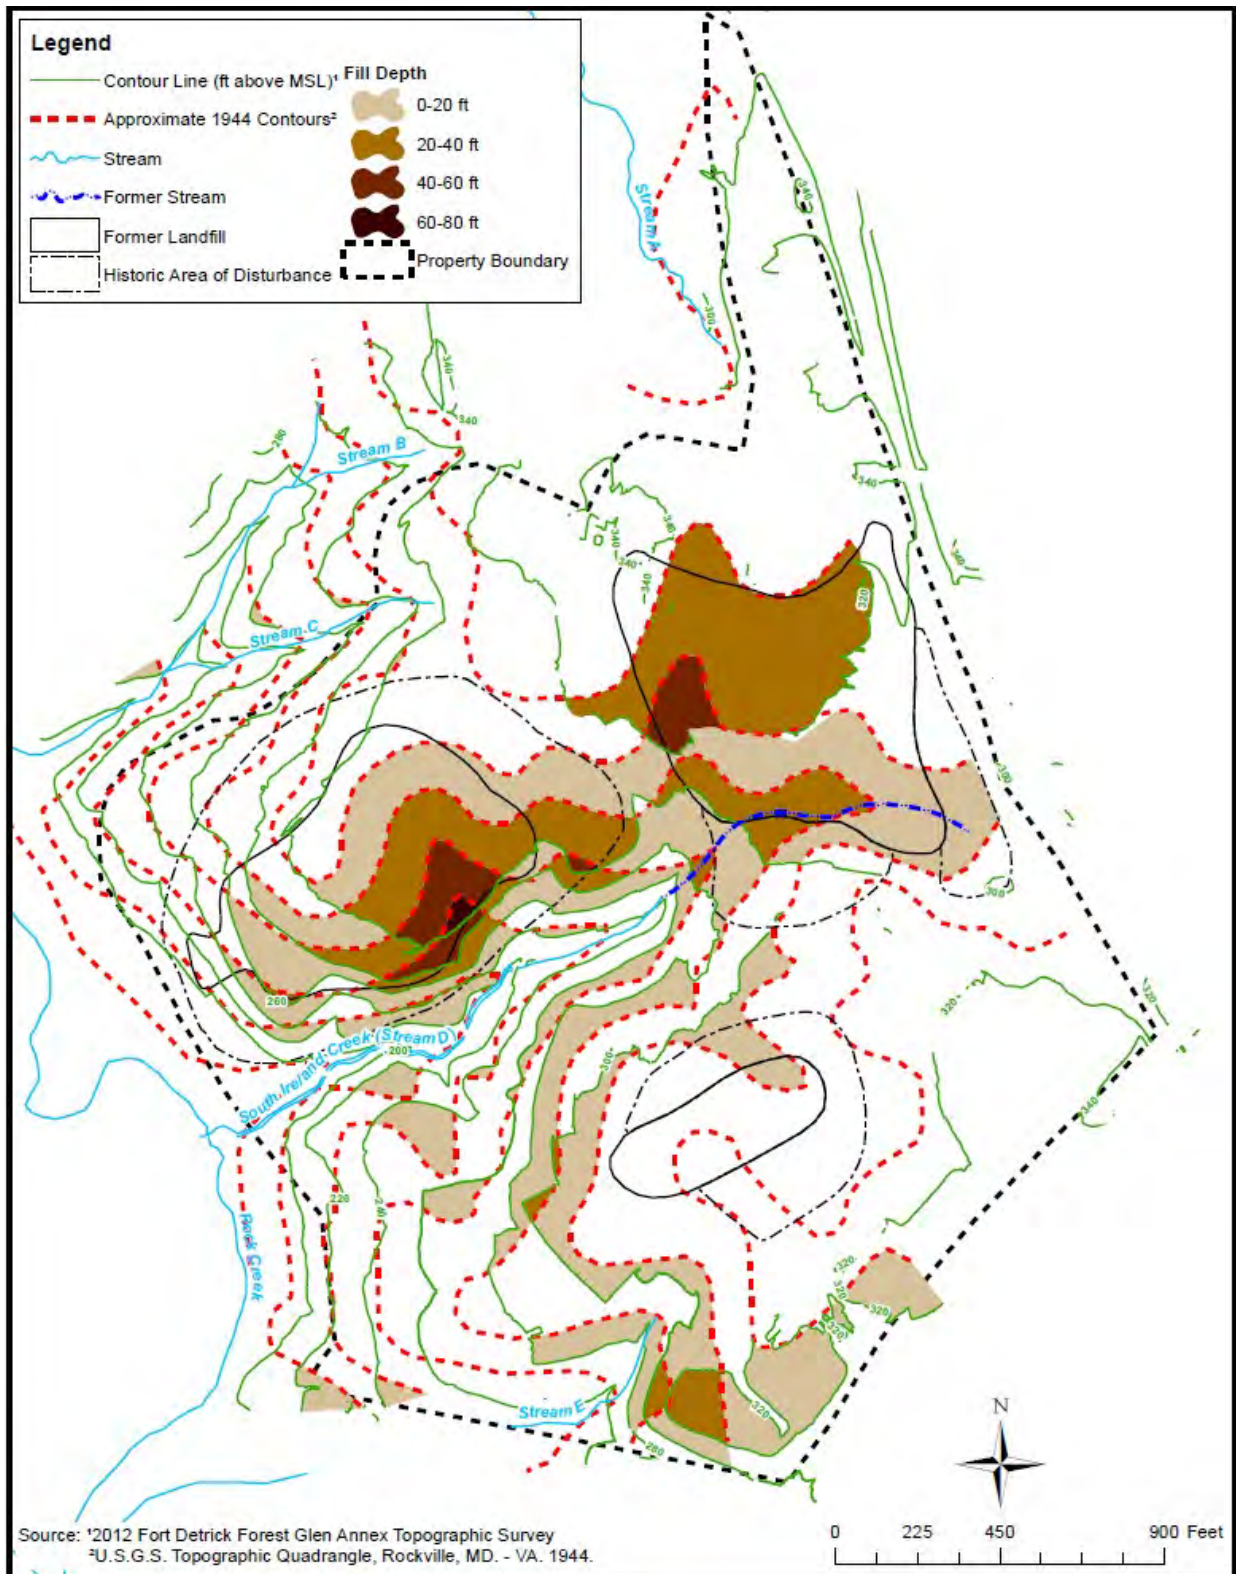
Figure 2-3: Estimated Fill Depths on FGA Based On USGS Topographic Map Comparison

As noted in Section 2.3, historical landfilling at the facility is an explanation for the filling of the valleys whose historical headwaters were moved west or buried by fill placement. A preliminary assessment of the alteration of topography at the FGA based on these landfilling activities was completed through a comparison of the 1944 U.S. Geological Survey (USGS) topographic map to current topographic data

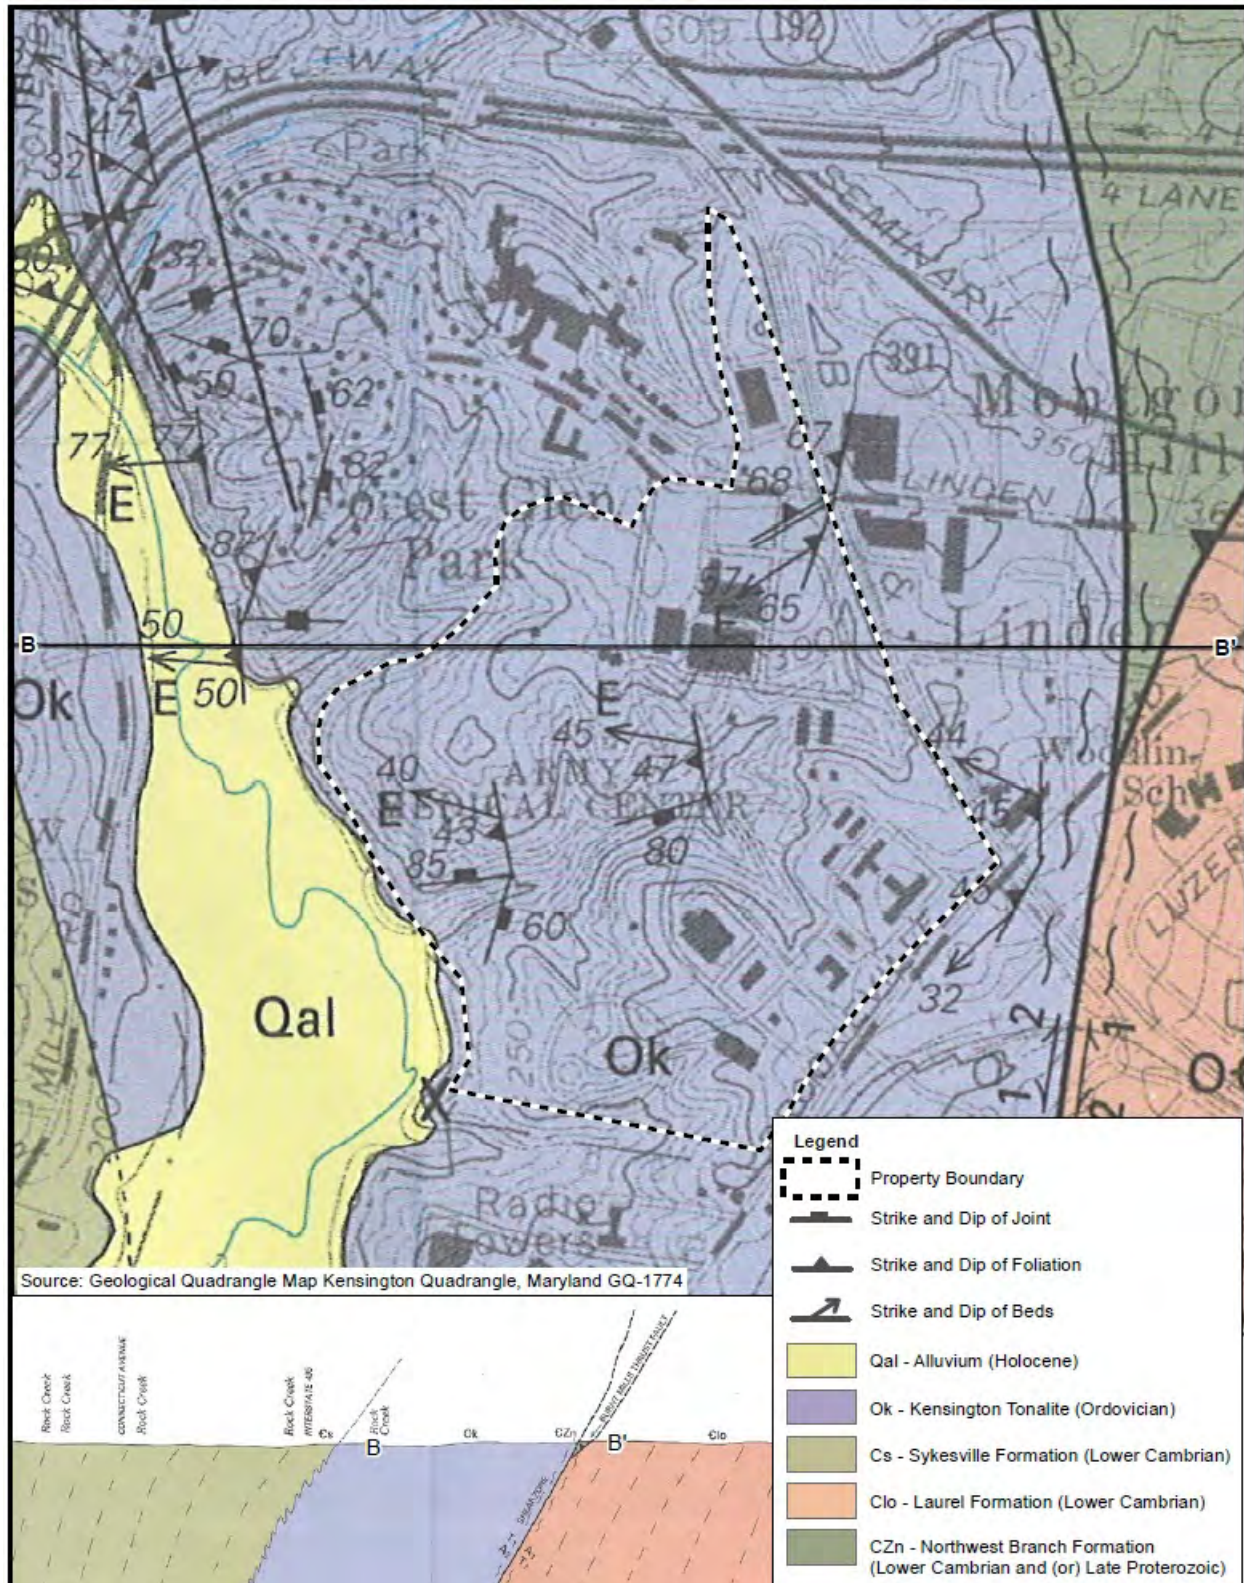
Figure 2-4: Geologic Map of Forest Glen Annex Area

The Kensington Tonalite is a Middle Ordovician formation that formed as an intrusion into the surrounding Sykesville Formation, a metasedimentary unit of the Lower Cambrian. The north trending Rock Creek Shear Zone separates the Kensington Tonalite from the Laurel Formation (Clo), at its nearest point, approximately 0.1 mile east of the easternmost point of the FGA. Slightly to the north of this point, the Shear Zone cuts off the northeast trending Burnt Mills thrust fault. To the north of the Burnt Mills, the Shear Zone forms the boundary between the Kensington Tonalite and the lower Cambrian Northwest Branch Formation (CZn). Varying degrees of metamorphism are observed in the Kensington Tonalite.

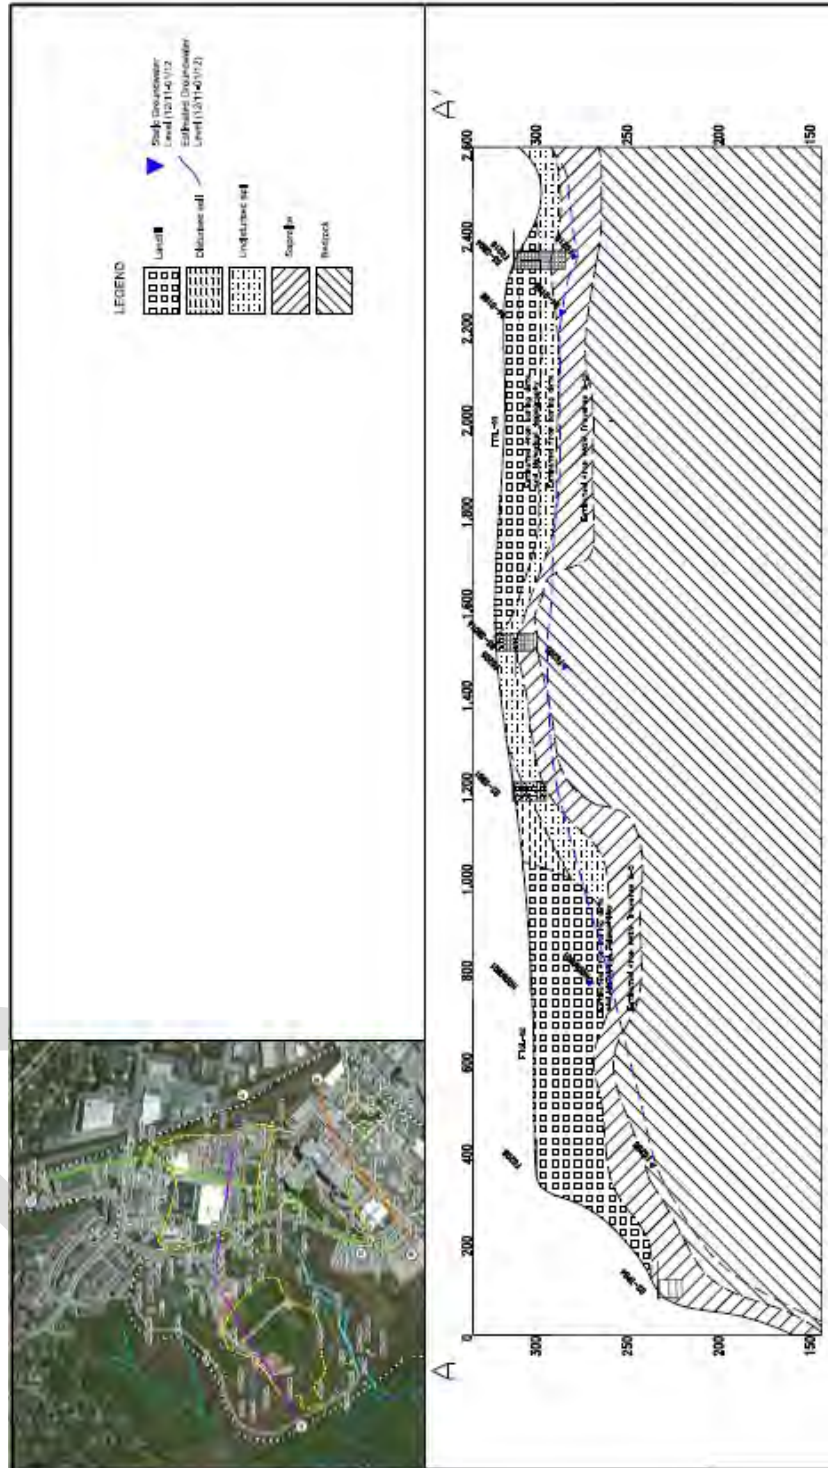
Figure 2-6: Cross Section A-A'

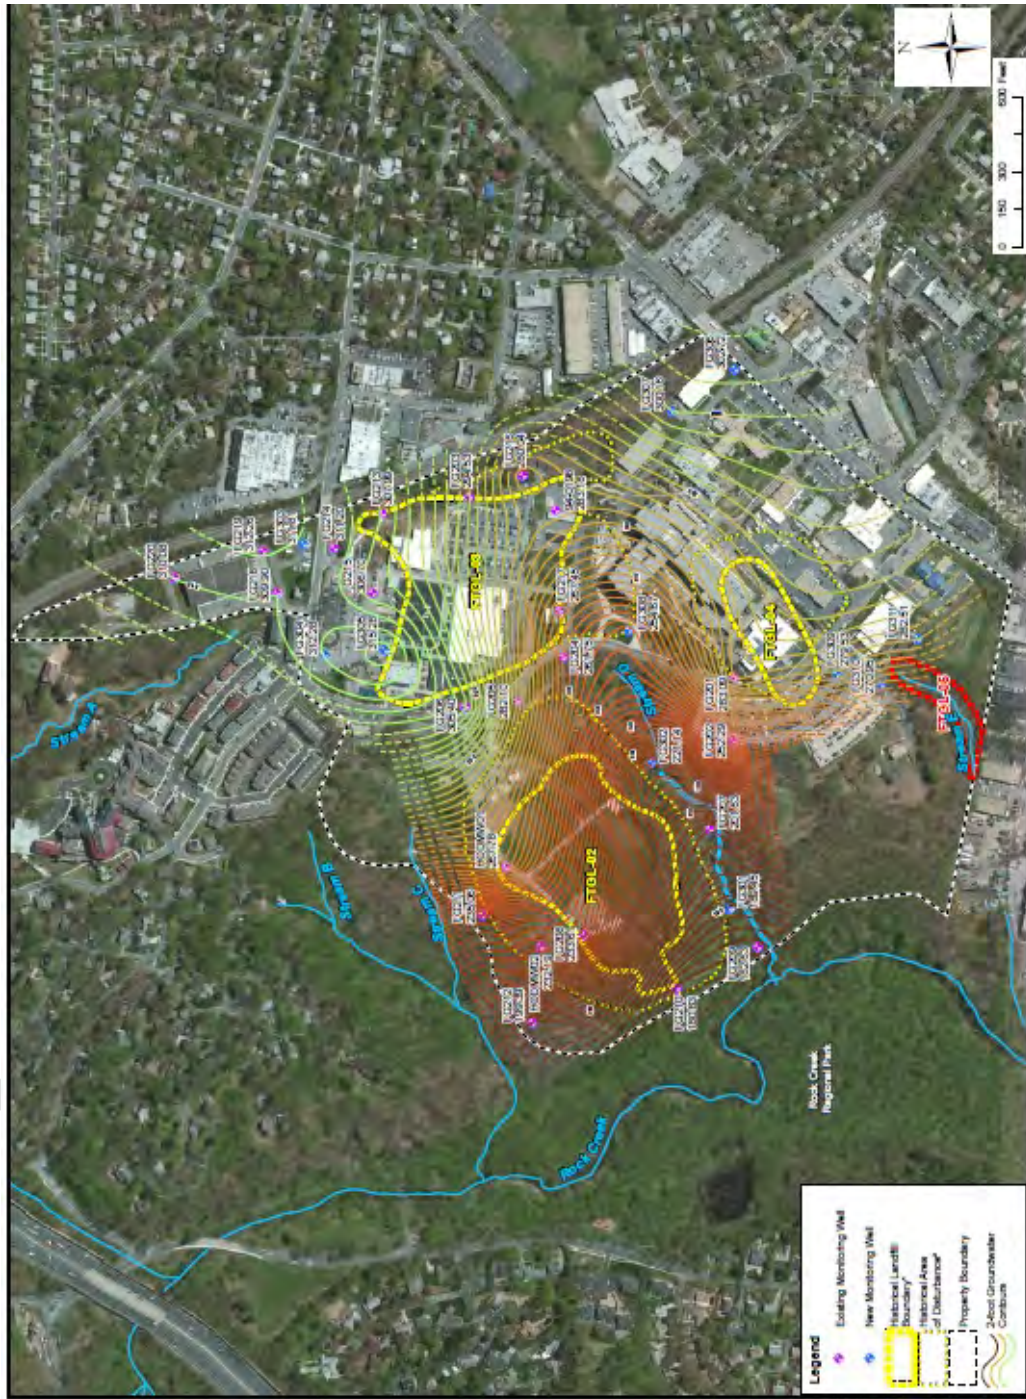
Figure 2-7: Groundwater contours in 2011-2012

Groundwater at the FGA, predominantly flows from the northeast to southwest, mimicking the topographic surface profile and eventually discharging into the surrounding surface water features of Rock Creek and its tributaries in the western portion of the facility, but will be greatly influenced by the presence of high permeability structural features (e.g. fracture zones, faults and foliation) present within the aquifer matrix.

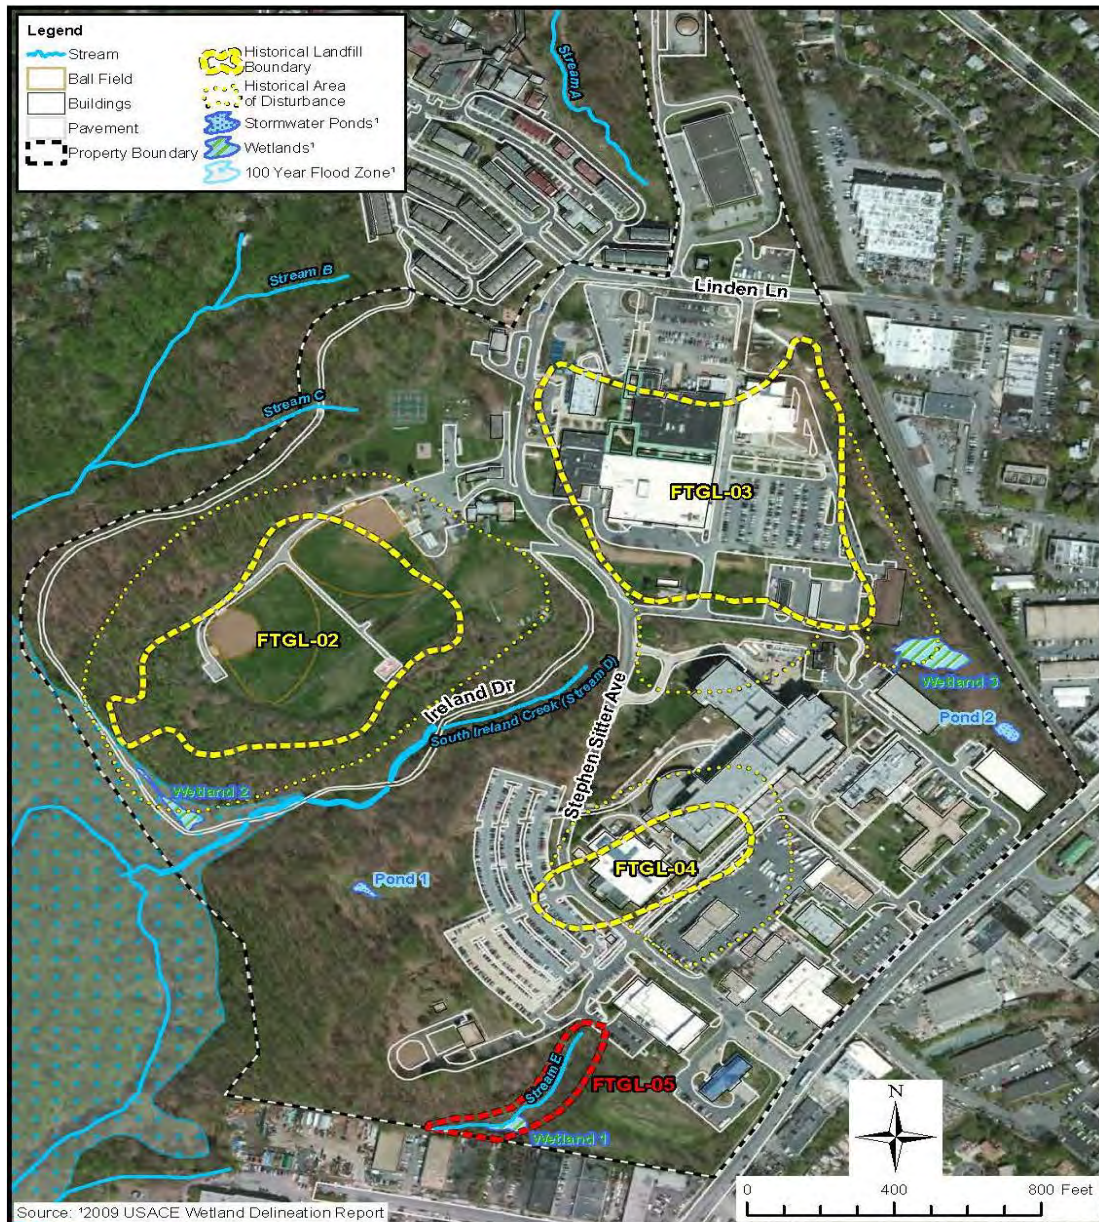
Figure 2-8: Surface water and wetlands

A stormwater retention pond is present outside the southwestern corner of FTGL-02 near South Ireland Creek (see **Figure 2-8**). The pond is located alongside the Ireland Trail as the trail makes a sharp left turn from paralleling the west FGA boundary to entering the Ireland Creek valley. The pond contains an outlet structure that drains to South Ireland Creek. The pond was observed to be generally dry throughout the implementation of the RI in 2010 through 2012, indicating that surface water drainage is not typically directed to the pond at a volume approaching its capacity.

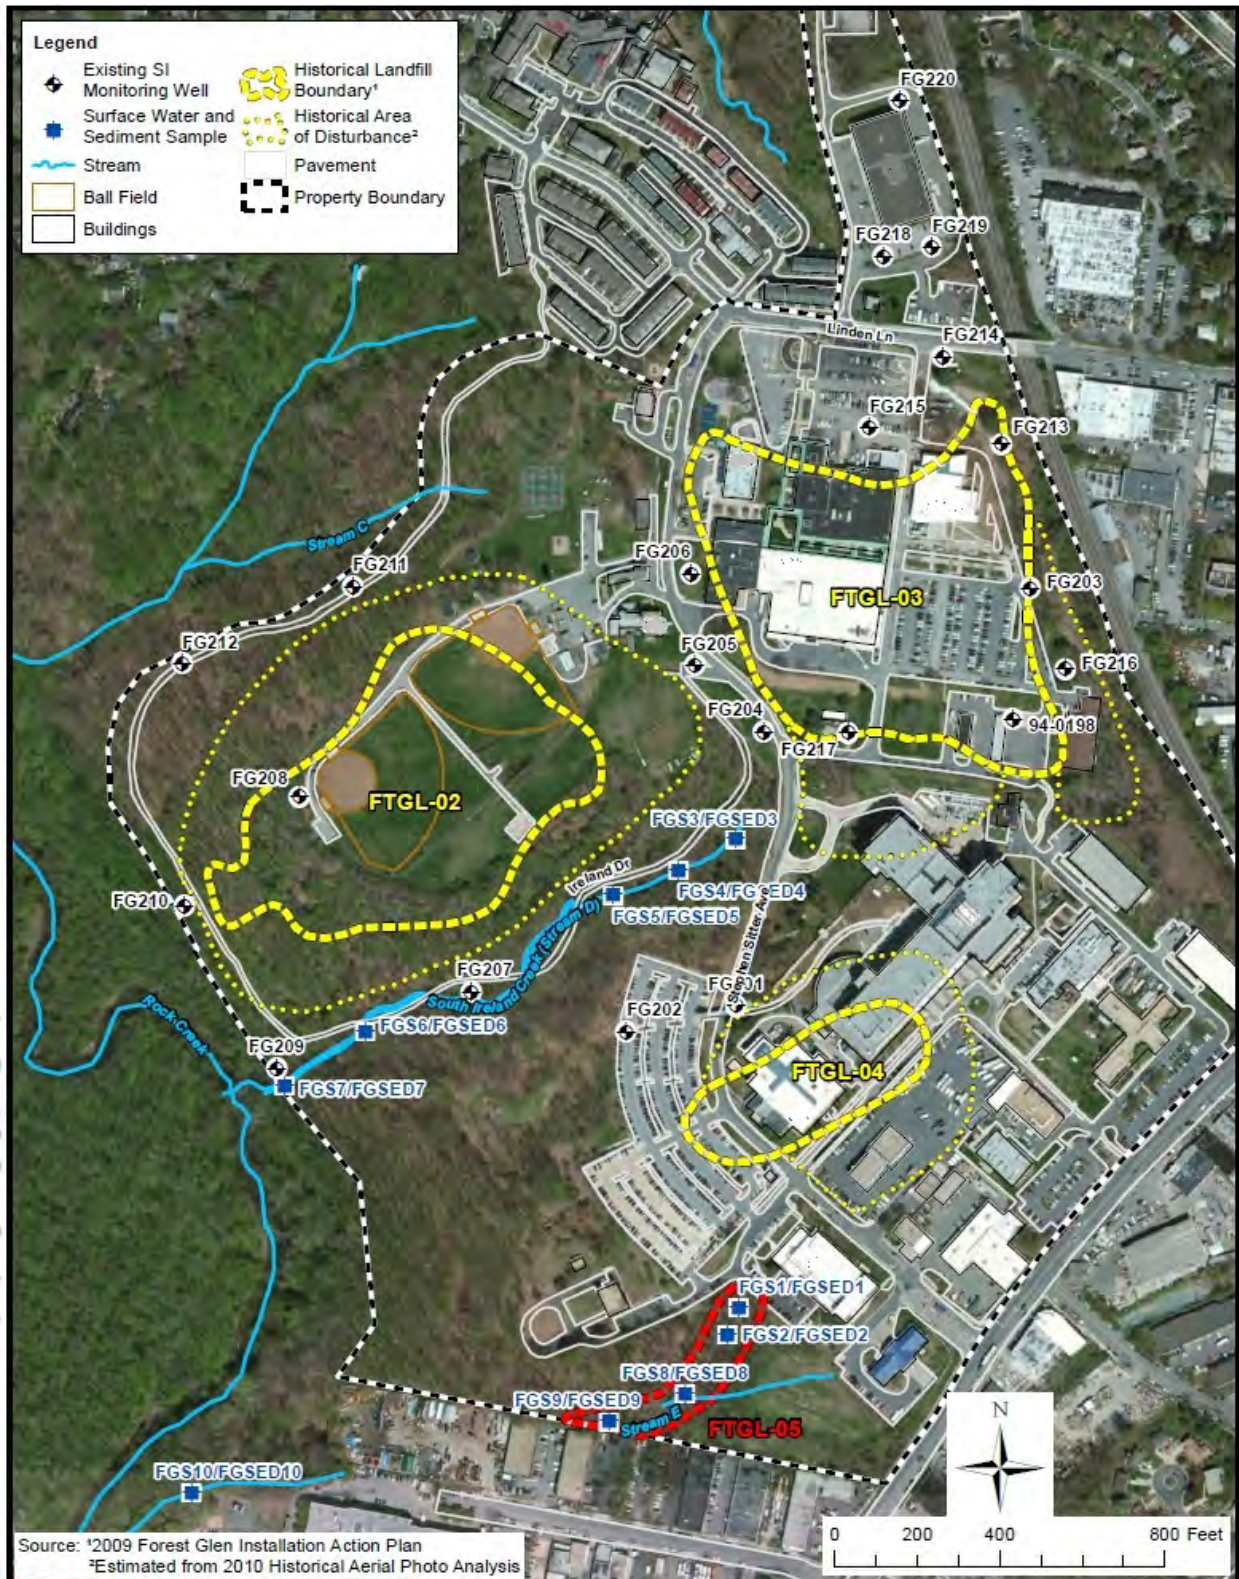
Figure 3-1: Groundwater Monitoring Wells at Site FTGL-02

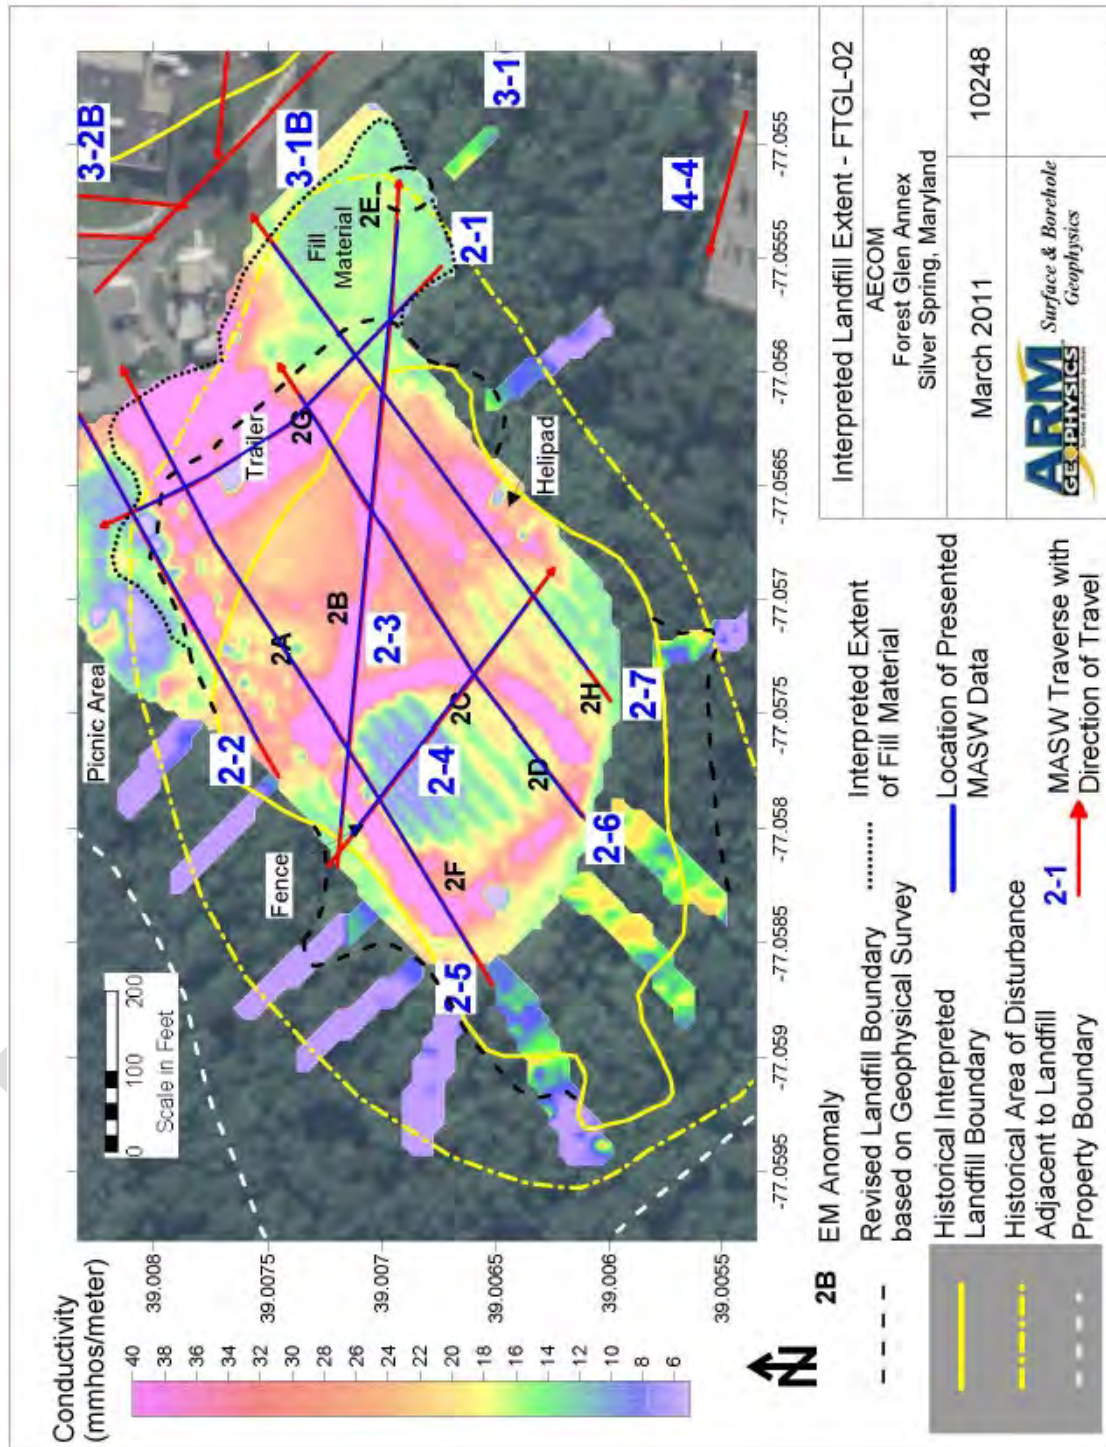
Figure 4-1: Geophysical Survey Results

Additionally, based on MASW results, ARM estimated the depth of landfill material to extend to approximately 57 to 60 feet bgs in the western and northern portions of the landfill. However, excessive subsurface moisture content along several traverses at FTGL-02 caused a reduction in the quality of the vertical data in the eastern and southern portions of the landfill. Depth estimates for landfill material in these areas were identified as extending greater than 40 feet bgs with no maximum estimate identified. Due to the uncertainty associated with geophysical-based depth estimates, other lines of evidence were considered in the estimation of landfill depth including nearby soil borings, and historical site topography. The resultant landfill depth estimate was approximately 45 feet bgs.

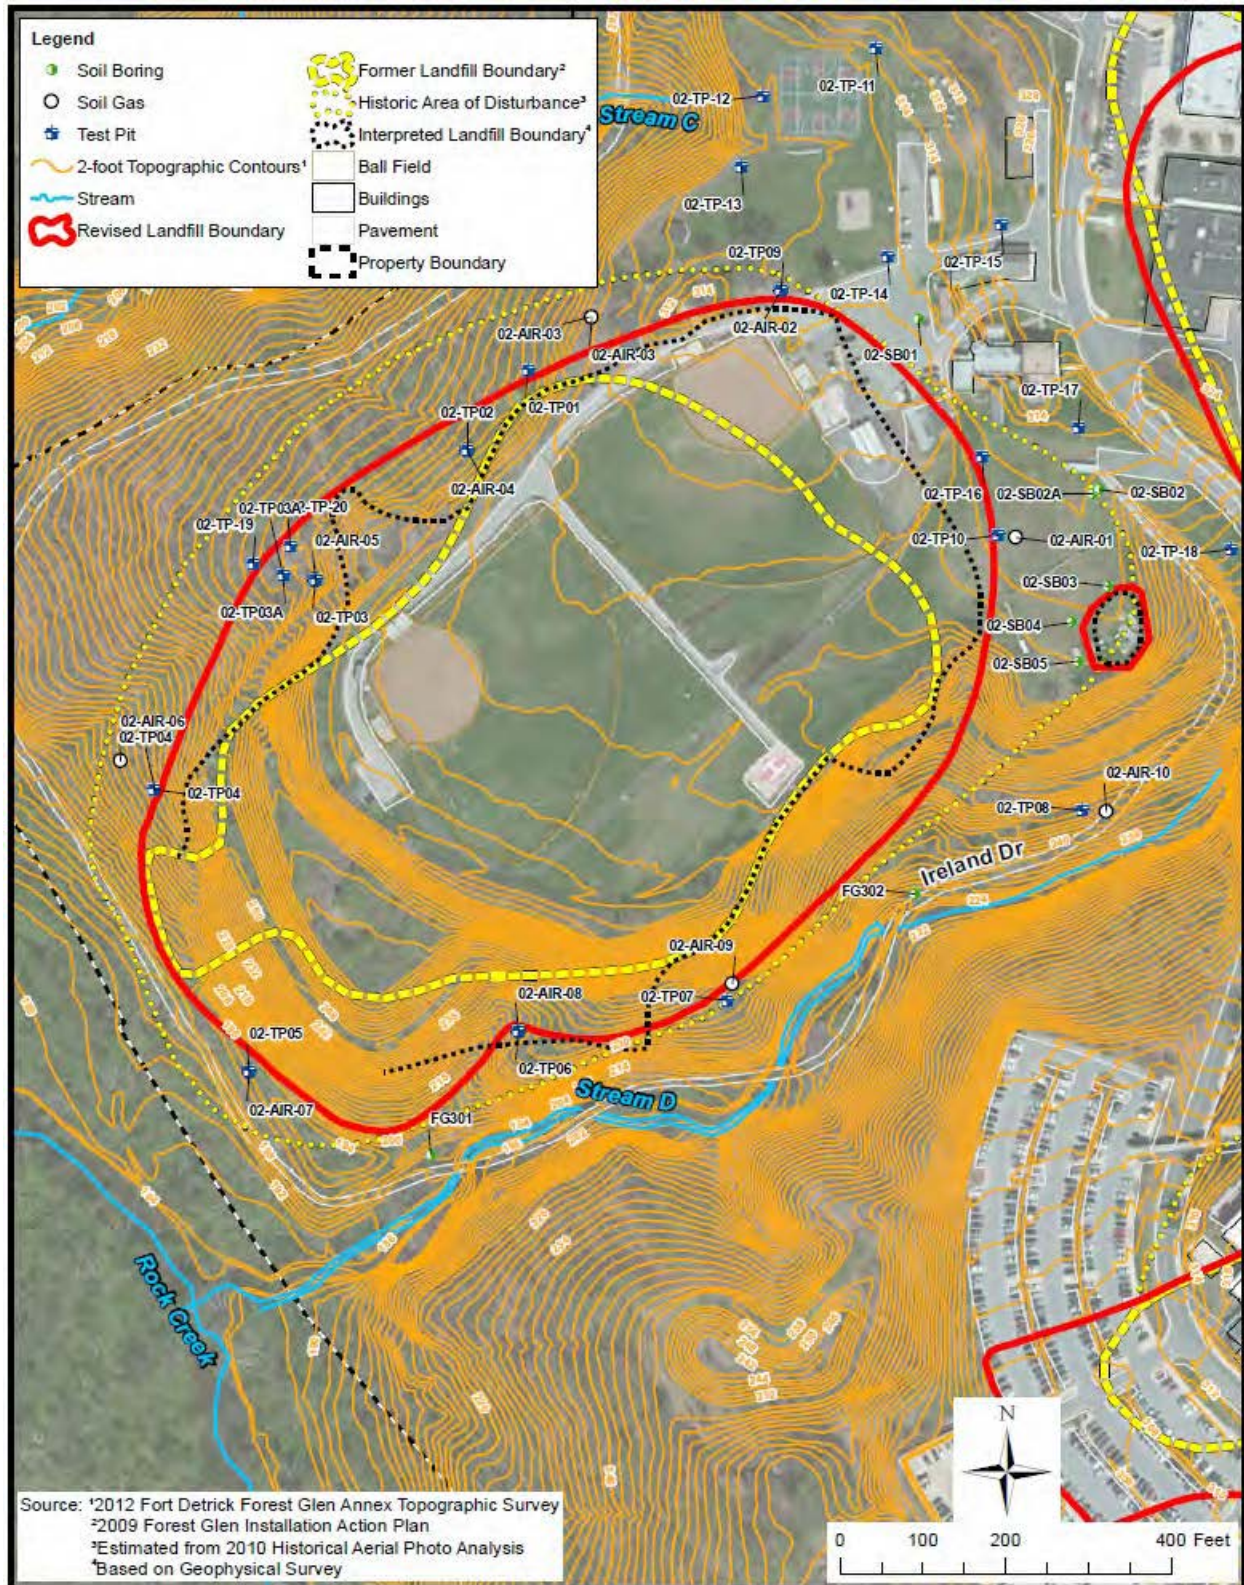
Figure 4-2: Test Pit Locations Around Perimeter of Site FTGL-02

Most of the test pit and soil boring results confirmed the limits of the landfill waste. However, waste material associated with the landfill was encountered in test pit TP03 and its initial offset location, TP03A. Wastes observed were consistent with materials typically associated with laboratory or medical waste, such as glass bottles, tubes, and vials. Consistent with the RI work plan procedure, excavation of test pits TP03 and TP03A was terminated immediately upon encountering the waste material and the pits were filled back in. Test pits TP19 and TP20, offsets from test pits TP03 and TP03A, were subsequently excavated and found to contain no landfill waste materials.

Passive soil gas samples were collected at FTGL-02 as a screening tool to aid in delineating the landfill perimeter. Samples were collected into vacuum sealed, six-liter stainless steel SUMMA® canisters from a depth of approximately three to four feet bgs and analyzed by the analytical laboratory for VOCs via Method TO-15. The probes were advanced using a hammer drill and the canister flow controllers were calibrated for a one-hour collection period. A total of 10 soil gas samples (02-AIR-01 through 02-AIR-10) were collected at FTGL-02 (see Figure 4-2).

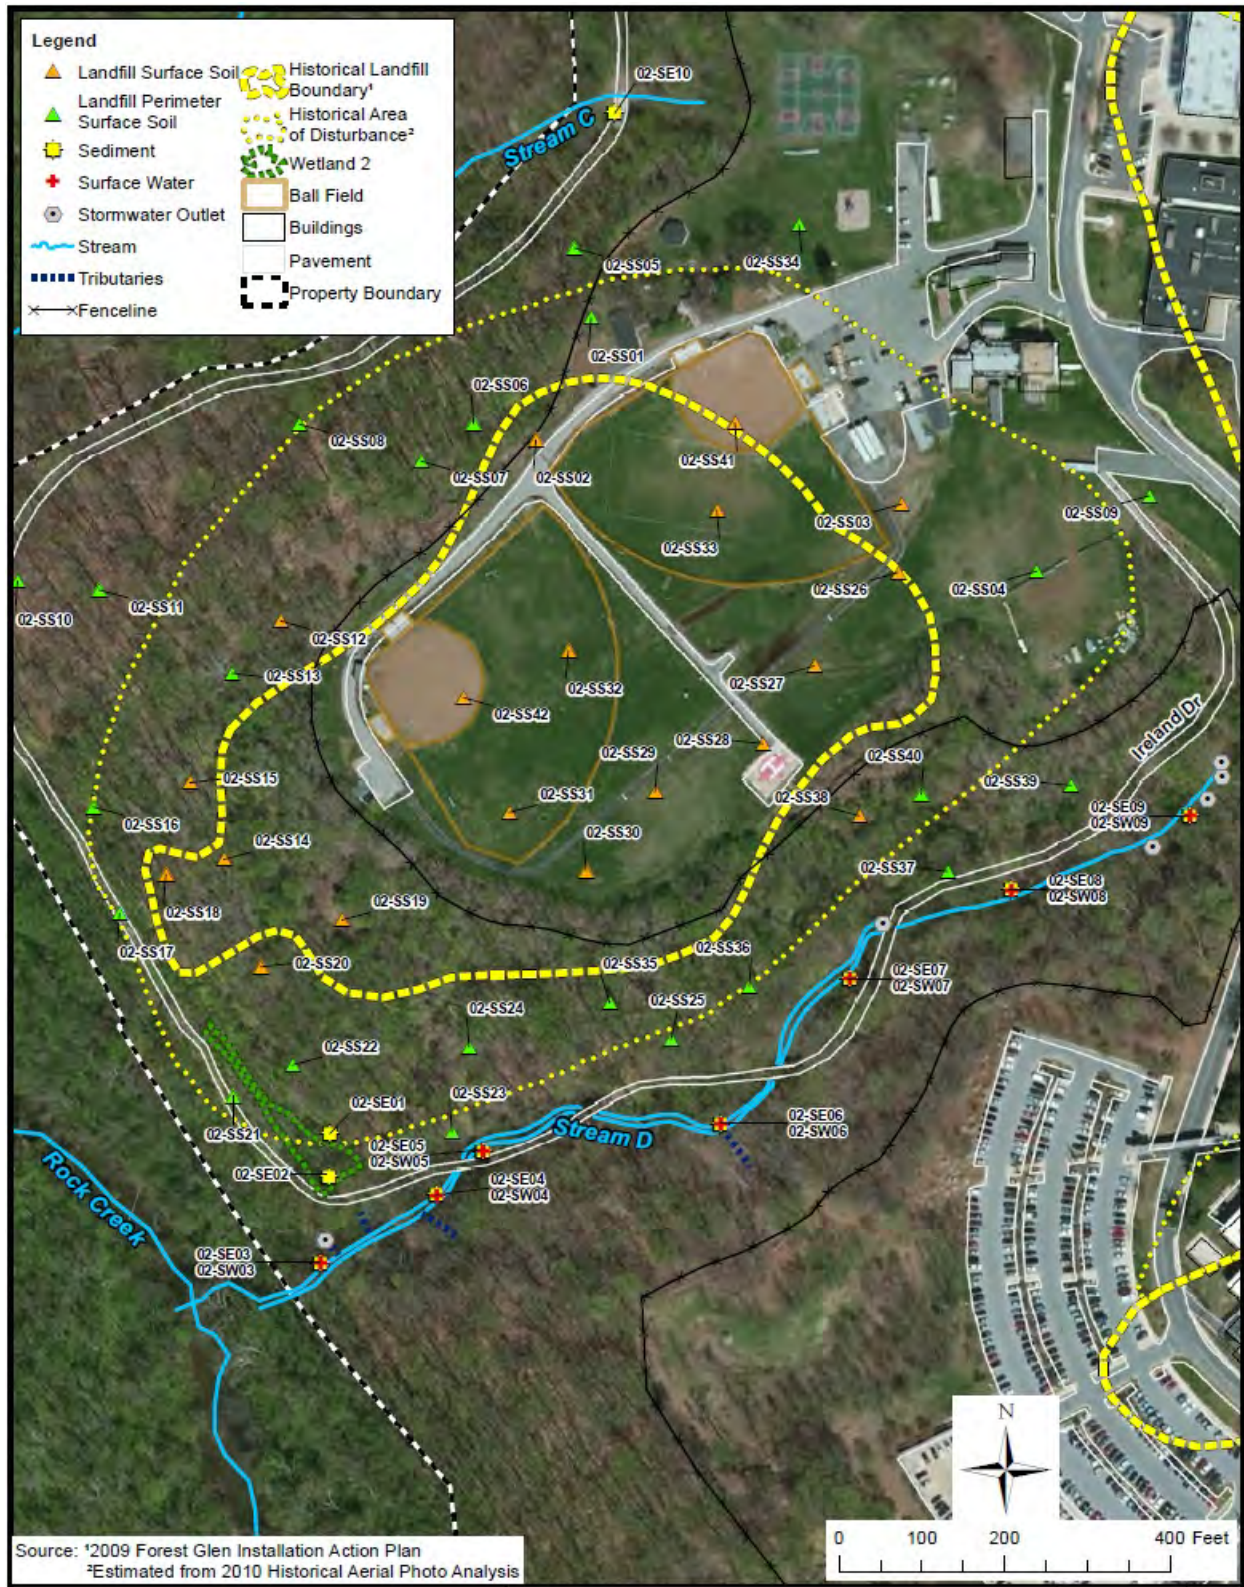
Figure 4-3: Surface soil sampling locations at site FTGL-02

Co-located surface water and sediment samples were collected in Stream D (South Ireland Creek), Stream C, and the retention pond down gradient from FTGL-02 on 27 and 28 June 2011 (see Figure 4-3). At locations without adequate surface water flow (i.e., 02-SE01 and 02-SE02 in the retention pond, and 02-SE10 in Stream C), only sediment samples were collected. These locations were also observed during subsequent storm events to ascertain if surface water sampling would be feasible and found to contain negligible surface water flow. Water quality measurements were taken at the time of sampling using a Horiba U-52 Multi-parameter Meter.

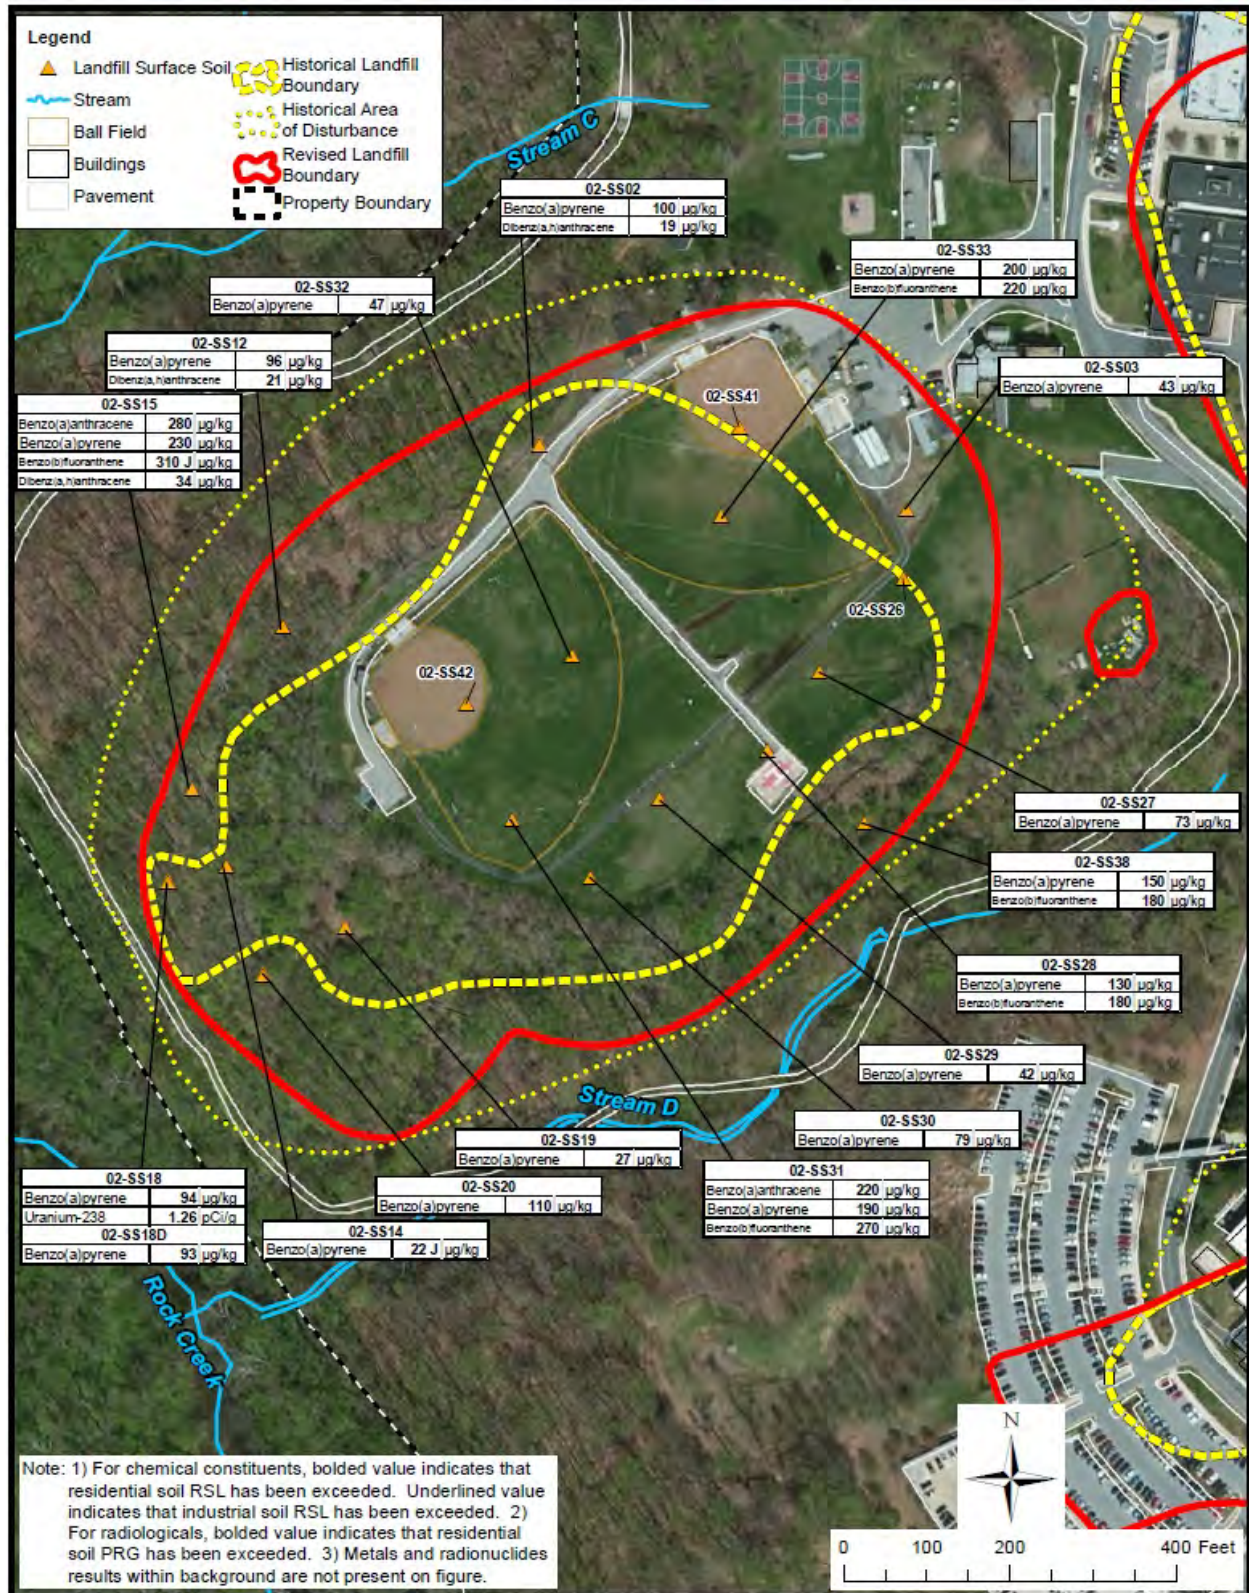
Figure 4-4: Significant sampling results in surface soils

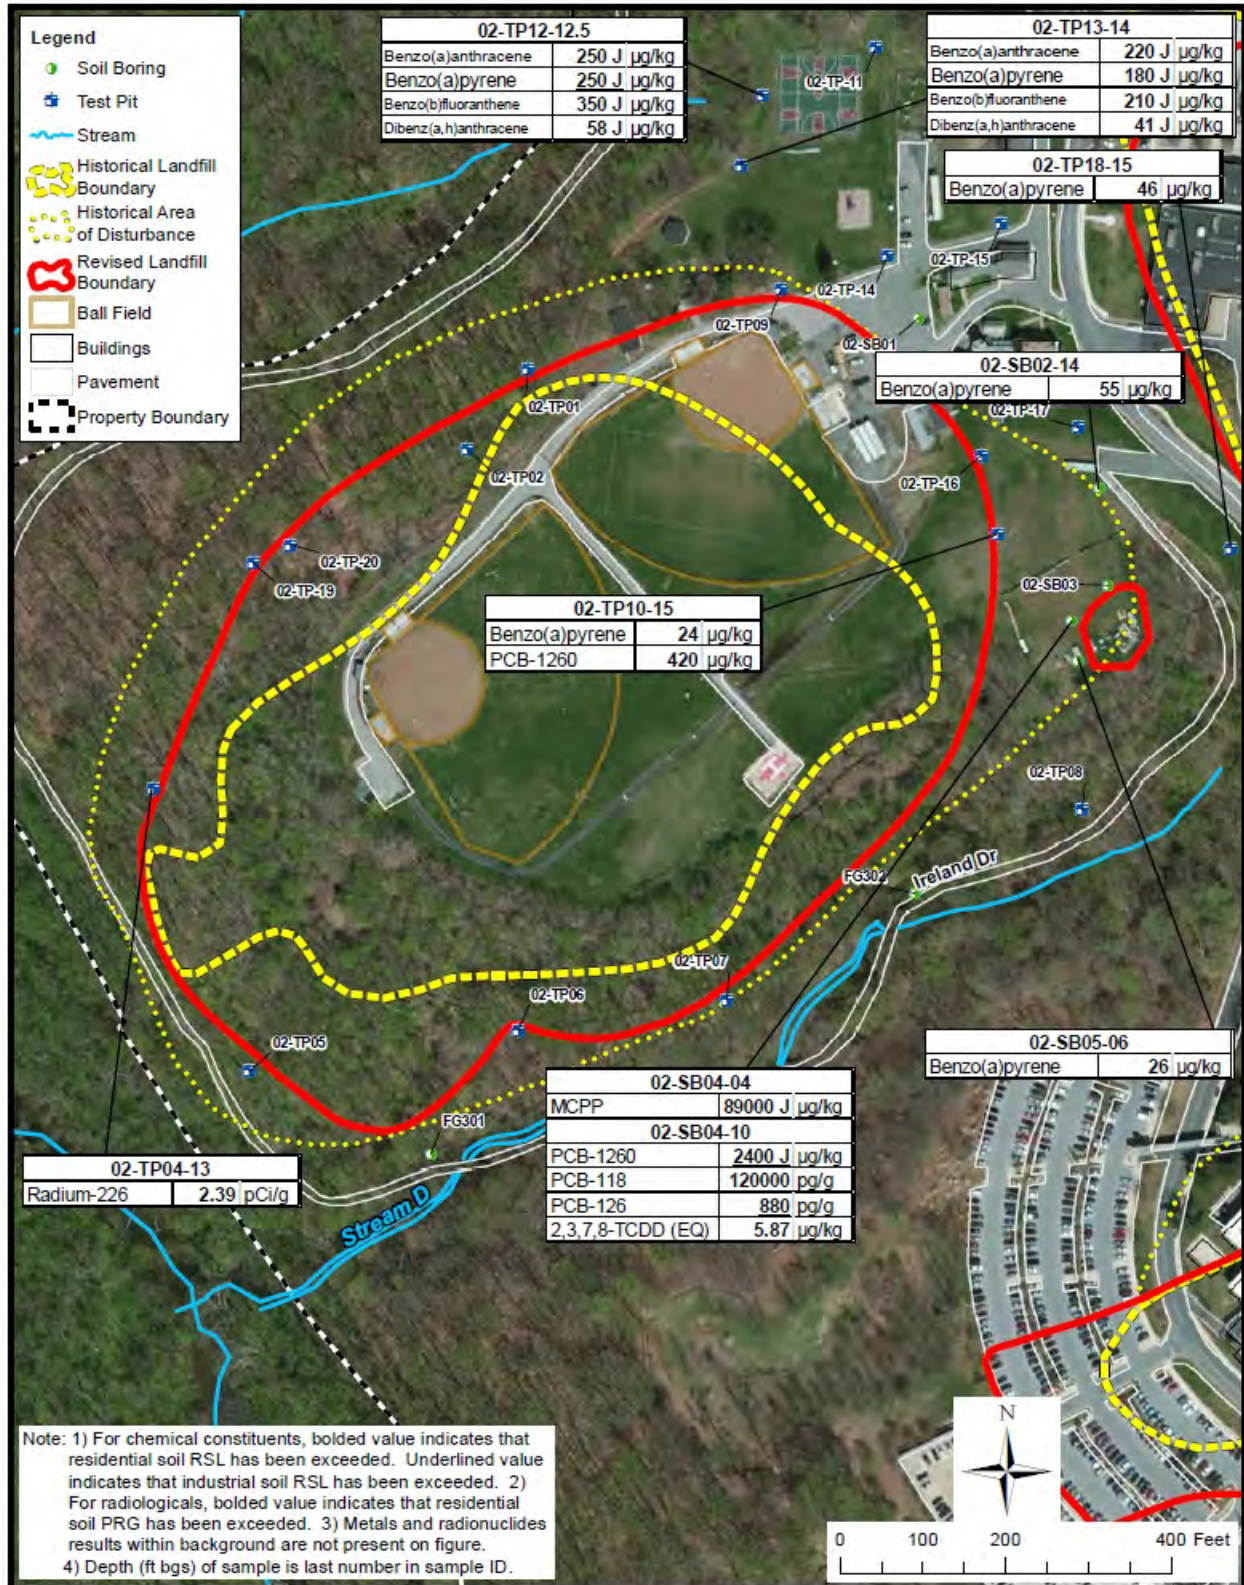
Figure 4-6: Subsurface soil criteria exceedances
