Draft Final

Engineering Evaluation / Cost Analysis

Control of Exposure to Near-Surface Waste at Ball Field Landfill

Forest Glen Annex

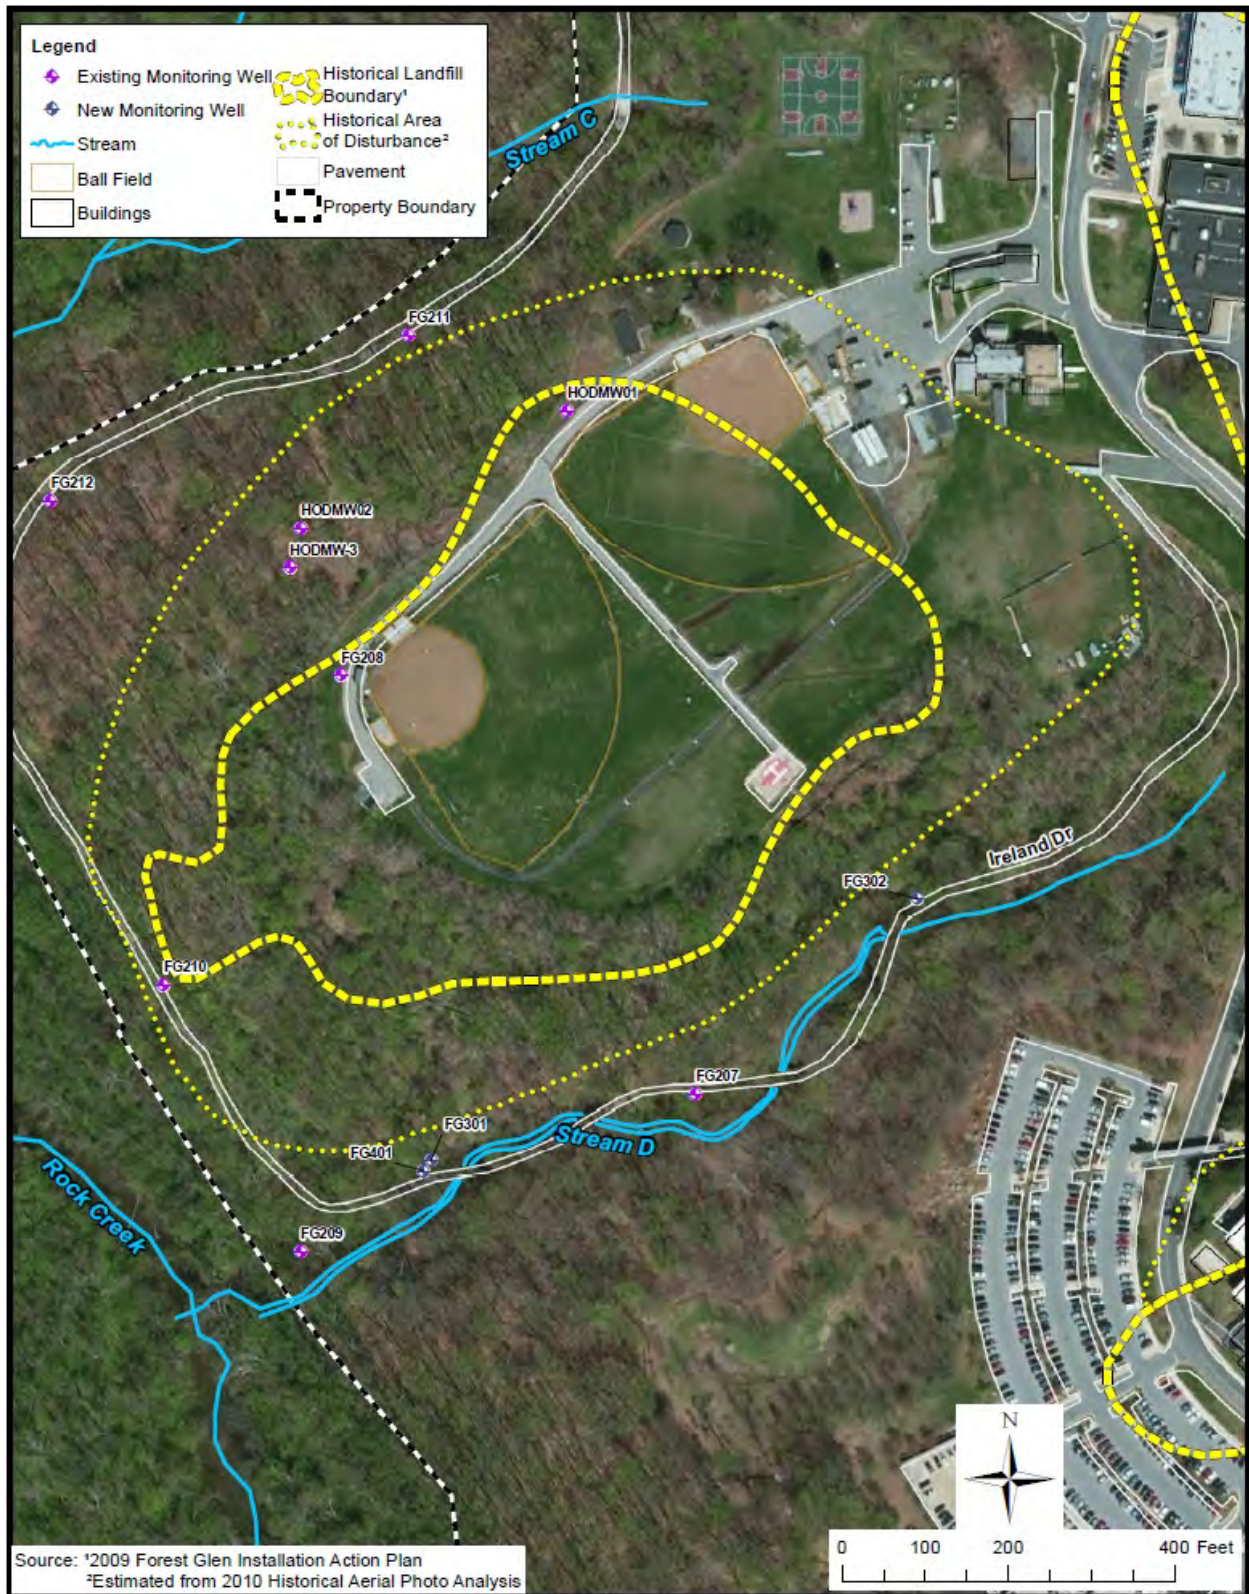
Figure 4-7: Groundwater monitoring well locations

Two shallow groundwater monitoring wells (FG301 and FG302) were constructed at FTGL-02 downgradient of the landfill near Stream D (South Ireland Creek) (see Figure 4-7). Due to the relatively low permeability observed in the saprolite, water was not observed during drilling. At locations where the depth to groundwater could not be identified during drilling, the boreholes were left open up to 24 hours to determine the depth to water prior to well construction. Well screens were installed below the water table wherever adequate depth was available.

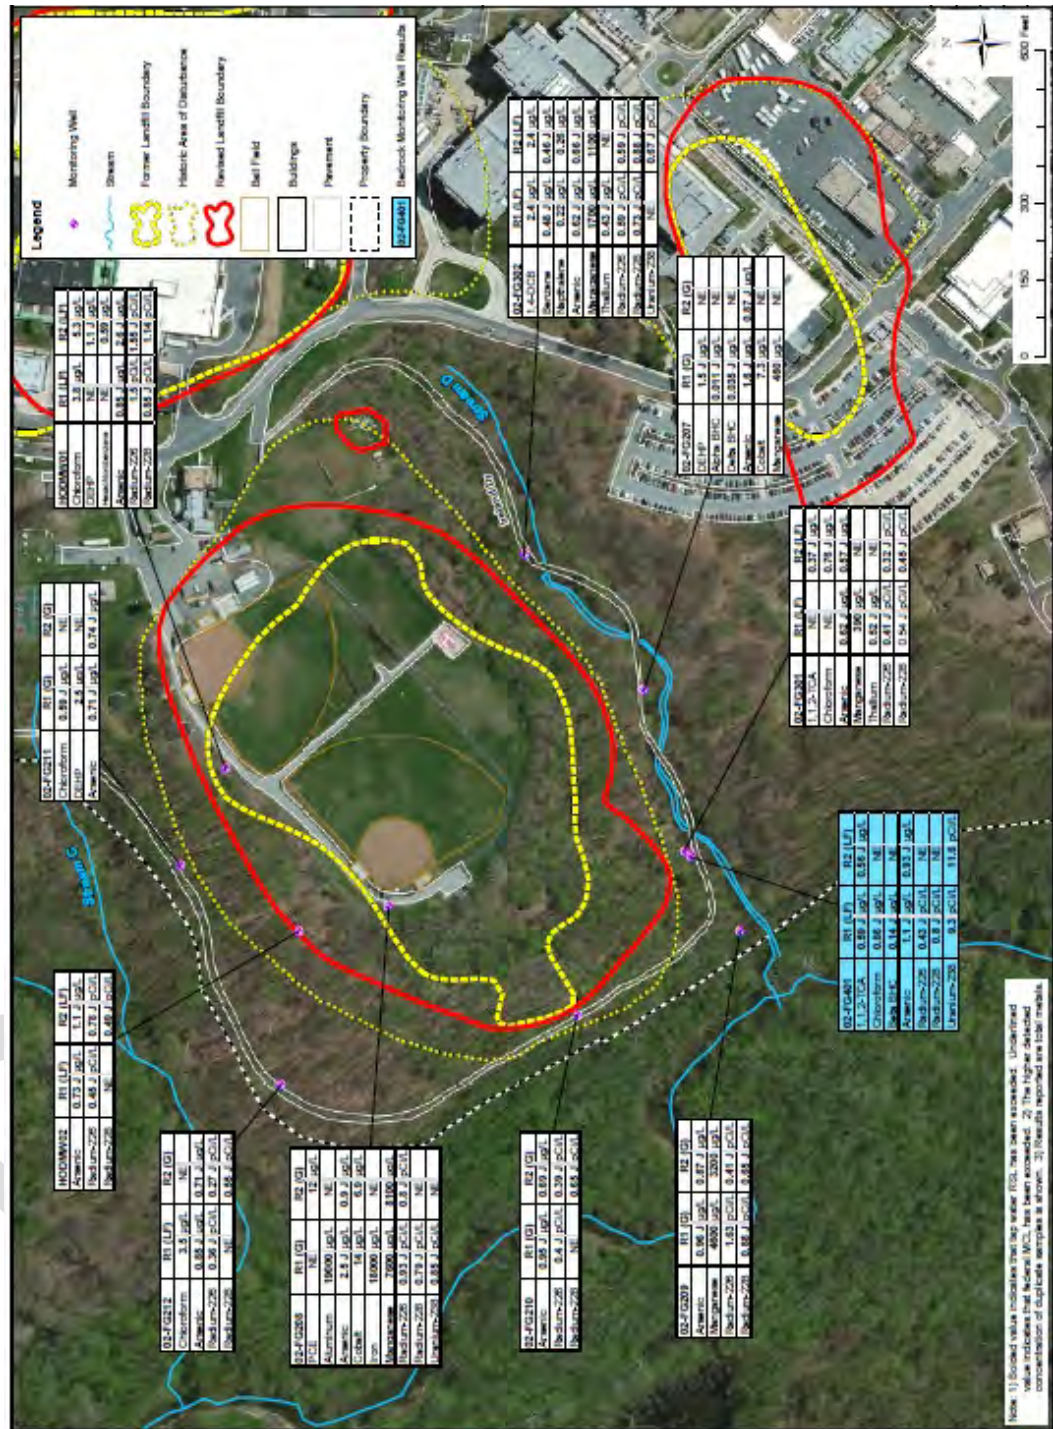
Figure 4-8: Exceedances of screening levels in groundwater

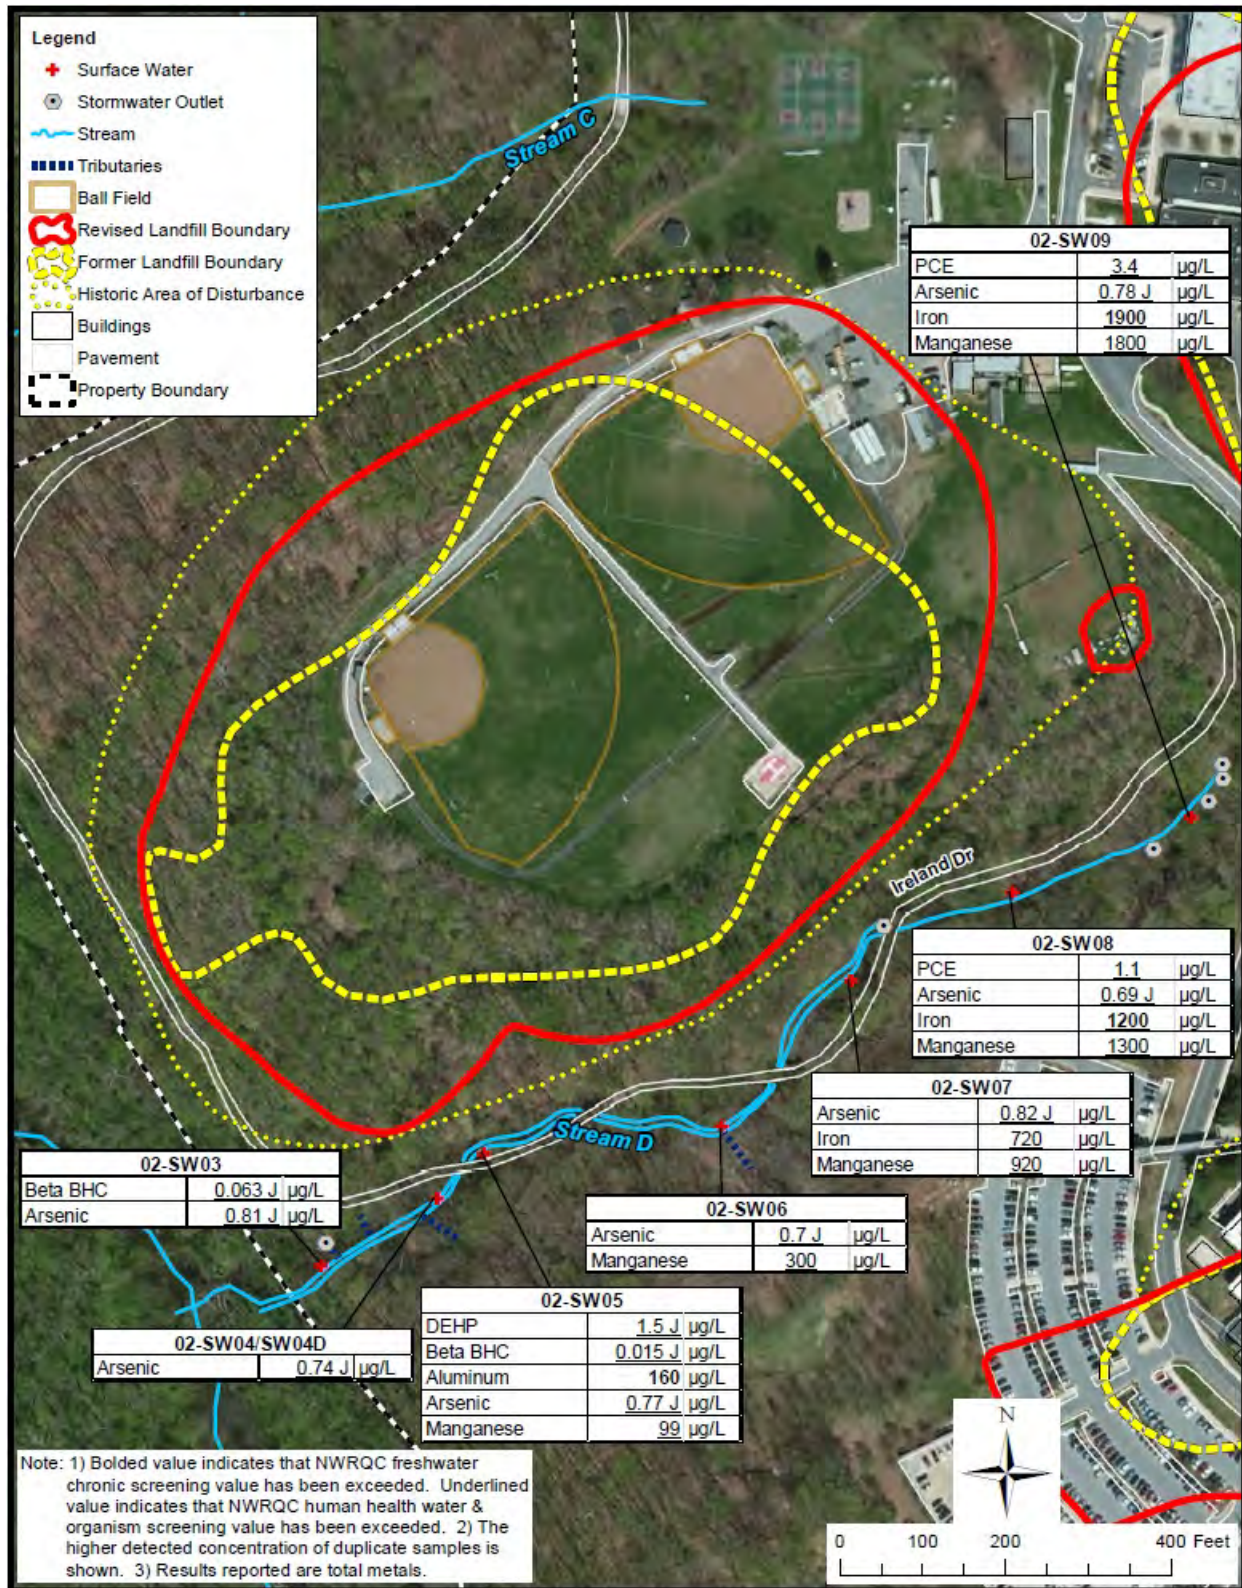
Figure 4-9: Screening level exceedances in surface water

A total of eight surface water samples, including one duplicate, co-located with sediment samples were collected from Stream D at FTGL-02 (see Figure 4-9). As discussed in Section 4.2.5, surface water flow was insufficient at three planned sampling locations (SW01, SW02, and SW10) therefore samples were not collected. Surface water sample results for VOCs, SVOCs, pesticides, herbicides, PCBs, and metals were screened in the draft RI Report against USEPA National Recommended Water Quality Criteria (NRWQC) for freshwater chronic toxicity, and human health and aquatic life. The following sections summarize the screening results of detected compounds. Figure 4-9 illustrates the locations of the exceedances in surface water for FTGL-02.

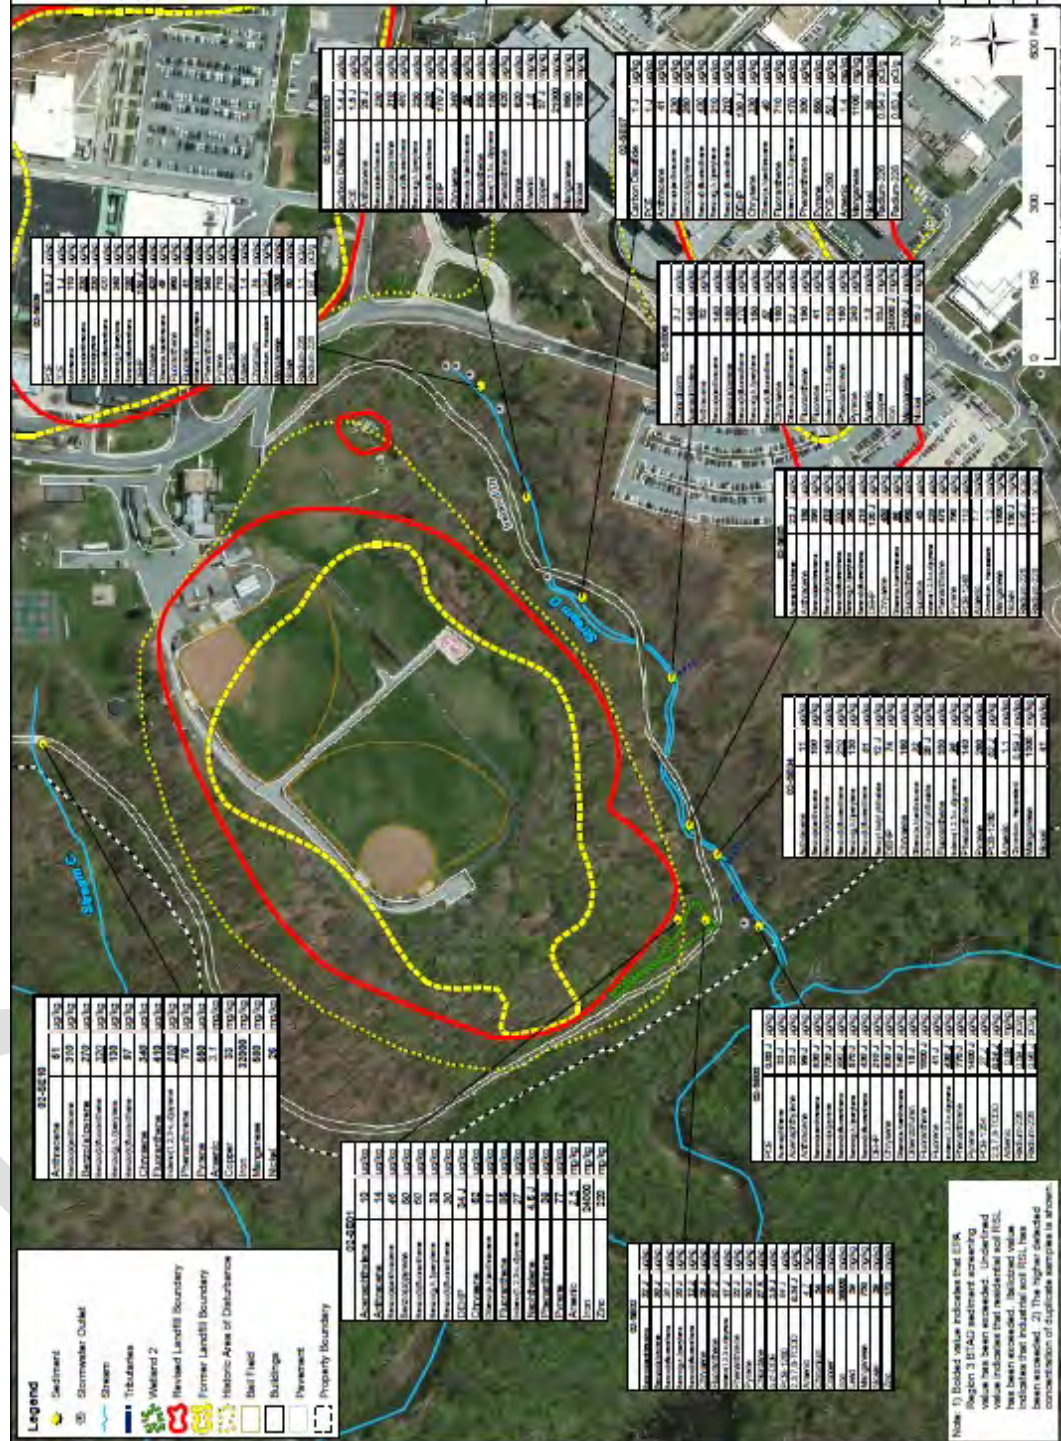
Figure 4-10: Criteria exceedances in sediment.

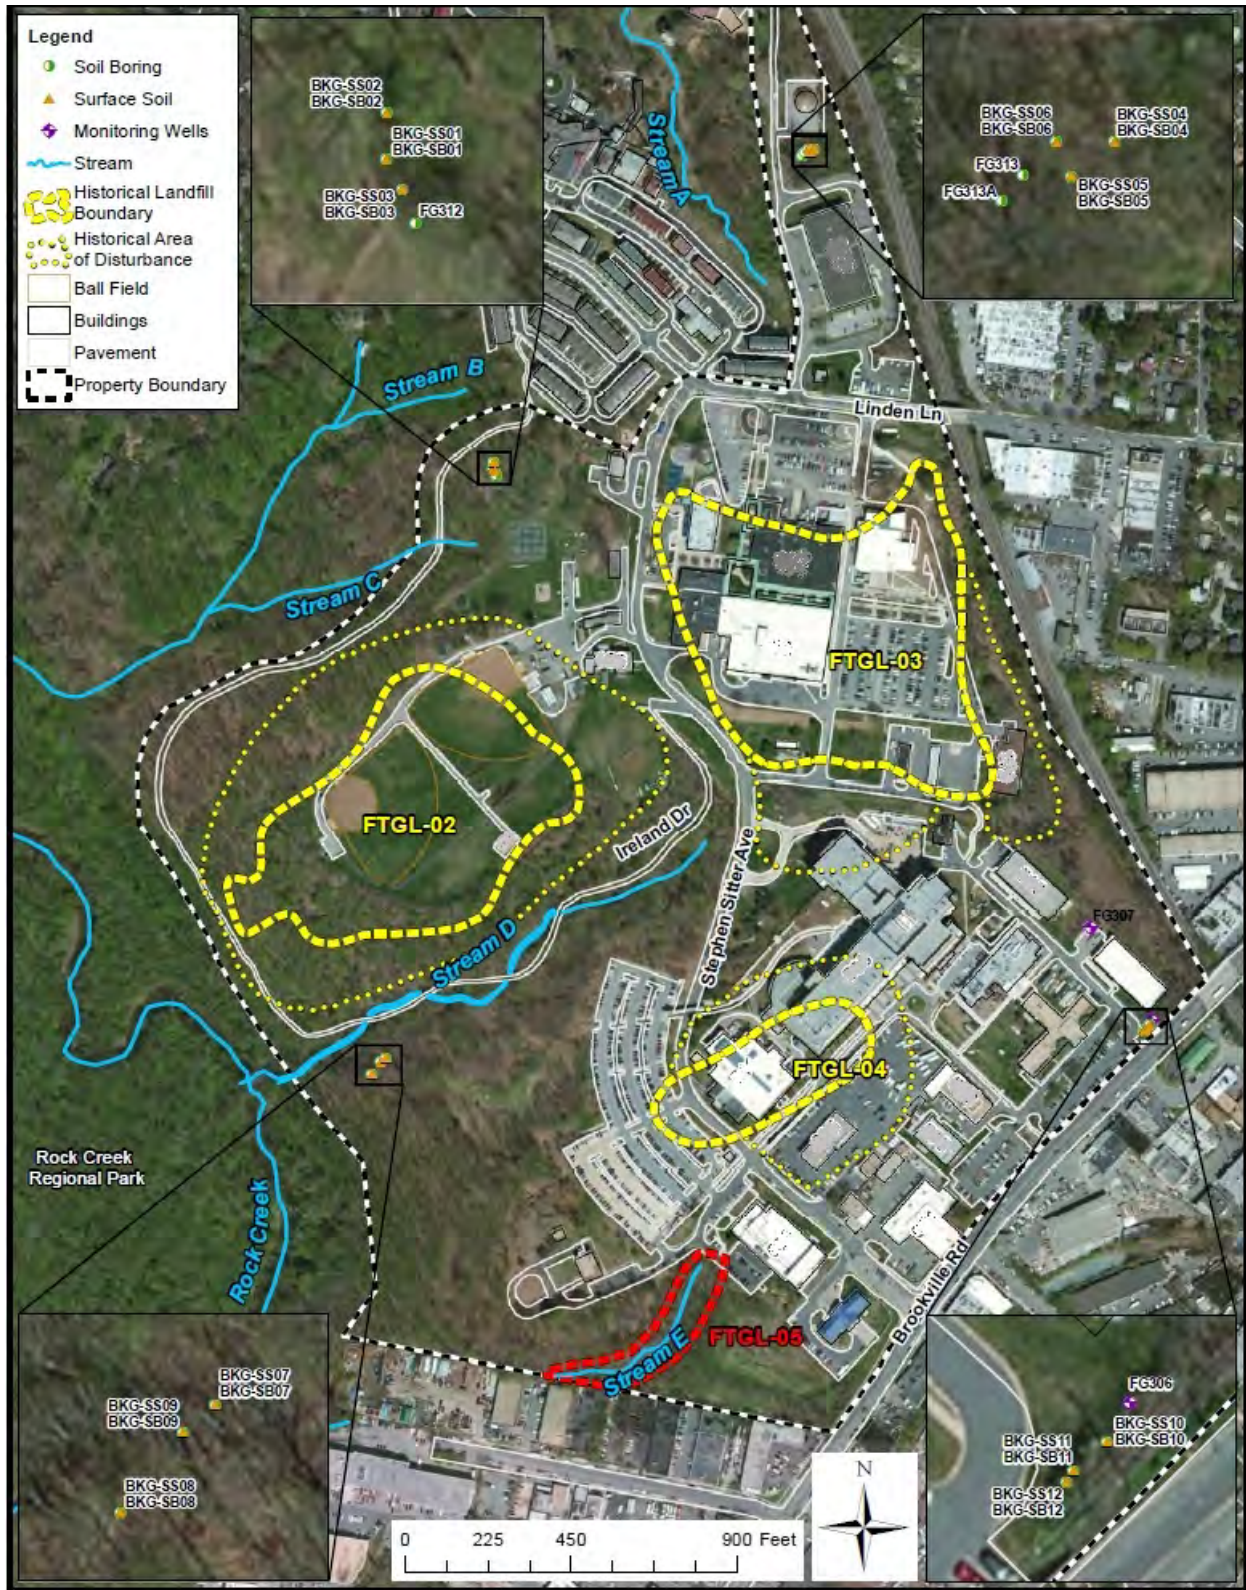
Figure 4-11: Background sampling locations

Monitoring wells were not constructed at locations FG312 and FG313 (see Figure 4-11) due to auger refusal in the saprolite prior to encountering groundwater during drilling. In replacement of one of these background wells, monitoring well FG307, installed as part of the FTGL-04 investigation, will be treated as a background well based on groundwater flow contours in the vicinity of this well. Lastly, three of the 12 soil borings (BKGSB07, SB08, and SB09 on Figure 4-11) were advanced using a manual hand auger due to inaccessibility to the soil boring locations for the HSA drill rig.

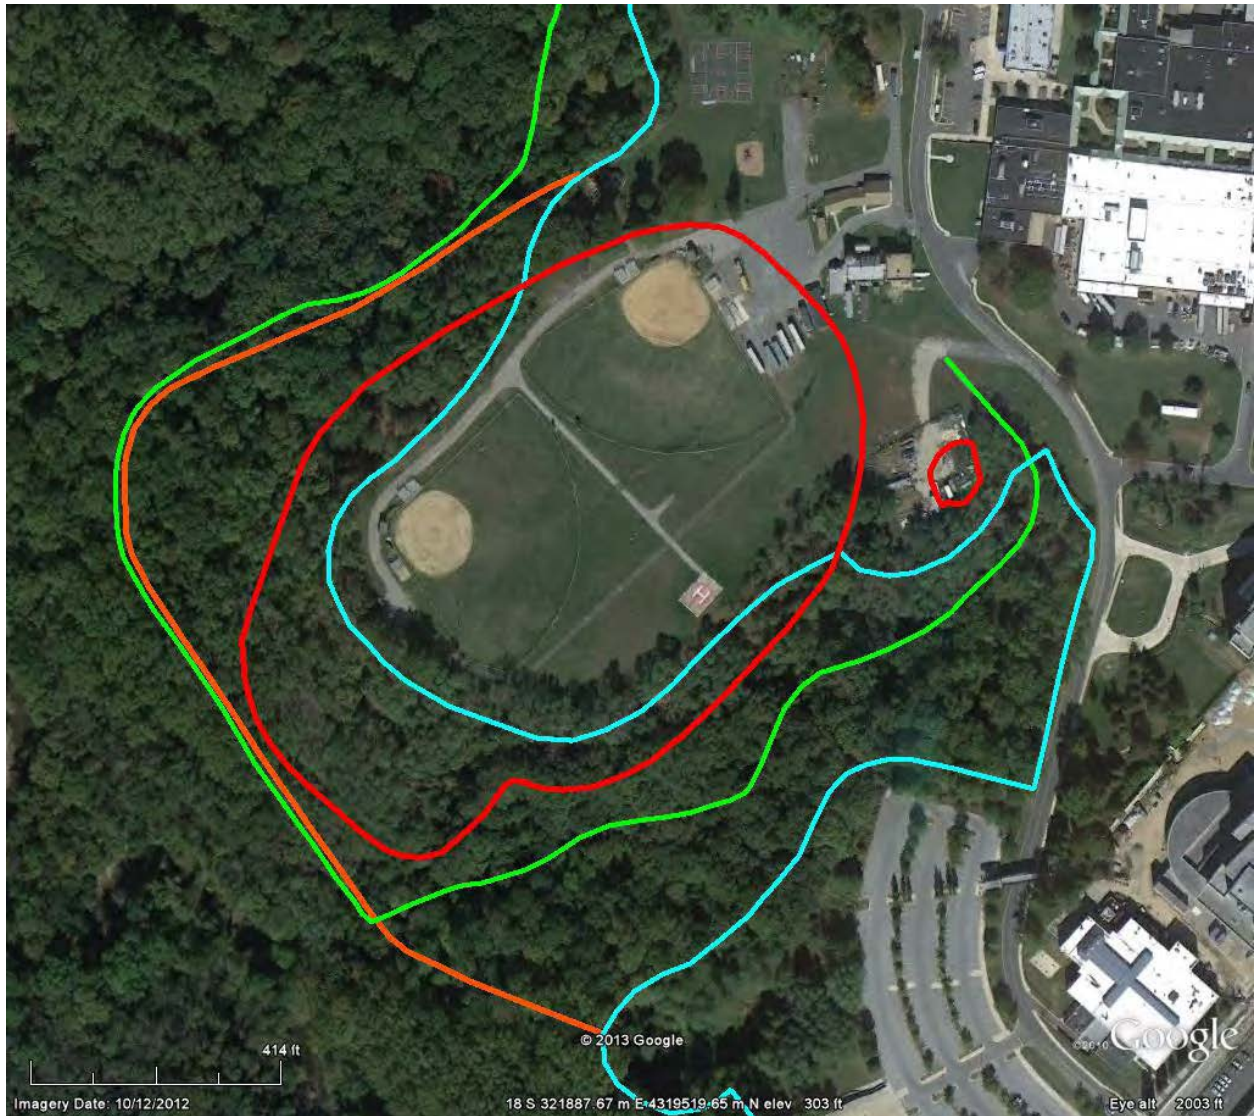
Figure 6-1: Alternative 3 (Green: Ireland Trail; Orange: Proposed fence; Blue: Existing fence; Red: Waste)

Alternative 3 will not only be an effective barrier to discourage the general public that uses Ireland Trail from accessing the steep slopes of FTGL-02, but will also inhibit access to the waters of Ireland Creek. Samples of Ireland Creek have shown the presence of one organic, PCE, and several metals that exceeded the National Recommended Water Quality Criteria. PCE was detected at low levels at two locations, the first near the stone picnic structure, and the second, downstream of the picnic structure and just upstream of the last stone bridge on Ireland trail. PCE was not found downstream of the last stone bridge before the picnic structure, probably the result of dilution or other natural attenuation process. The Army intends that people and pets not enter or drink the waters of Ireland Creek to prevent possible exposure to PCE and metals.

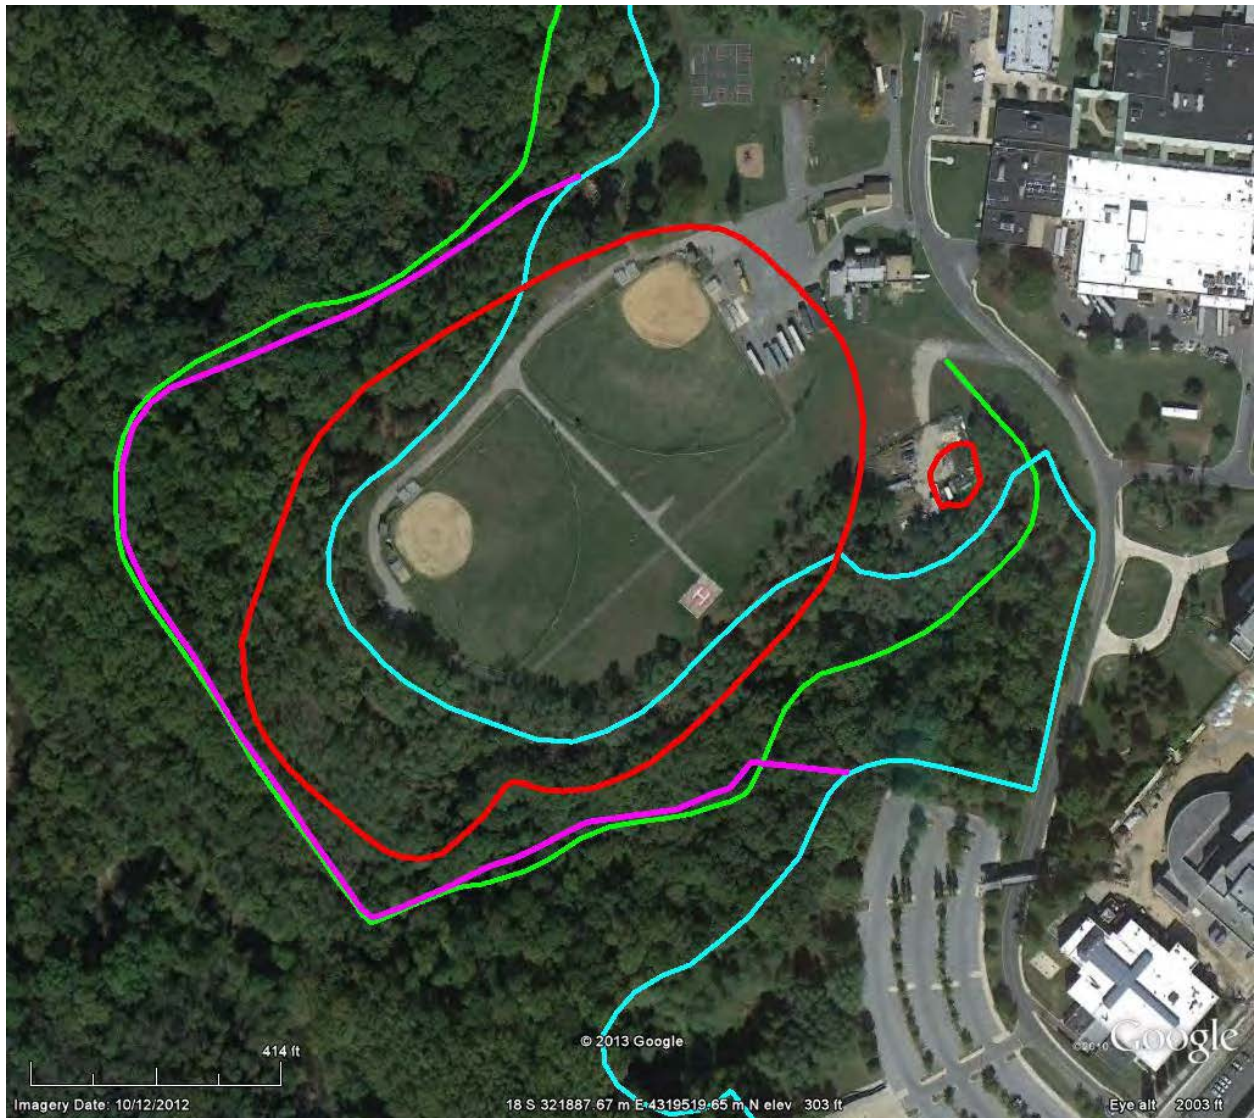
Figure 6-2: Alternative 4 (Green: Ireland Trail; Purple: Proposed fence; Blue: Existing fence; Red: Waste)

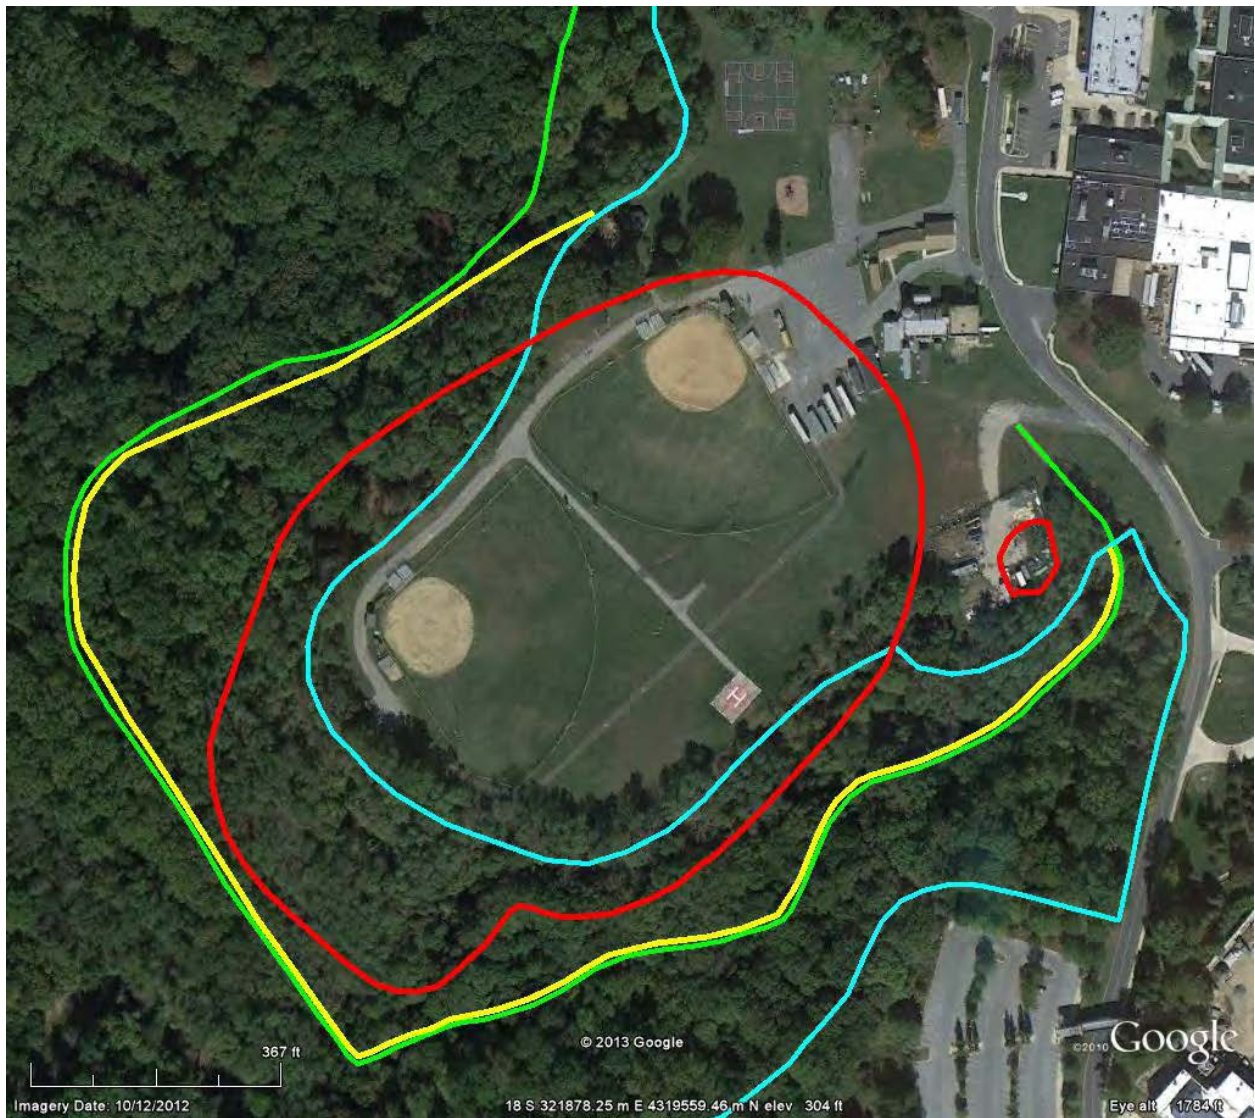
Figure 6-3: Alternative 5 (Green: Ireland Trail; Yellow: Proposed fence; Blue: Existing fence; Red: Waste)

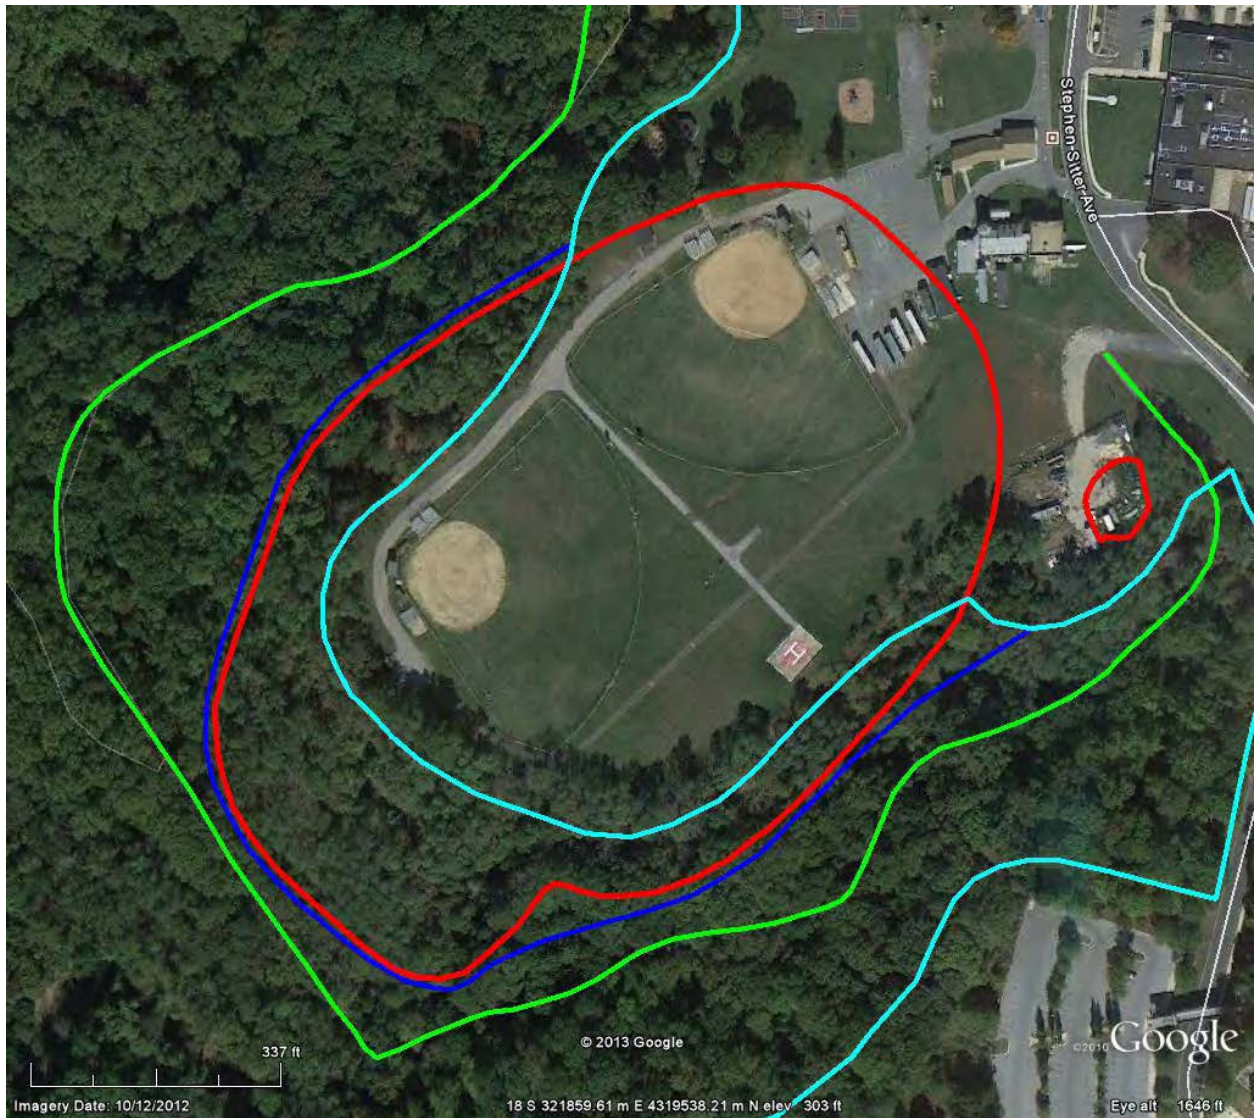
Figure 6-4: Alternative 6 (Green: Ireland Trail; Dark Blue: Proposed fence; Lt Blue: Existing fence; Red: Waste)

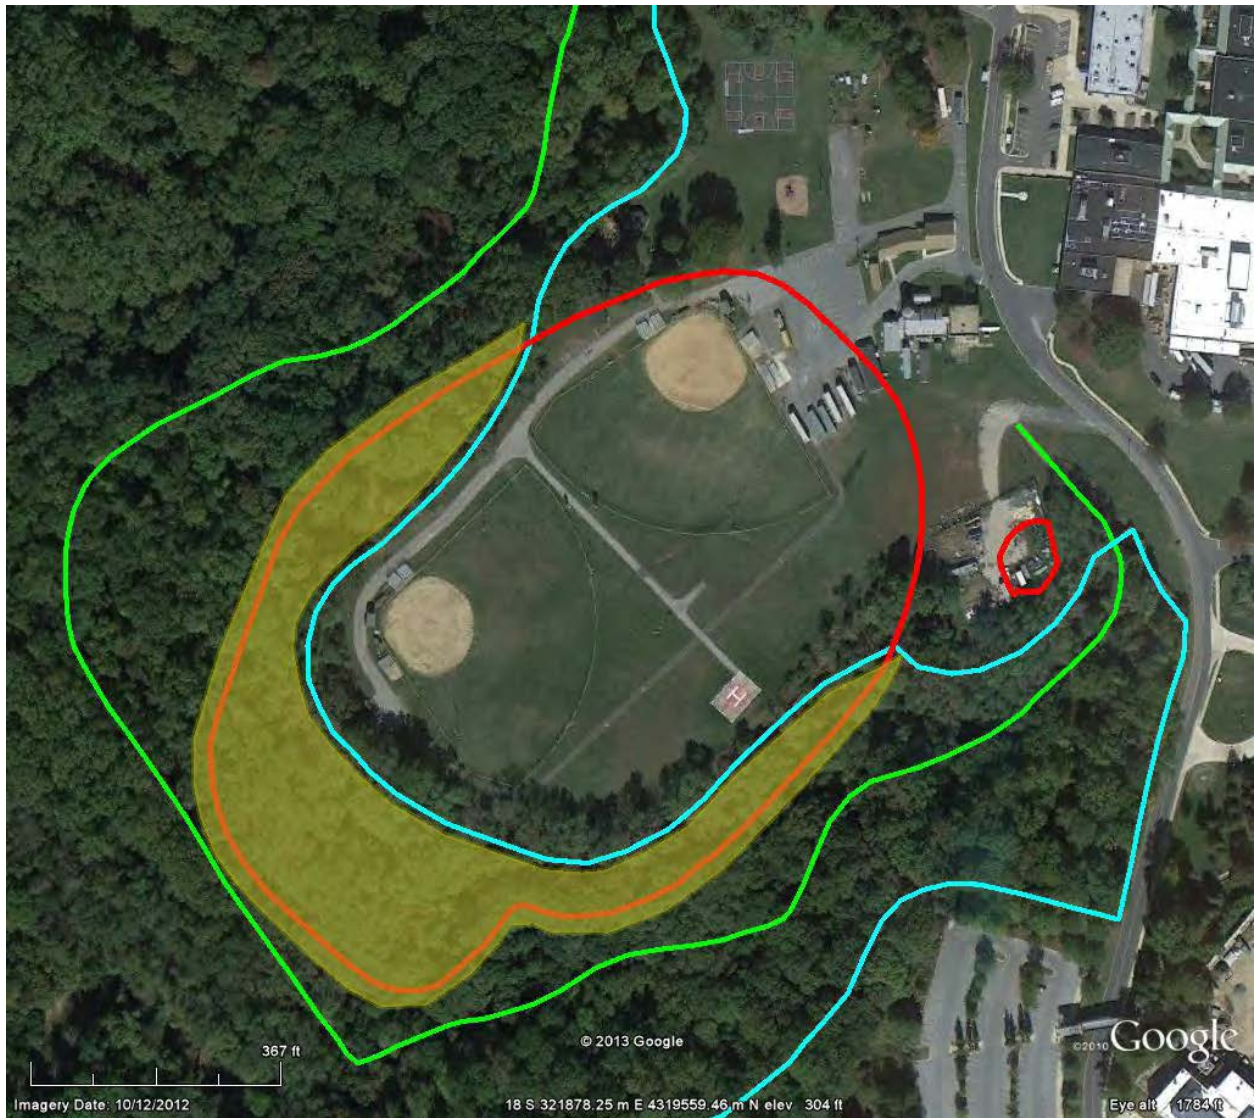
Figure 6-5: Alternatives 7 and 8 (Green: Ireland Trail; Yellow: Proposed cover/excavation; Blue: Existing fence; Red: Waste)
