# Safety Notice – 9/3/2024

## Bay Door Remote Placement on Apparatus

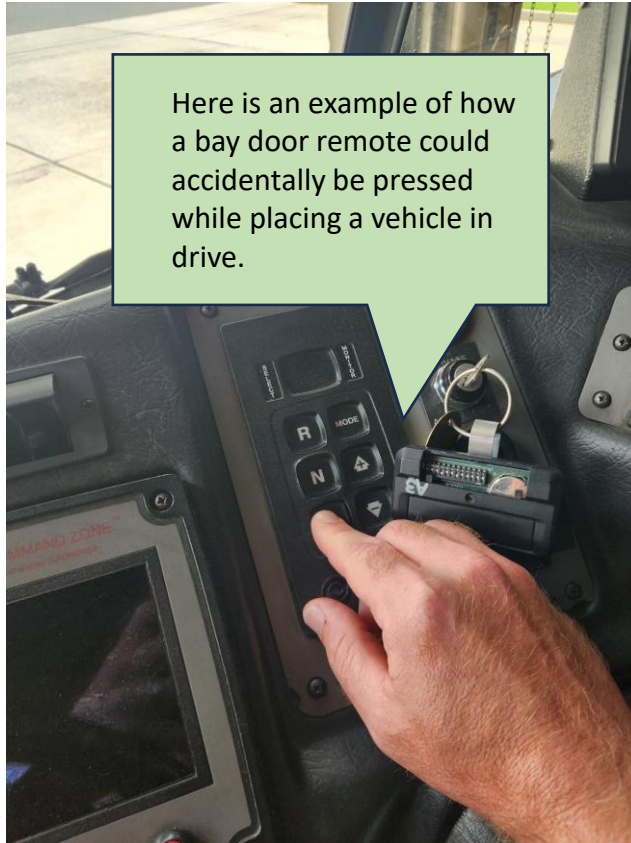
Here is an example of how a bay door remote could accidentally be pressed while placing a vehicle in drive.

- MCFRS has recently had two significant bay door strikes involving doors that did NOT have a timer.
- If there is no timer, the only way the door can come down is if the remote or wall switch were inadvertently pressed.
- To combat this, the Safety Section recommends that all bay door remotes be placed on the driver's visor to prevent interference with other switches/buttons/radios etc.
- If your remote is broken/missing a clip, please go through the proper channels to have it replaced.
