Hollywood Branch Stream Restoration

Preliminary Assessment Report_ Revised
January 2009

30% Concept Design Report
June 2009

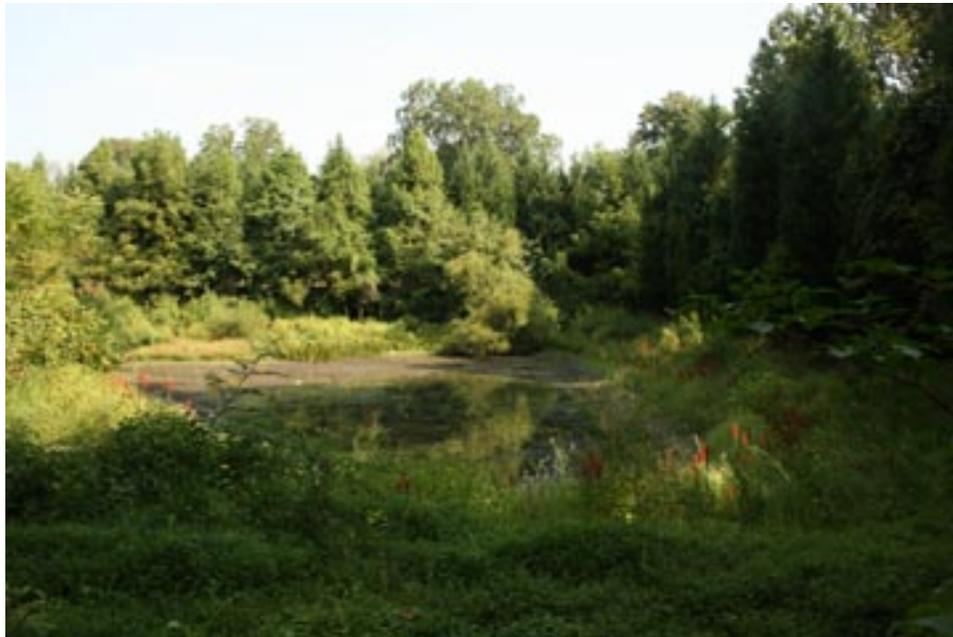
Fig. 3 – Stormwater Management Pond upstream of Reach 1

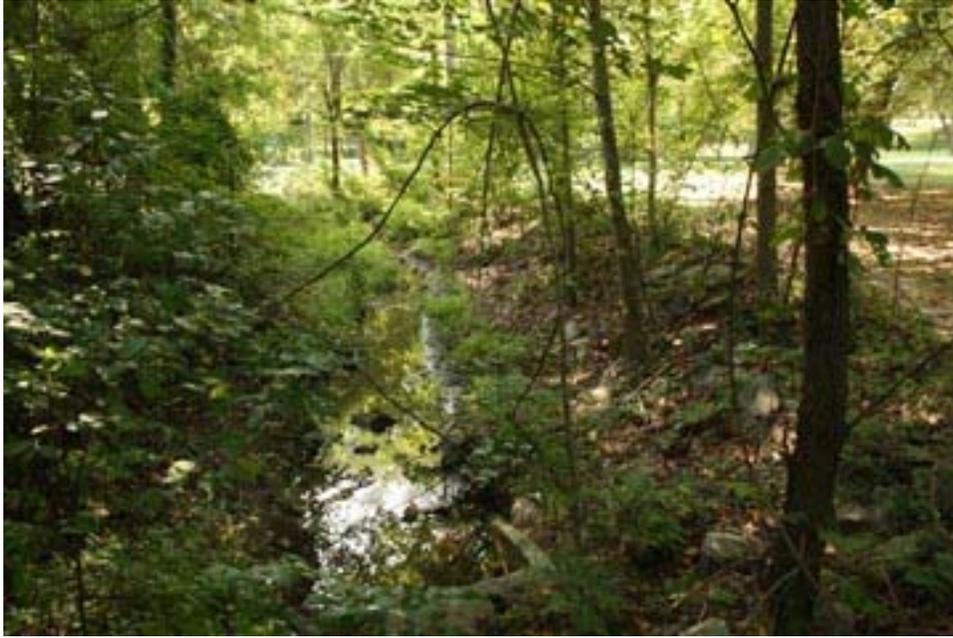
Fig. 4 – Looking downstream along Reach 1

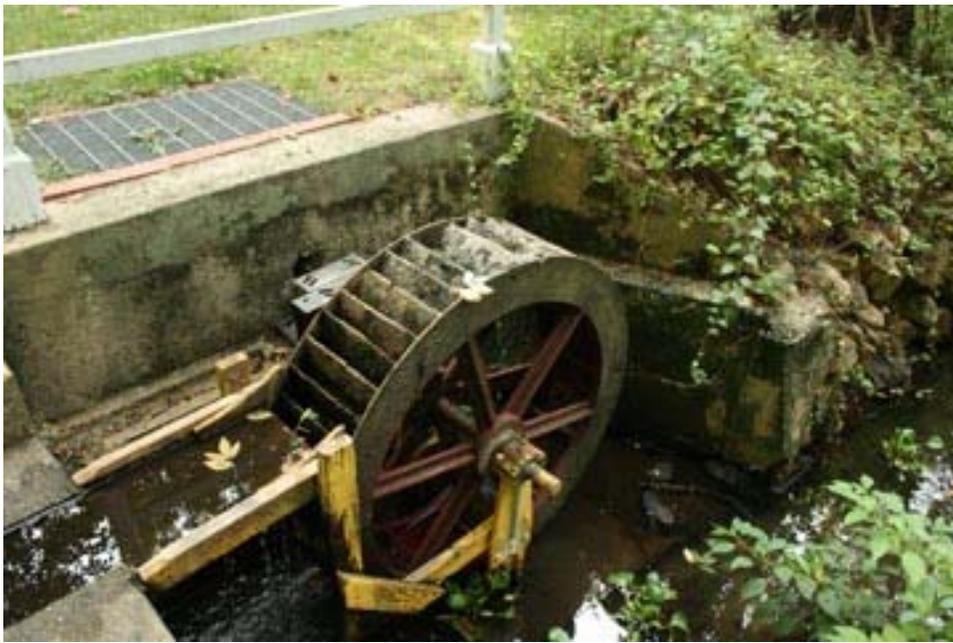
Fig. 7 – One of several small dams with waterwheel constructed along Reach 2

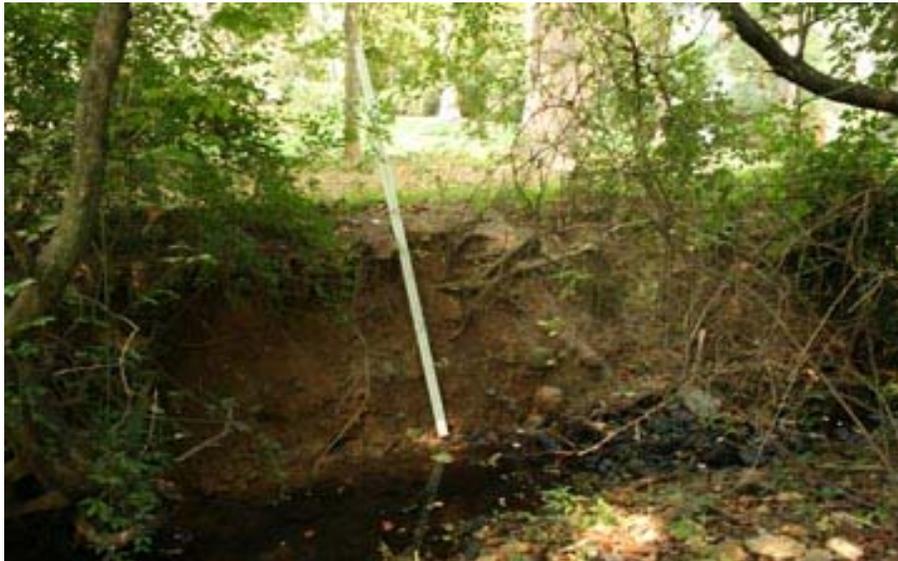
Results of the stability assessment show bank height to bankfull ratio of 1.5 throughout. BEHI ratings were very high and NBS was moderate.

Figs. 8 and 9 – Eroding banks along upstream section of Reach 3

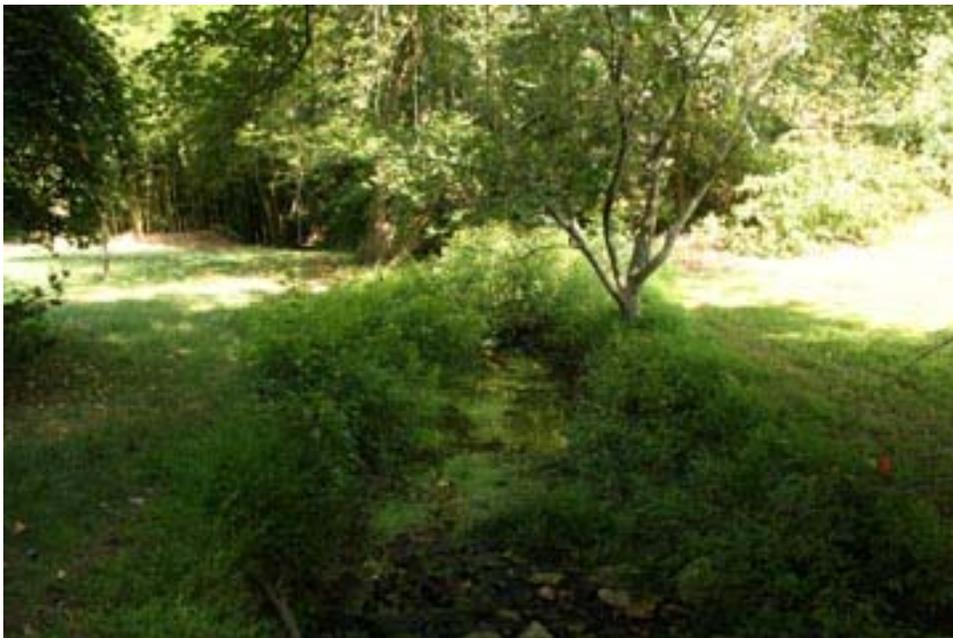
Fig. 14 – Stable section at upstream end of Reach 4.3

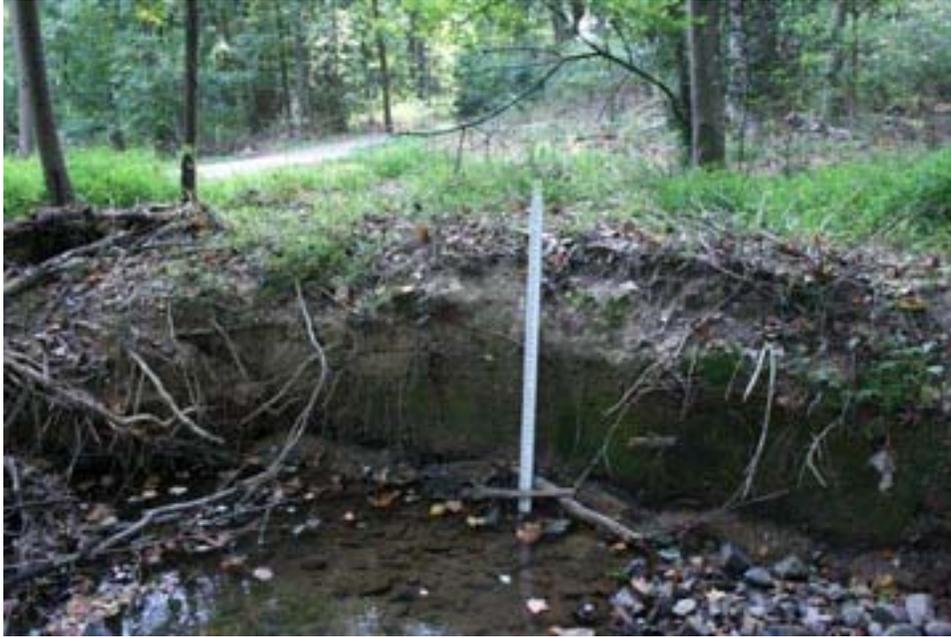
Fig 33 – Bank erosion along lower section of Reach 6.3.

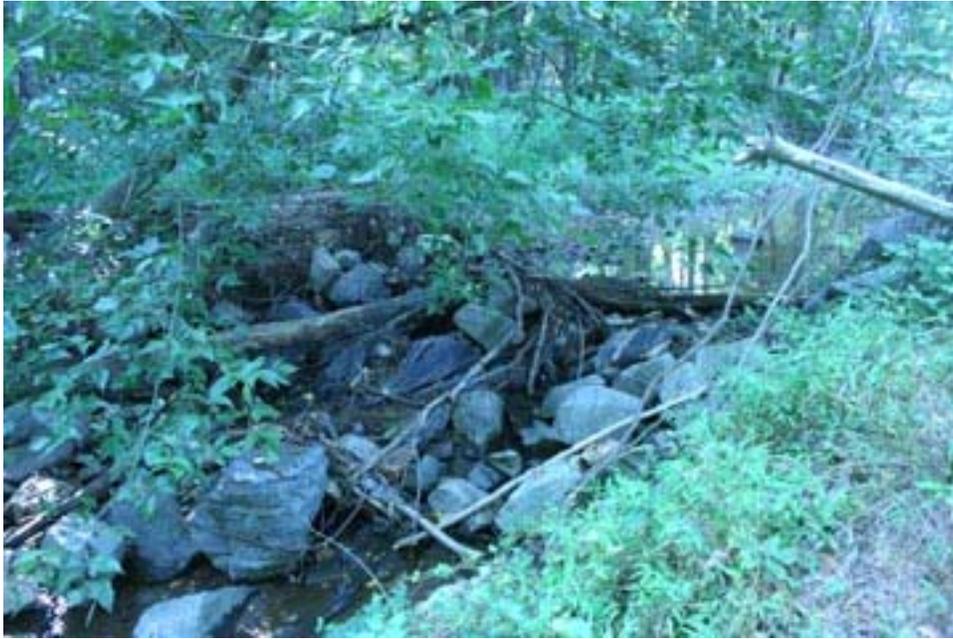
Fig 39 – Rip-rap check dam along left side of split channel in upper section of Reach 7

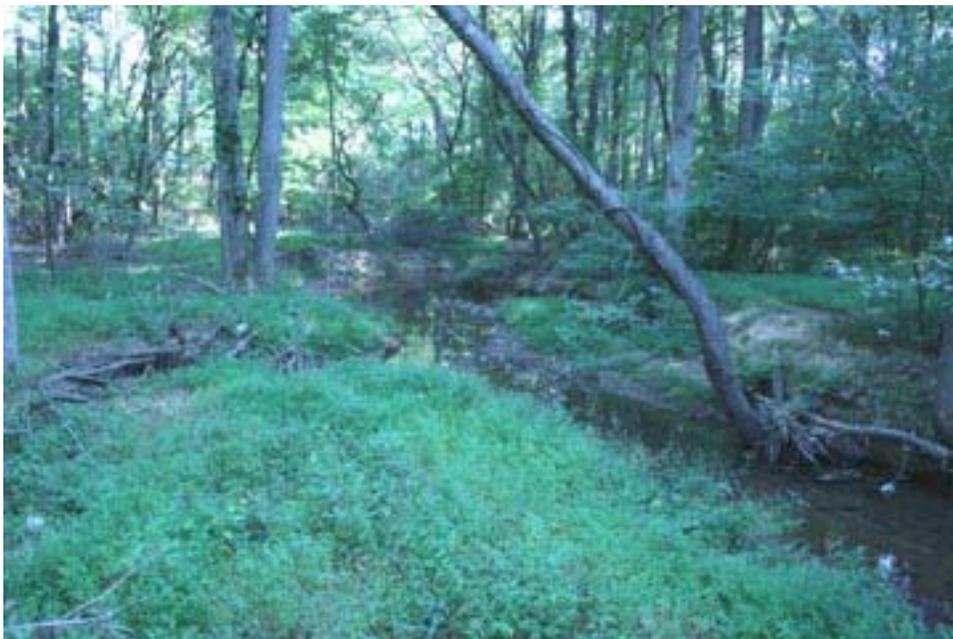
Fig 40 – Floodplain bench formed by sediment deposition in old meander scar

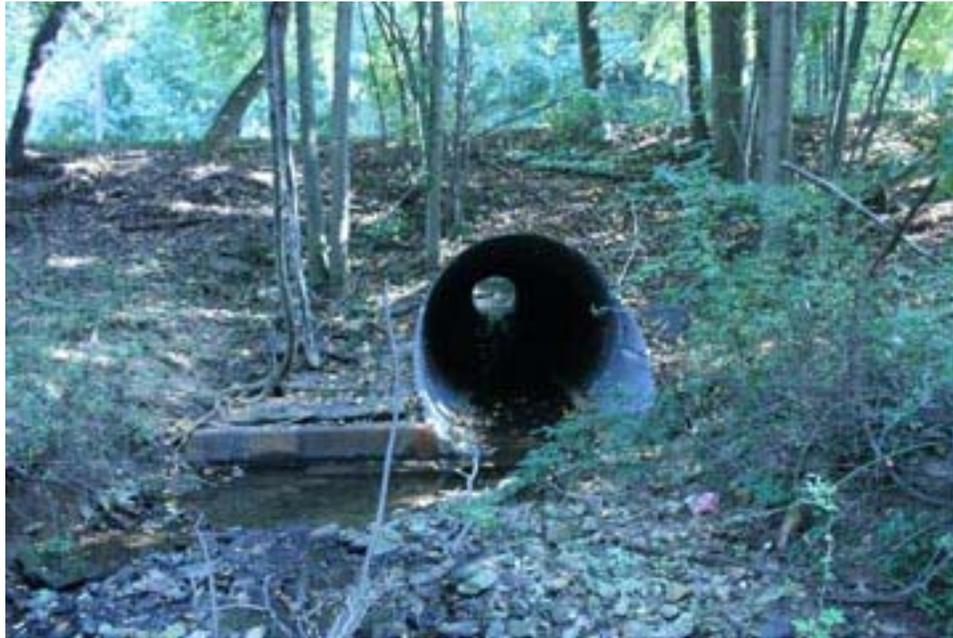
Fig 44 – Culvert under Cannon Road at downstream end of Reach 7

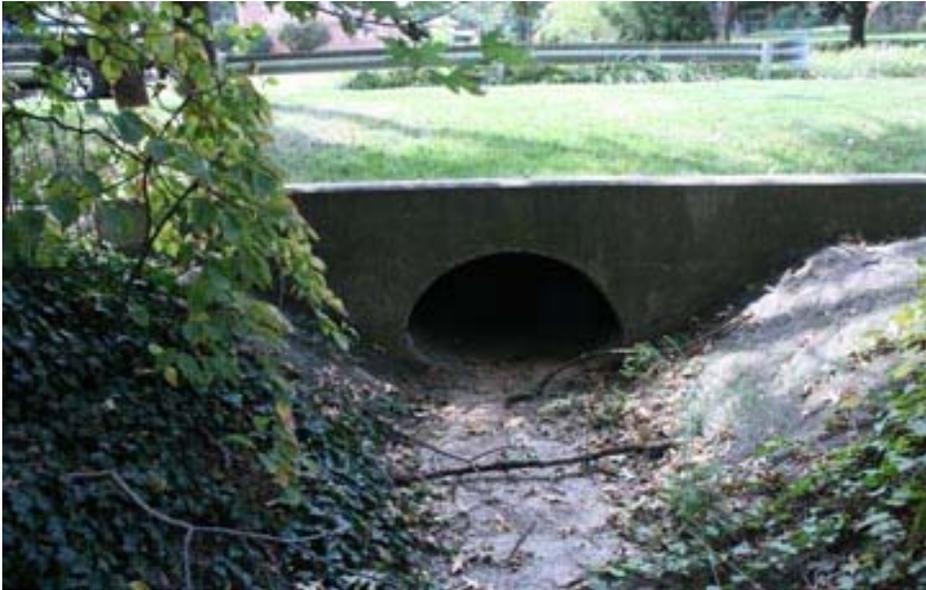
Figs. 45 and 46 – Storm drain outfall at Clifton Road and concrete storm drain channel

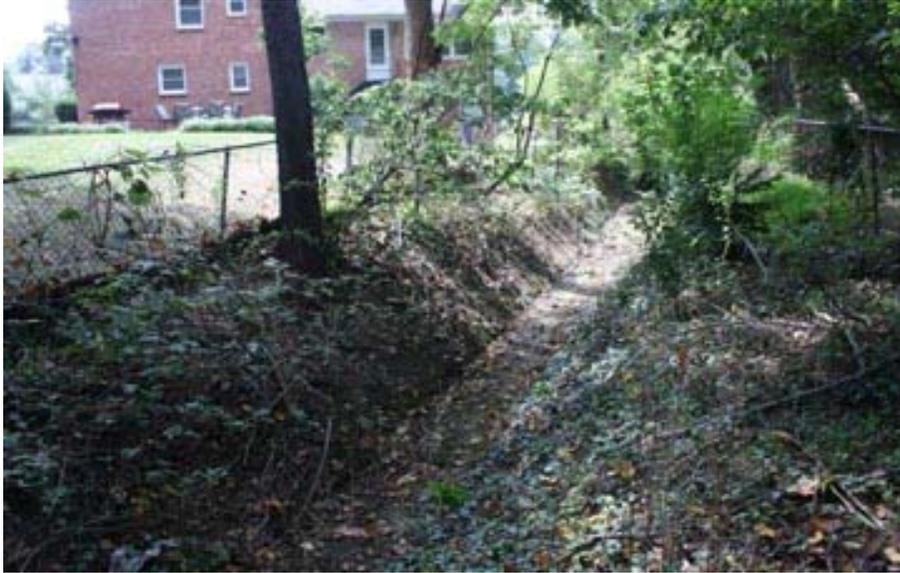
Fig. 47 – Exposed sanitary sewer manhole

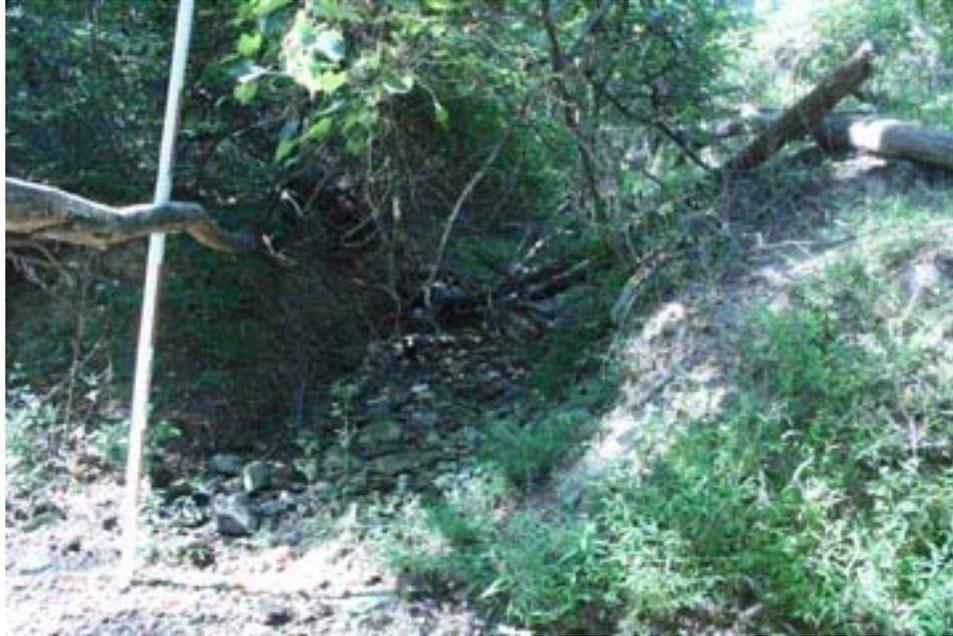
Fig. 48 – Confluence of Tributary 1 with Reach 5 Hollywood Branch

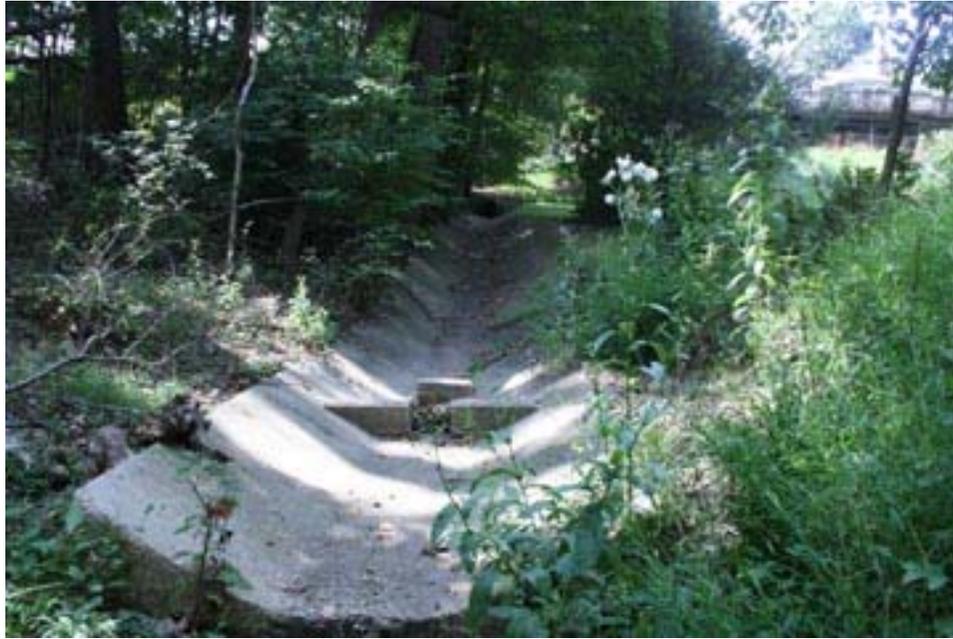
An ephemeral stream, Tributary 2 conveys stormwater runoff from a storm drain outfall located along Clifton Road. The entire 150 feet of Tributary 2 is a concrete storm drain channel. The channel appeared to be in good condition. Energy dissipators were installed at the downstream end of the channel to slow the water velocity and reduce scour. In addition, rip-rap was installed immediately downstream of the concrete channel.

Fig. 49 – Concrete storm drain channel

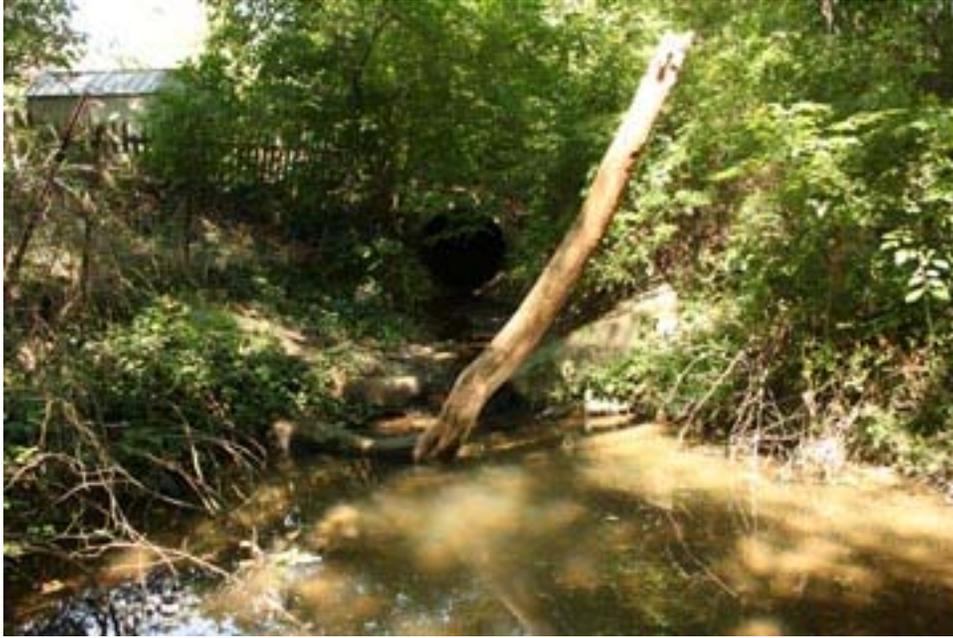
Fig. 50 – Storm drain outfall below Randolph Road at upstream end of Tributary 3.1

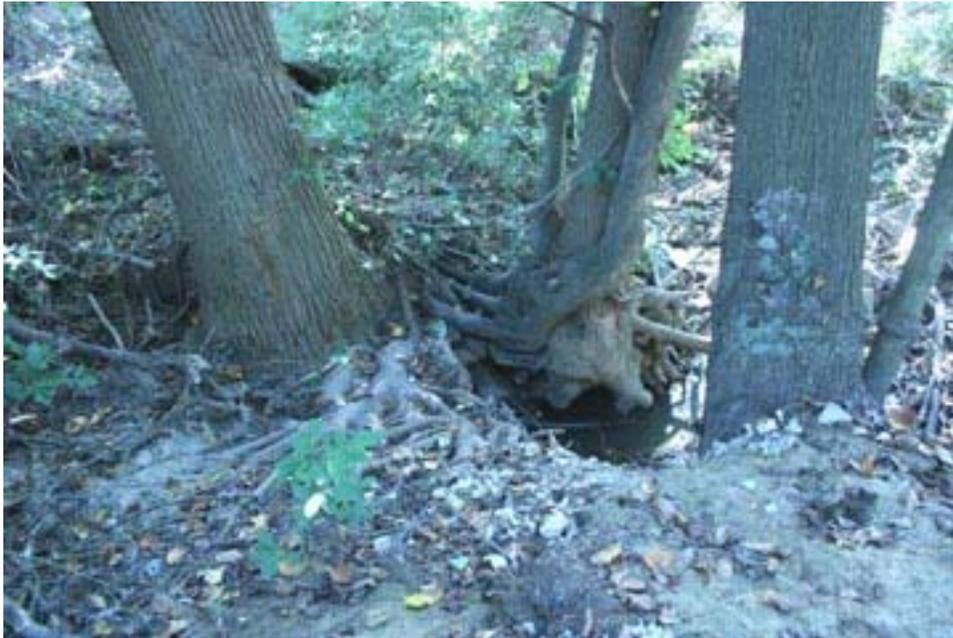
Figs. 55 and 56 – Head-cut at upstream end of Tributary 3.3
Note – debris jam and aggradation upstream of head-cut

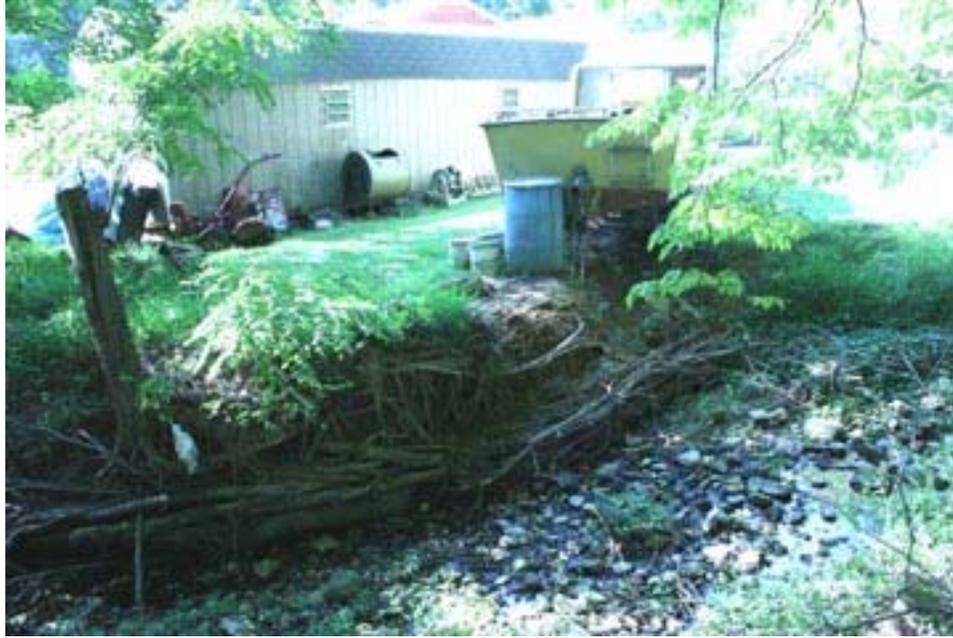
Fig. 58 – Active bank erosion adjacent to structure along downstream end of Tributary 3.3.

Note – Branch bundles installed by MC DEP attempting to stabilize bank

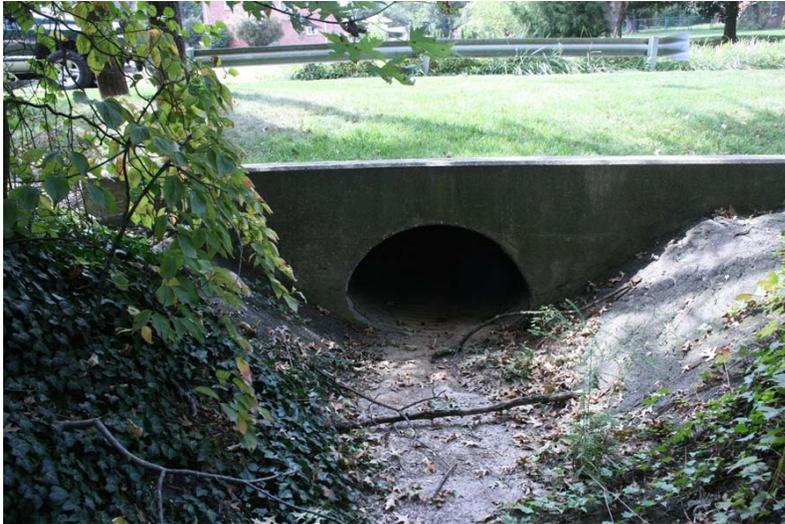
see Figure 5.1.2(a). The outfall channel starts as a concrete channel (see Figure 5.1.2(b)), but channel degradation is evident downstream of the concrete in the natural channel segment prior to discharge into Hollywood Branch (see Figure 5.1.2(c)). An exposed WSSC sewer manhole (contract number same as above in Repair 4.2.1) exists in this downstream section; see Figure 5.1.2(d). Tributary 1 is also described in Section III G9.; since an exposed sewer manhole exists in this tributary, it is listed as an infrastructure repair also in addition to being mentioned in the main narrative.

Figure 5.1.2(a) Clifton Road outfall.

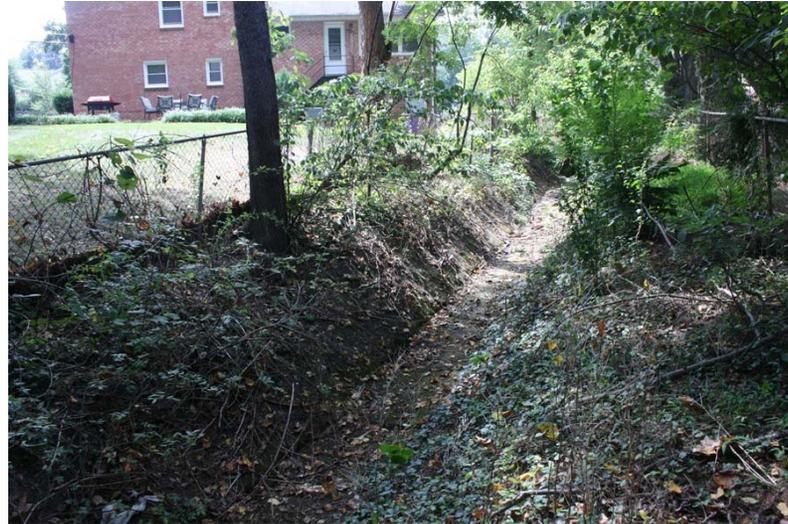
Figure 5.1.2(b) Concrete channel outfall.

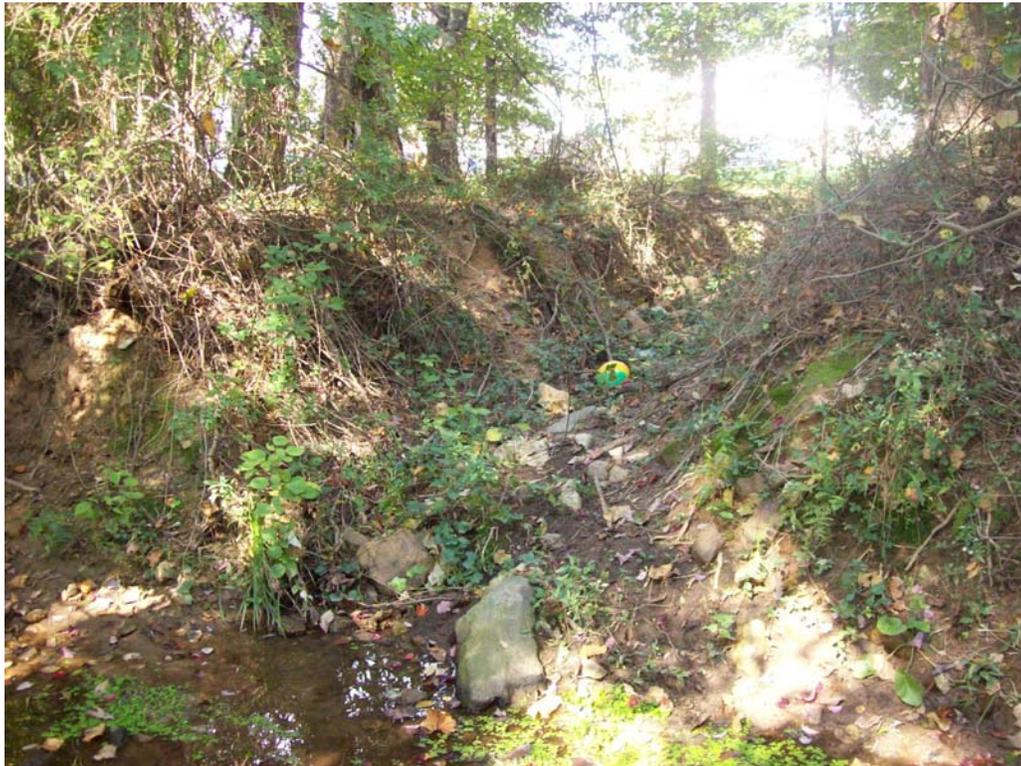
In Reach 5.3, a storm drain outfall off of Anderson Street, near the intersection of Anderson Street and Octagon Lane, is half-full of sediment; see Figure 5.3.1(a). At the earthen outfall channel junction with Hollywood Branch, the channel is eroded; see Figure 5.3.2(b). The outfall channel discharges just downstream of cross section 5.7.

Figure 5.3.1(b) Anderson St. outfall junction with Hollywood Br. (view upstream).

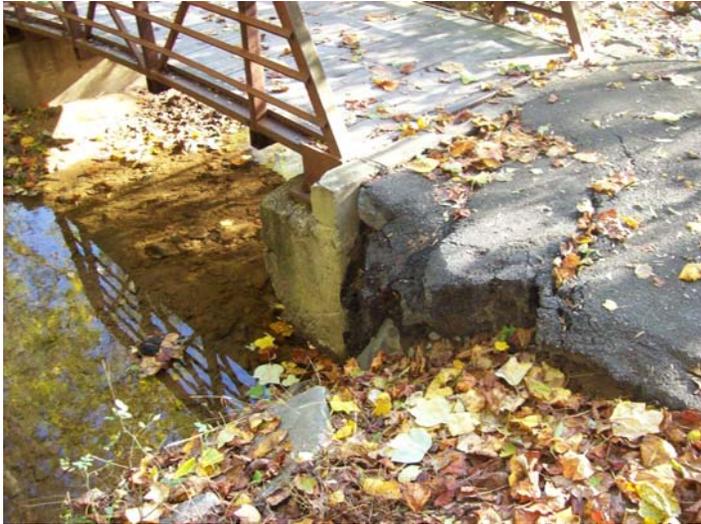
As described in Section III G8 summarizing Reach 7, the asphalt pathway to the pedestrian bridge shows evidence of damage by flows above the stream banks. Most of the apparent damage is to the asphalt pathway adjacent to the bridge footers; see Figures 7.1.1(a), (b), and (c). Assuming the right bridge footer was initially on the stream bank, the stream has scoured the right stream bank to the extent the right footer is exposed to the stream; see Figure 7.1.1(d).

Figure 7.1.1(a) Pathway on right bank/upstream

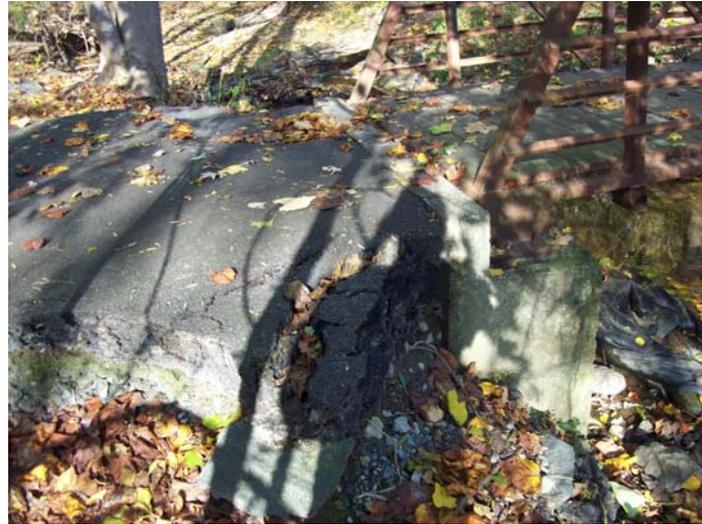
Figure 7.1.1(b) Pathway on right bank/downstream.

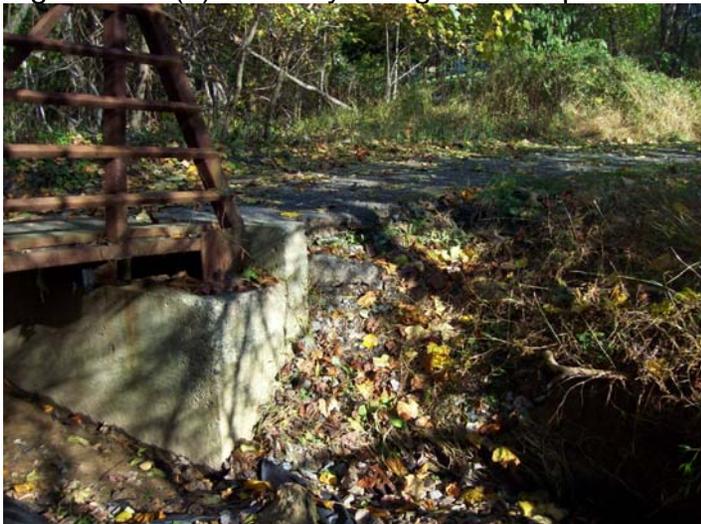
Figure 7.1.1(c) Pathway on left bank/downstream

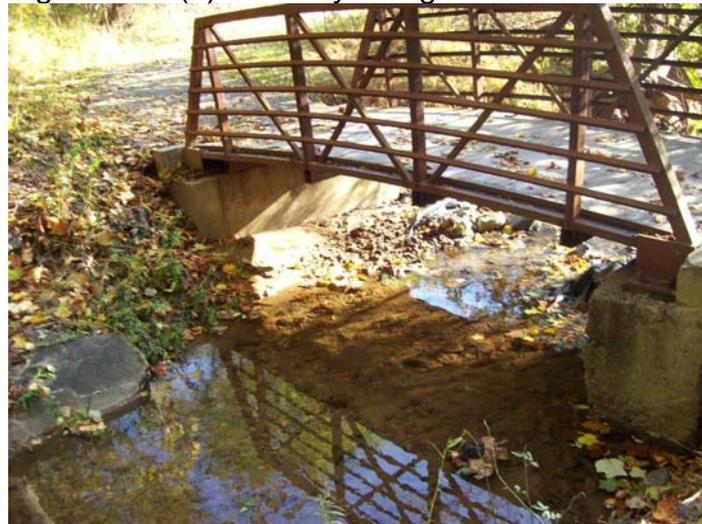
7.1.1(d) Pedestrian bridge right footer exposed to stream.

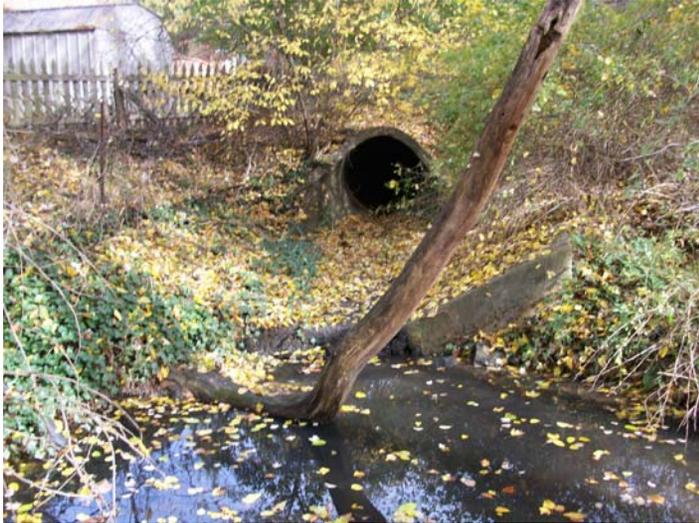
Figure Trib. 3.1.1(a) Storm drain outfall from Randolph Rd.

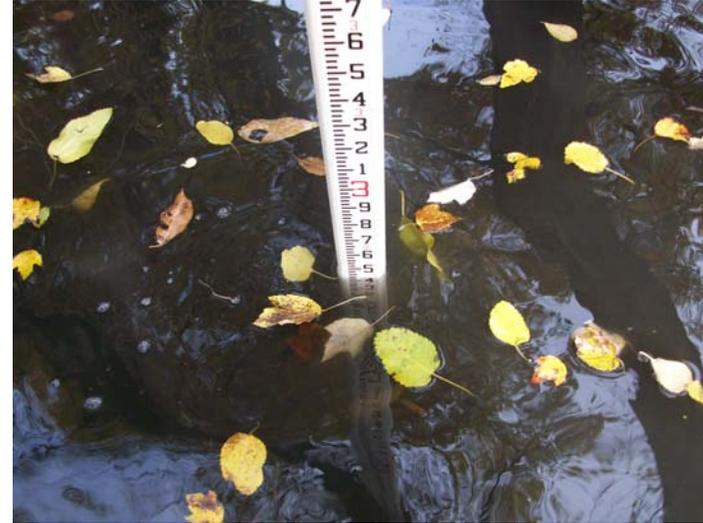
Figure Trib. 3.1.1(b) Outfall scour pool depth.

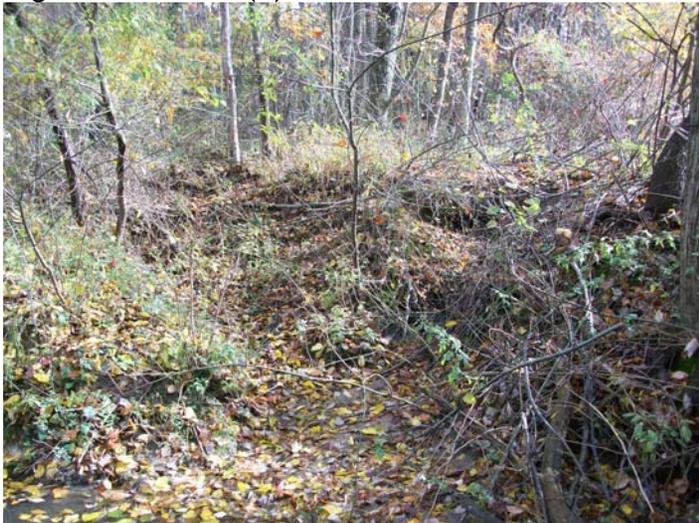
Figure Trib. 3.1.1(c) Nickpoint near outfall apron.

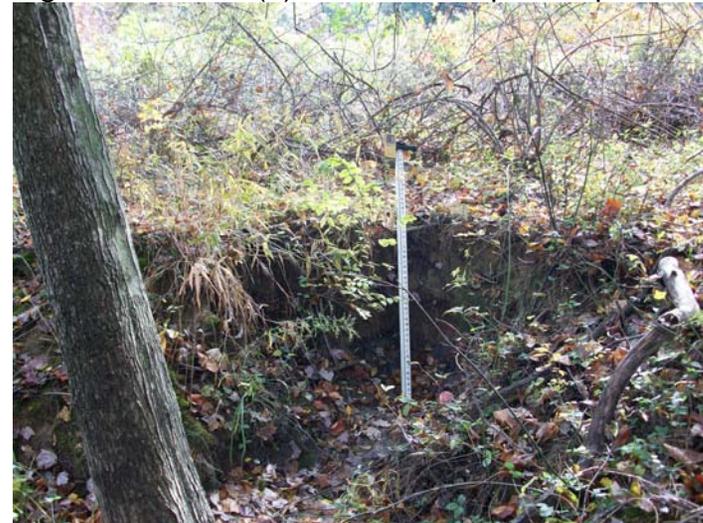
Figure Trib. 3.1.1(d) 2nd nickpoint near outfall apron.
