Hollywood Branch Stream Restoration

Preliminary Assessment Report *January 2009*

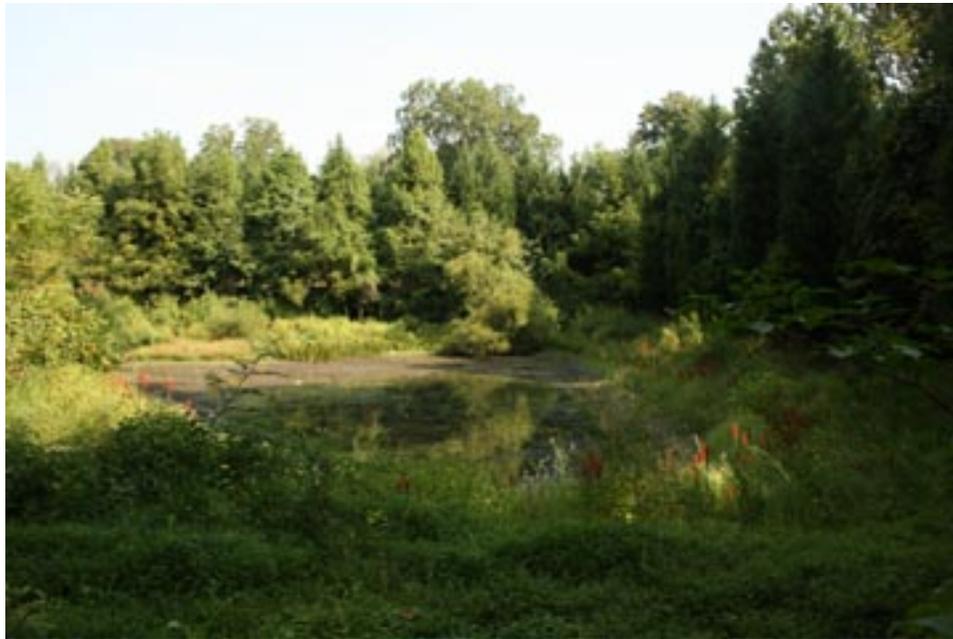
Fig. 3 – Stormwater Management Pond upstream of Reach 1

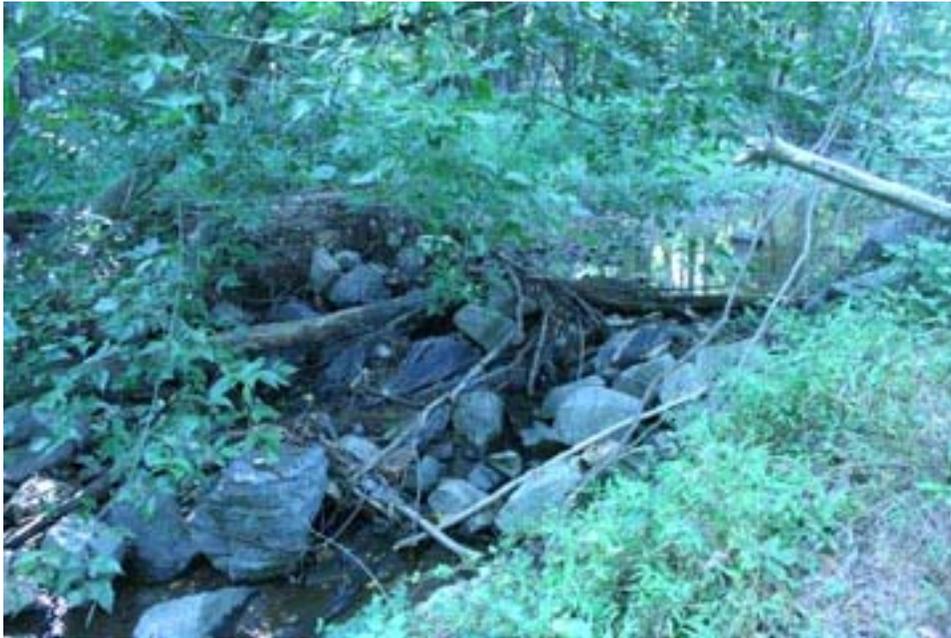
Fig 39 – Rip-rap check dam along left side of split channel in upper section of Reach 7

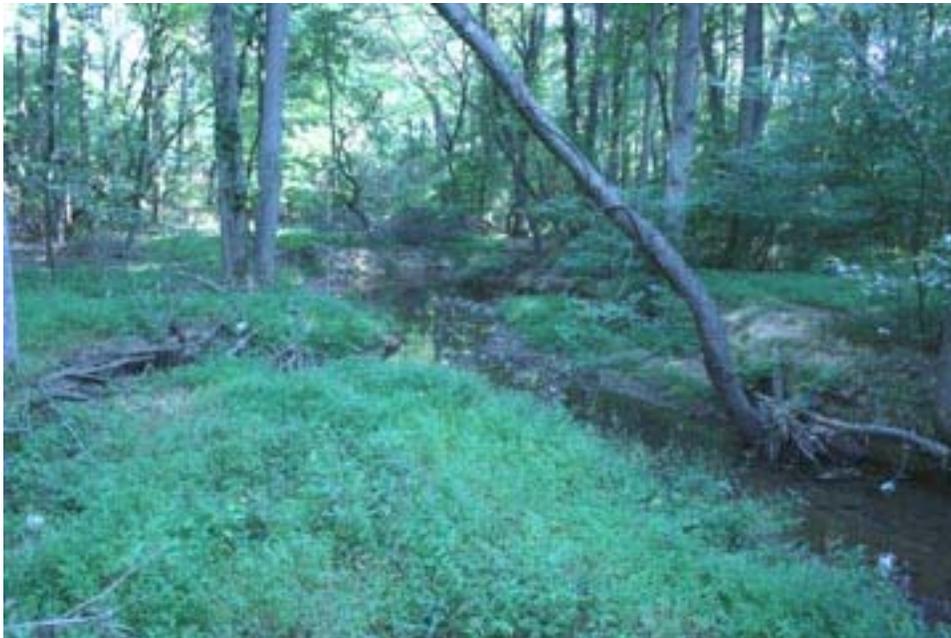
Fig 40 – Floodplain bench formed by sediment deposition in old meander scar

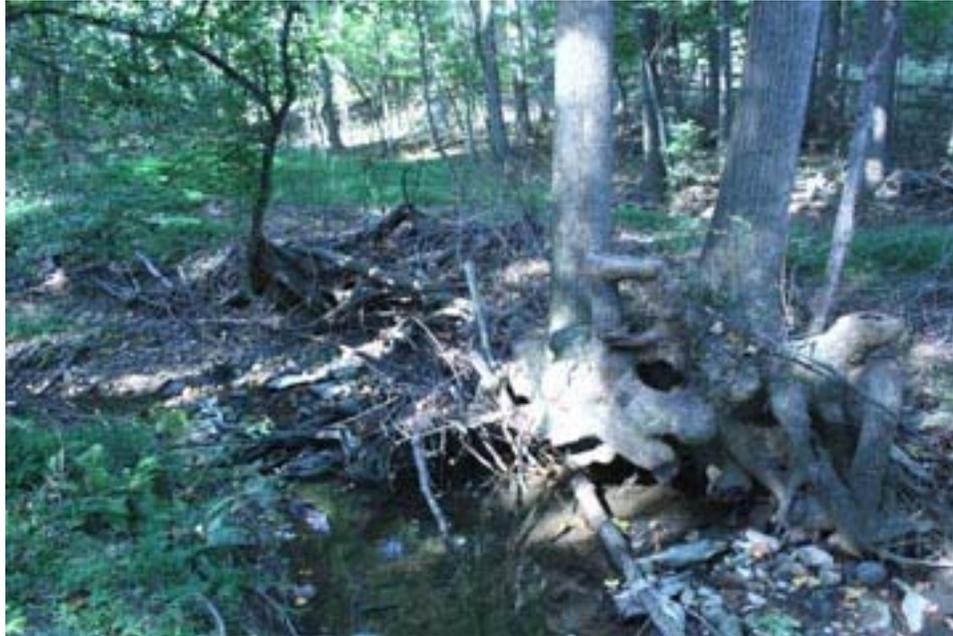
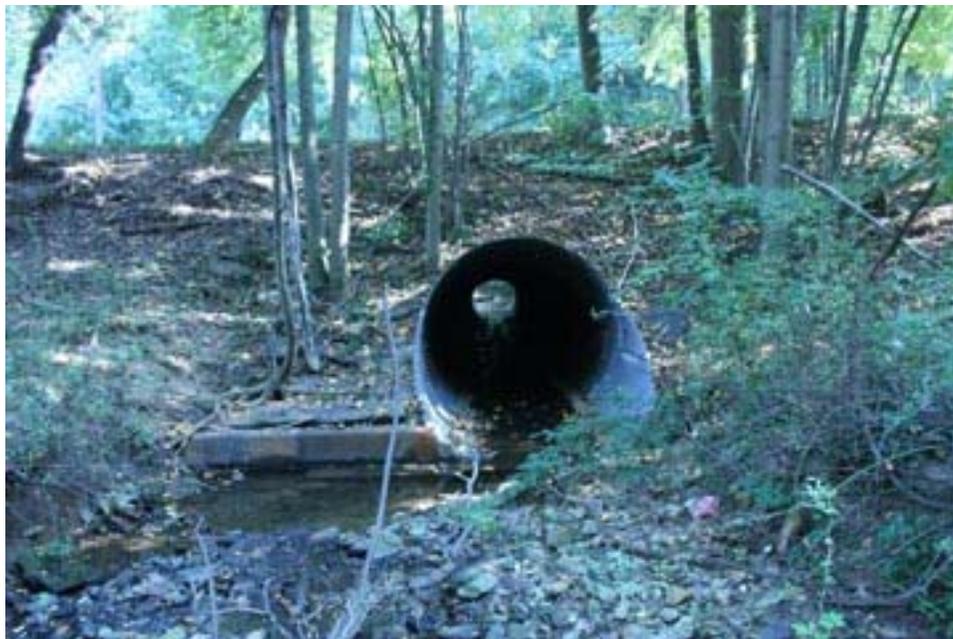
Fig 44 – Culvert under Cannon Road at downstream end of Reach 7

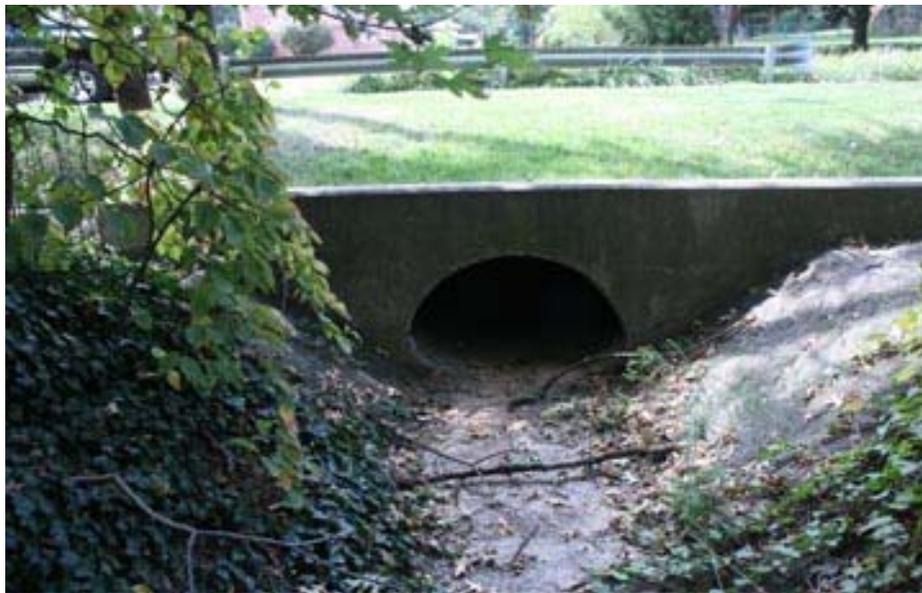
Figs. 45 and 46 – Storm drain outfall at Clifton Road and concrete storm drain channel

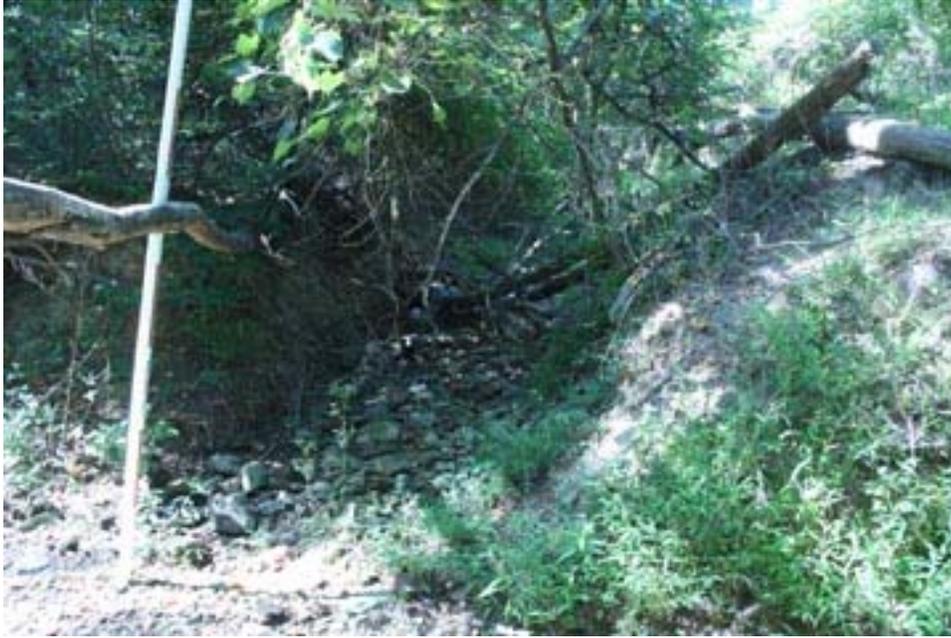
Fig. 48 – Confluence of Tributary 1 with Reach 5 Hollywood Branch

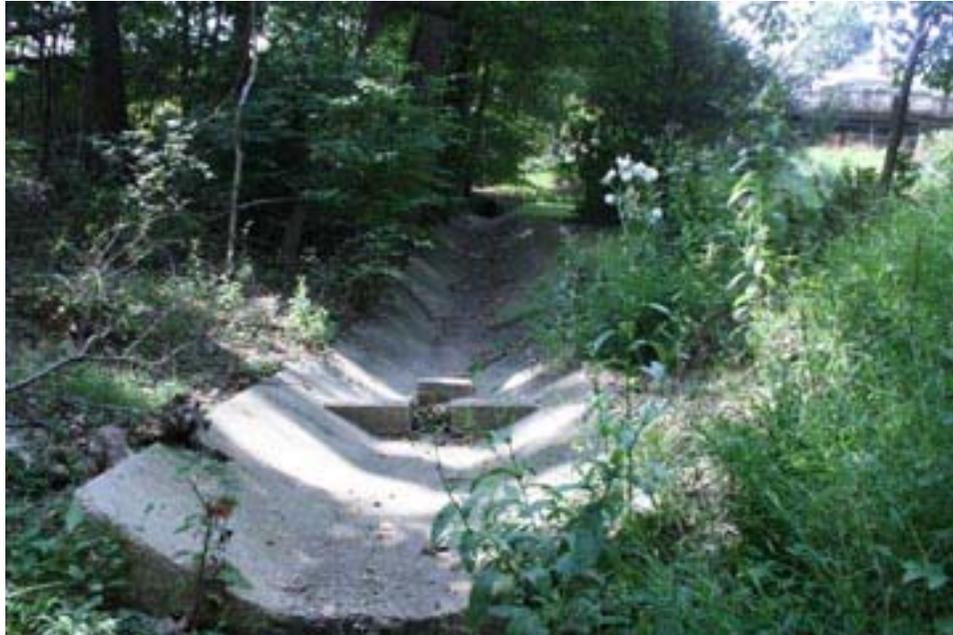
An ephemeral stream, Tributary 2 conveys stormwater runoff from a storm drain outfall located along Clifton Road. The entire 150 feet of Tributary 2 is a concrete storm drain channel. The channel appeared to be in good condition. Energy

dissipators were installed at the downstream end of the channel to slow the water velocity and reduce scour. In addition, rip-rap was installed immediately downstream of the concrete channel.

Fig. 49 – Concrete storm drain channel

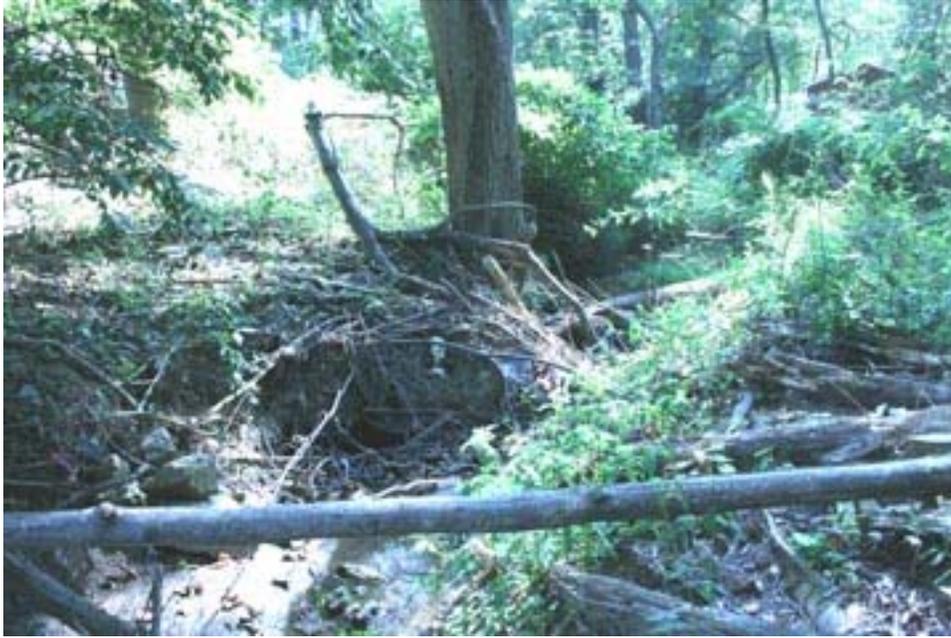
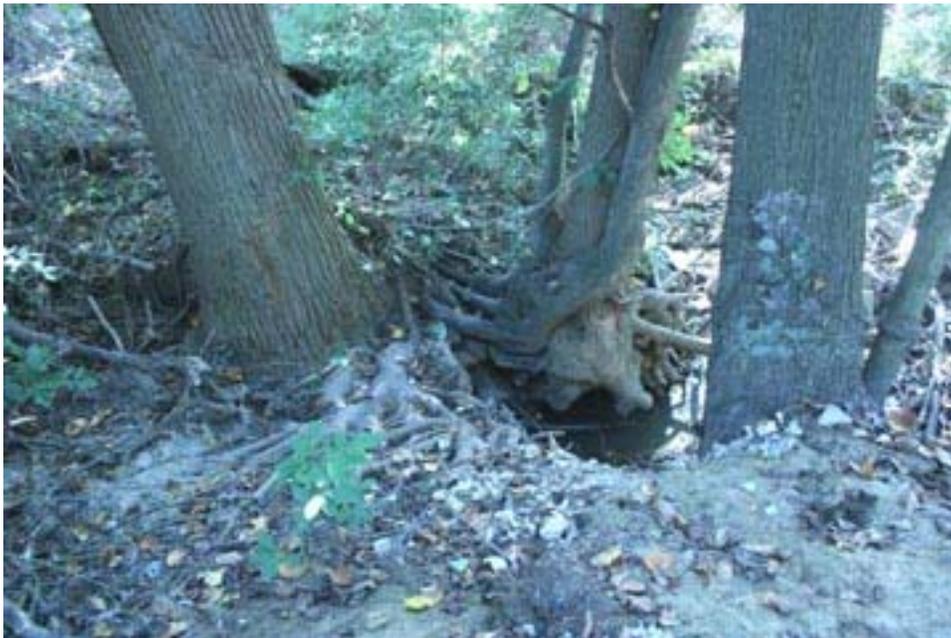
Figs. 55 and 56 – Head-cut at upstream end of Tributary 3.3
Note – debris jam and aggradation upstream of head-cut

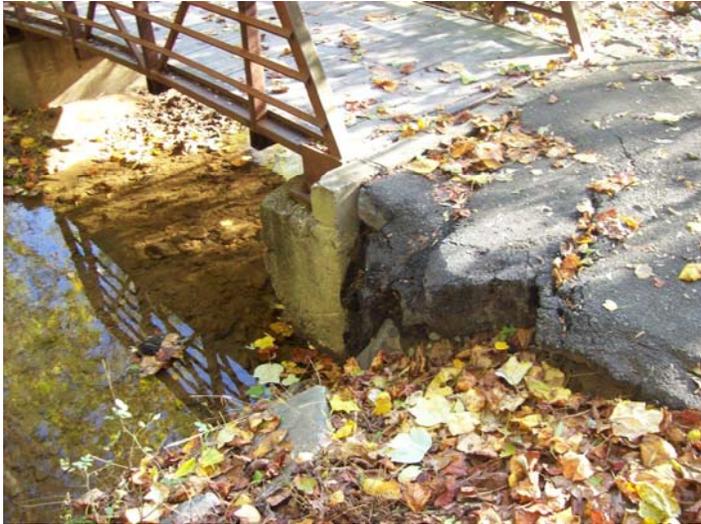
As described in Section III G8 summarizing Reach 7, the asphalt pathway to the pedestrian bridge shows evidence of damage by flows above the stream banks. Most of the apparent damage is to the asphalt pathway adjacent to the bridge footers; see Figures 7.1.1(a), (b), and (c). Assuming the right bridge footer was initially on the stream bank, the stream has scoured the right stream bank to the extent the right footer is exposed to the stream; see Figure 7.1.1(d).

Figure 7.1.1(a) Pathway on right bank/upstream

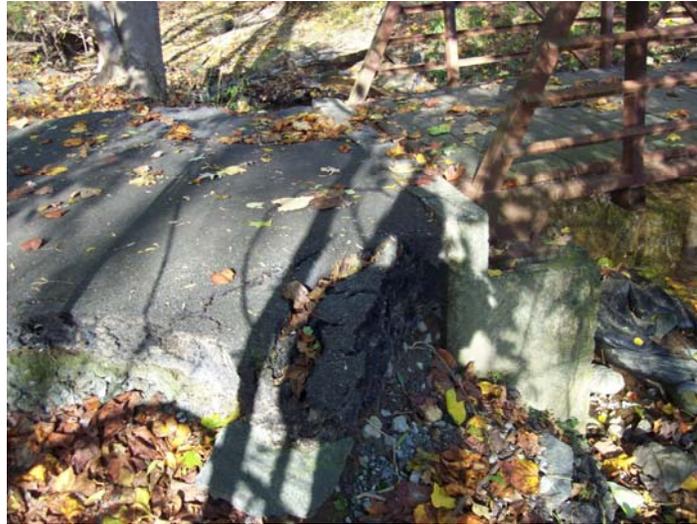
Figure 7.1.1(b) Pathway on right bank/downstream.

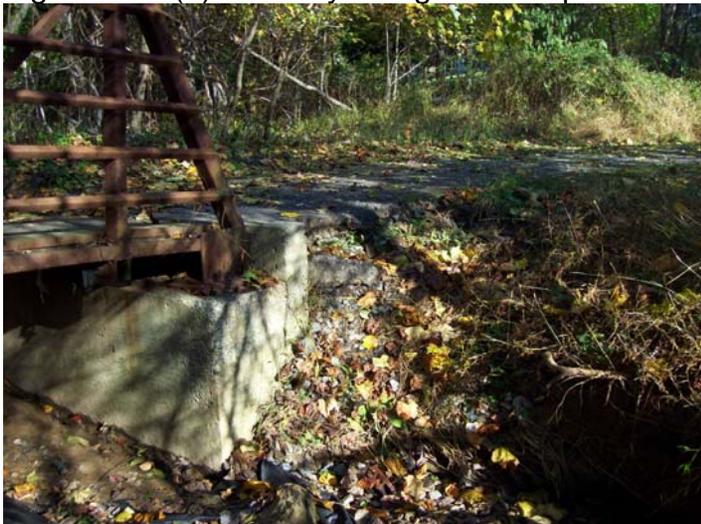
Figure 7.1.1(c) Pathway on left bank/downstream

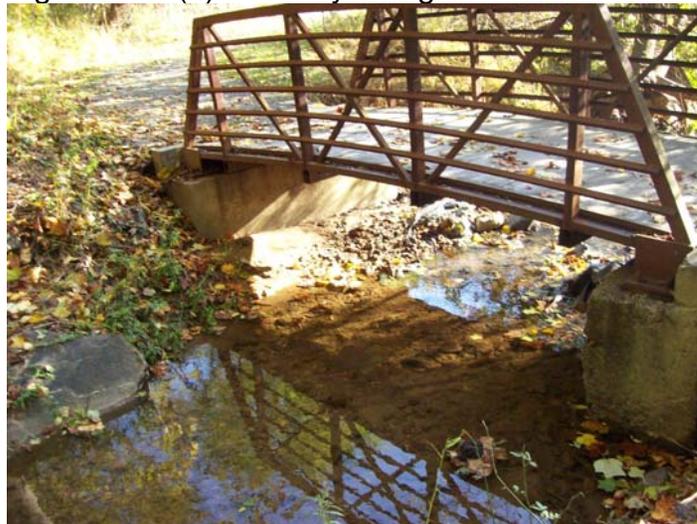
7.1.1(d) Pedestrian bridge right footer exposed to stream.

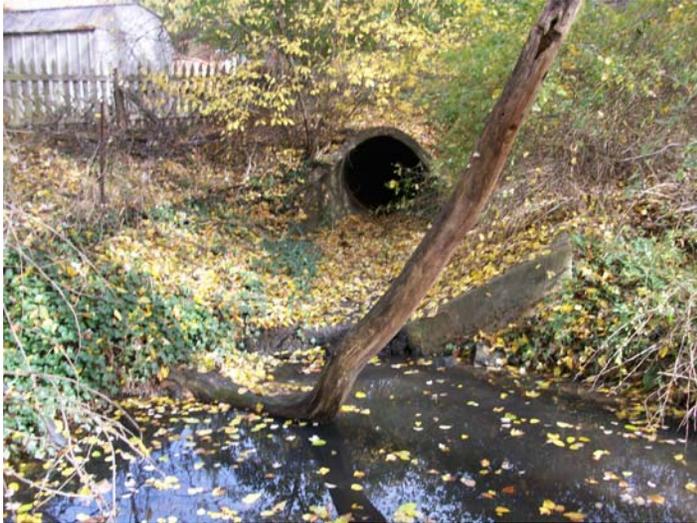
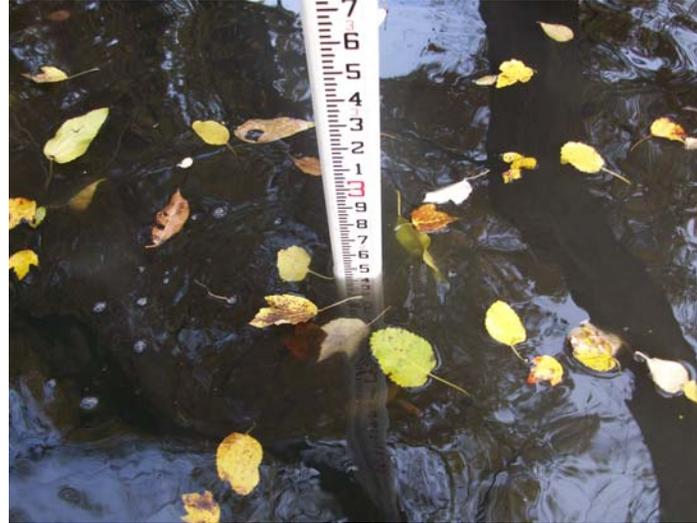
Tributary 3 is described in Section III G11. A repair to the Randolph Road storm drain outfall is also listed here as infrastructure in addition to being mentioned in Section 1. At the end of the concrete apron to the 54" storm drain CMP outfall is a plunge pool that is approximately 2.5 feet to 3 feet deep; see Figures 8.1.1(a) and 8.1.1(b). CPJ is assuming these depths exceed design depths. If a plunge pool was not designed at installation, then a scour pool has developed. Adjacent to the concrete apron, on the left bank (as viewed downstream), are a couple of nickpoints that may influence the integrity of the outfall headwall, concrete apron, design plunge pool, and natural stream channel; see Figures 8.1.1(c) and 8.1.1(d).

Figure 8.1.1(a) Storm drain outfall from Randolph Rd. Figure 8.1.1(b) Outfall scour pool depth.

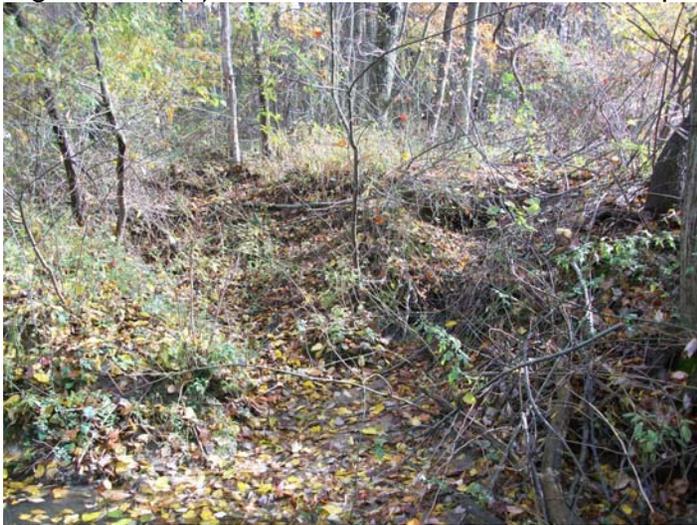
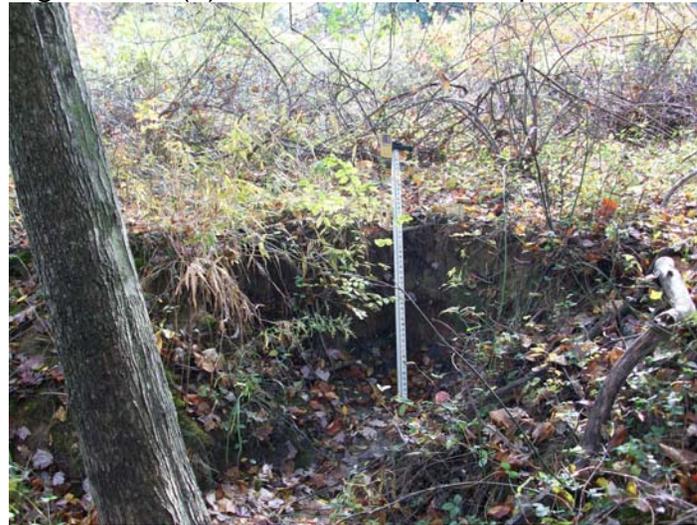
Figure 8.1.1(c) Nickpoint near outfall apron. Figure 8.1.1(d) 2nd nickpoint near outfall apron.
